Ricerca di Sistema elettrico

Risultati relativi alle campagne sperimentali di breve e medio termine sui fenomeni di erosione/corrosione da litio liquido fluente nell'impianto Lifus 6

RISULTATI RELATIVI ALLE CAMPAGNE SPERIMENTALI DI BREVE E MEDIO TERMINE SUI FENOMENI DI EROSIONE/CORROSIONE DA LITIO LIQUIDO FLUENTE NELL'IMPIANTO LIFUS 6

Settembre 2016

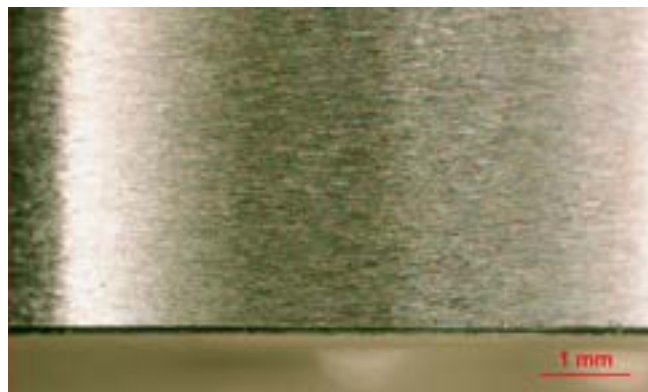
Figure 4: stereoscope image of a representative Eurofer 97 specimen: curved external surface, viewed from the top. The surface is in good shape.

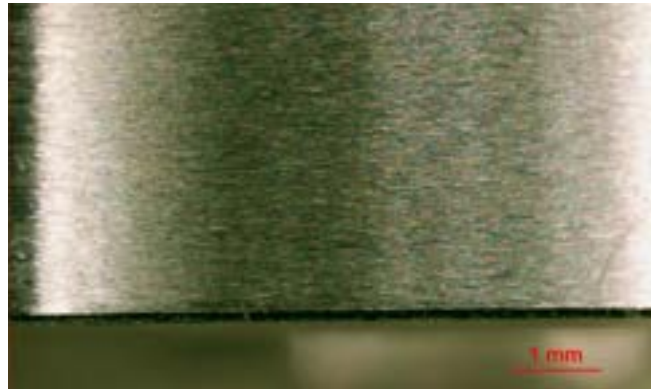
Figure 7: stereoscope image of a representative F82H specimen: curved external surface, viewed from the top. The surface is in good shape.

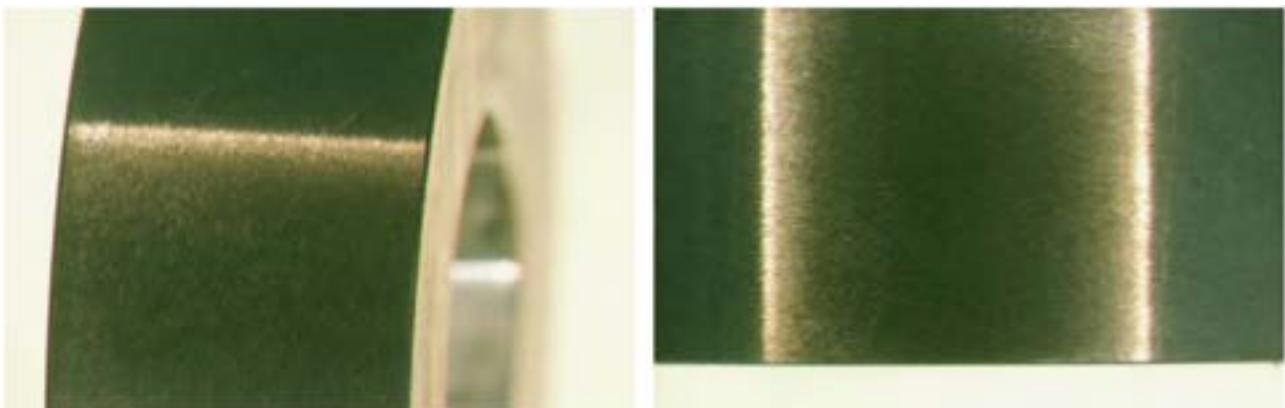
All the 8 specimens present, after the short term test, a smooth and regular surface, not different from that of the fresh specimens. Figure 11 and 12 show the surface of tested specimens n°2 (Eurofer 97) and n° 23 (F82H), as representative of all the investigated specimens.

Figure 11: visual inspection of the surface of tested specimen n°2 (Eurofer 97). Left: overall view; right: external (cylindrical) surface, from the top

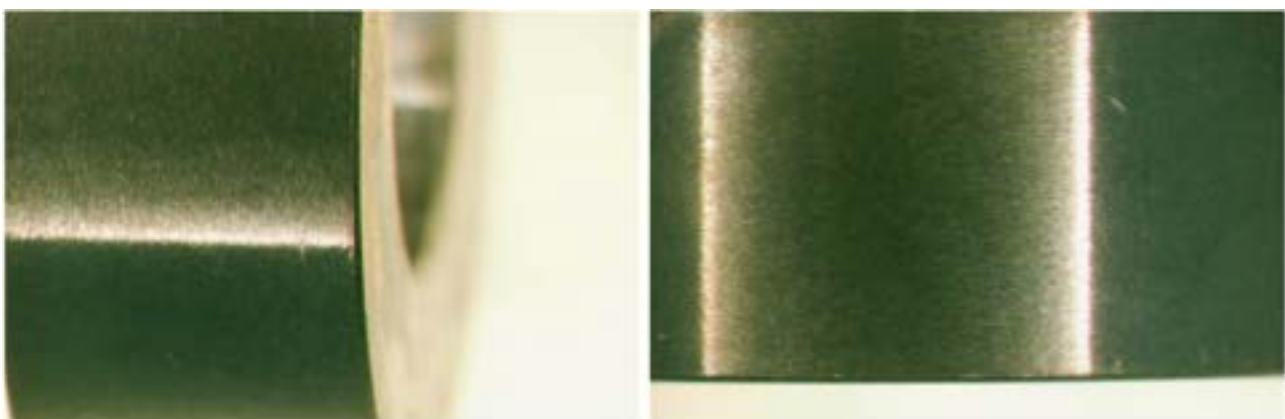
Figure 12: visual inspection of the surface of tested specimen n°23 (F82H). Left: overall view; right: external (cylindrical) surface, from the top

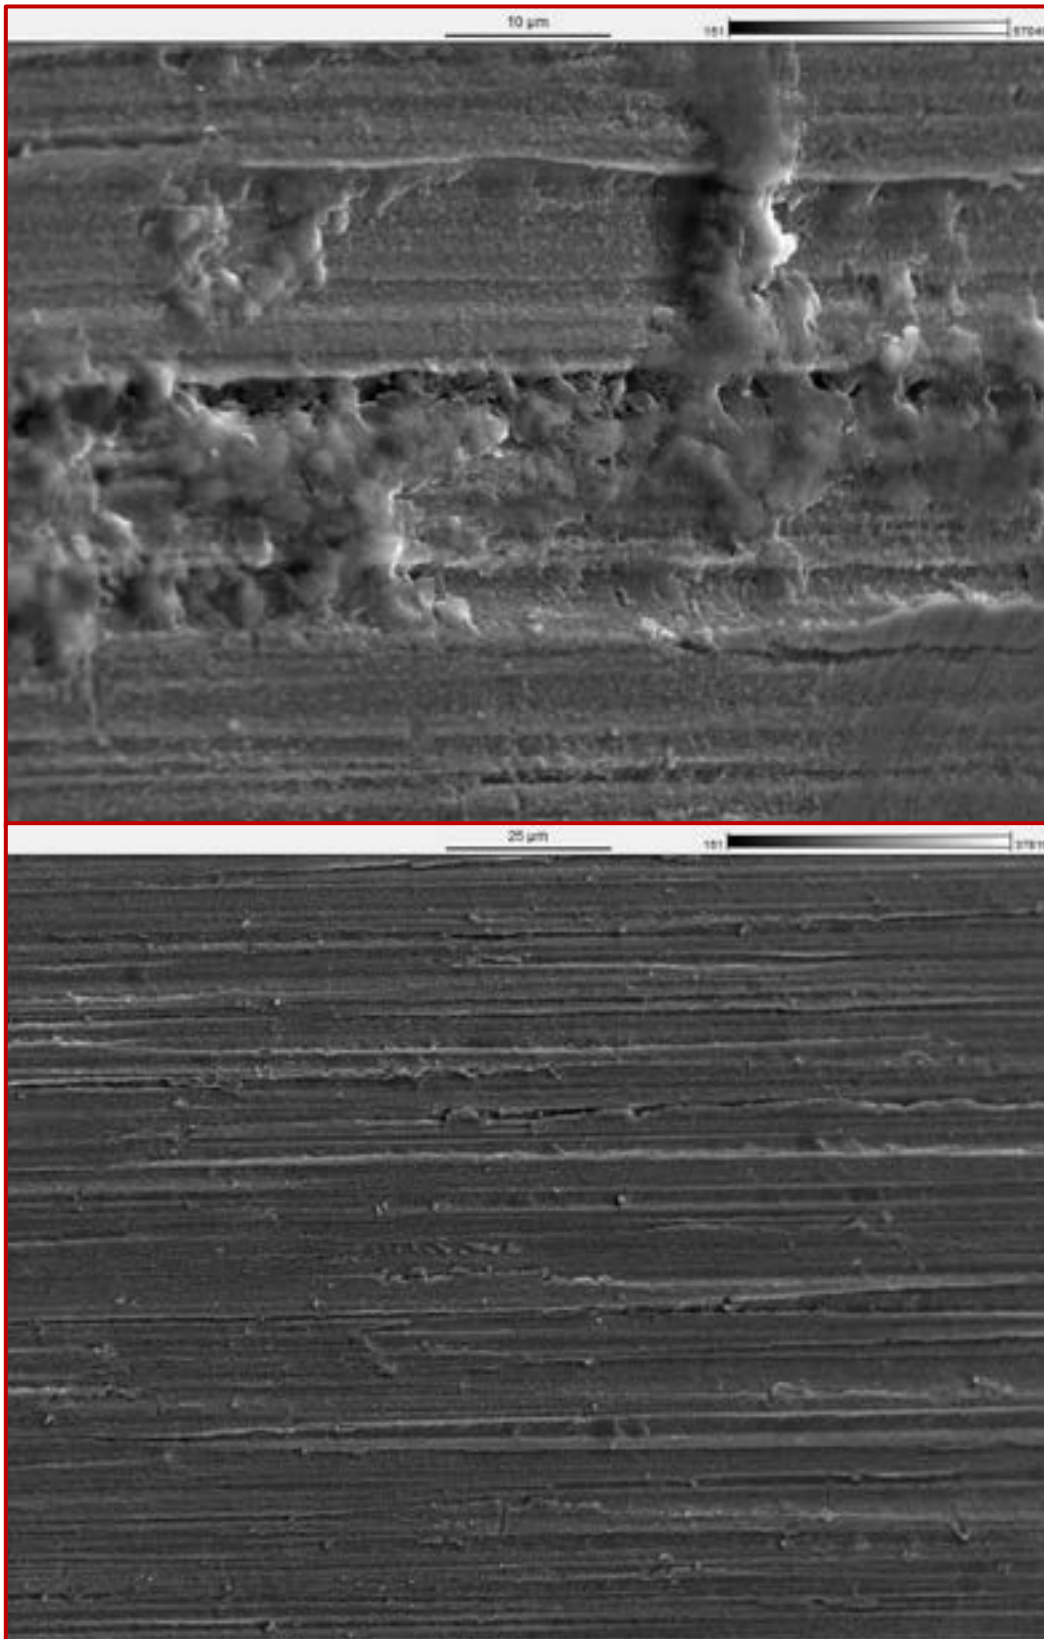
Figure 15: SEM images of specimen n°2 surface (secondary electrons) at different magnitudes. Scale bar above the image.

From the inspection of specimen n° 2 surface, no evident phenomenon of corrosion or erosion appears. All over the investigated surface are present instead the signs produced by the mechanical manufacturing, which precede the experimental test execution. Such signs are similar to the ones already observed on specimen n° 10 surface.

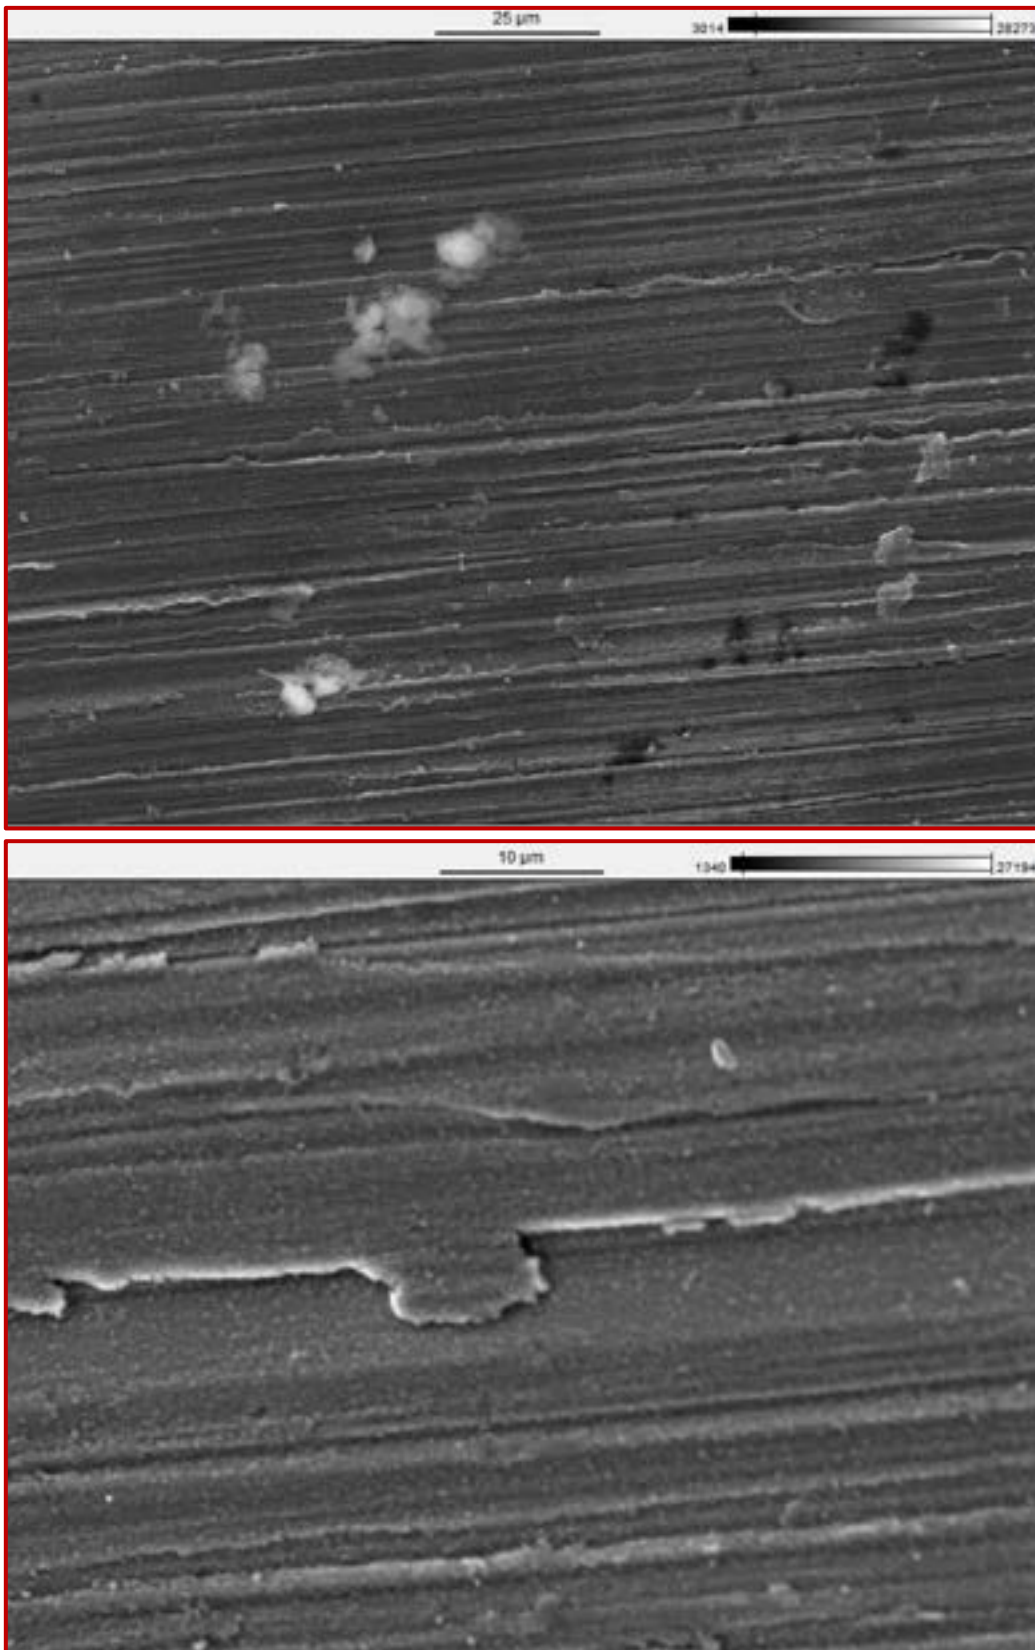
Figure 17: SEM images of specimen n° 3 surface (secondary electrons) at different magnitudes. Scale bar above the image.

Also for this specimen, the observed morphology is a consequence of the mechanical manufacturing executed before the erosion-corrosion test.

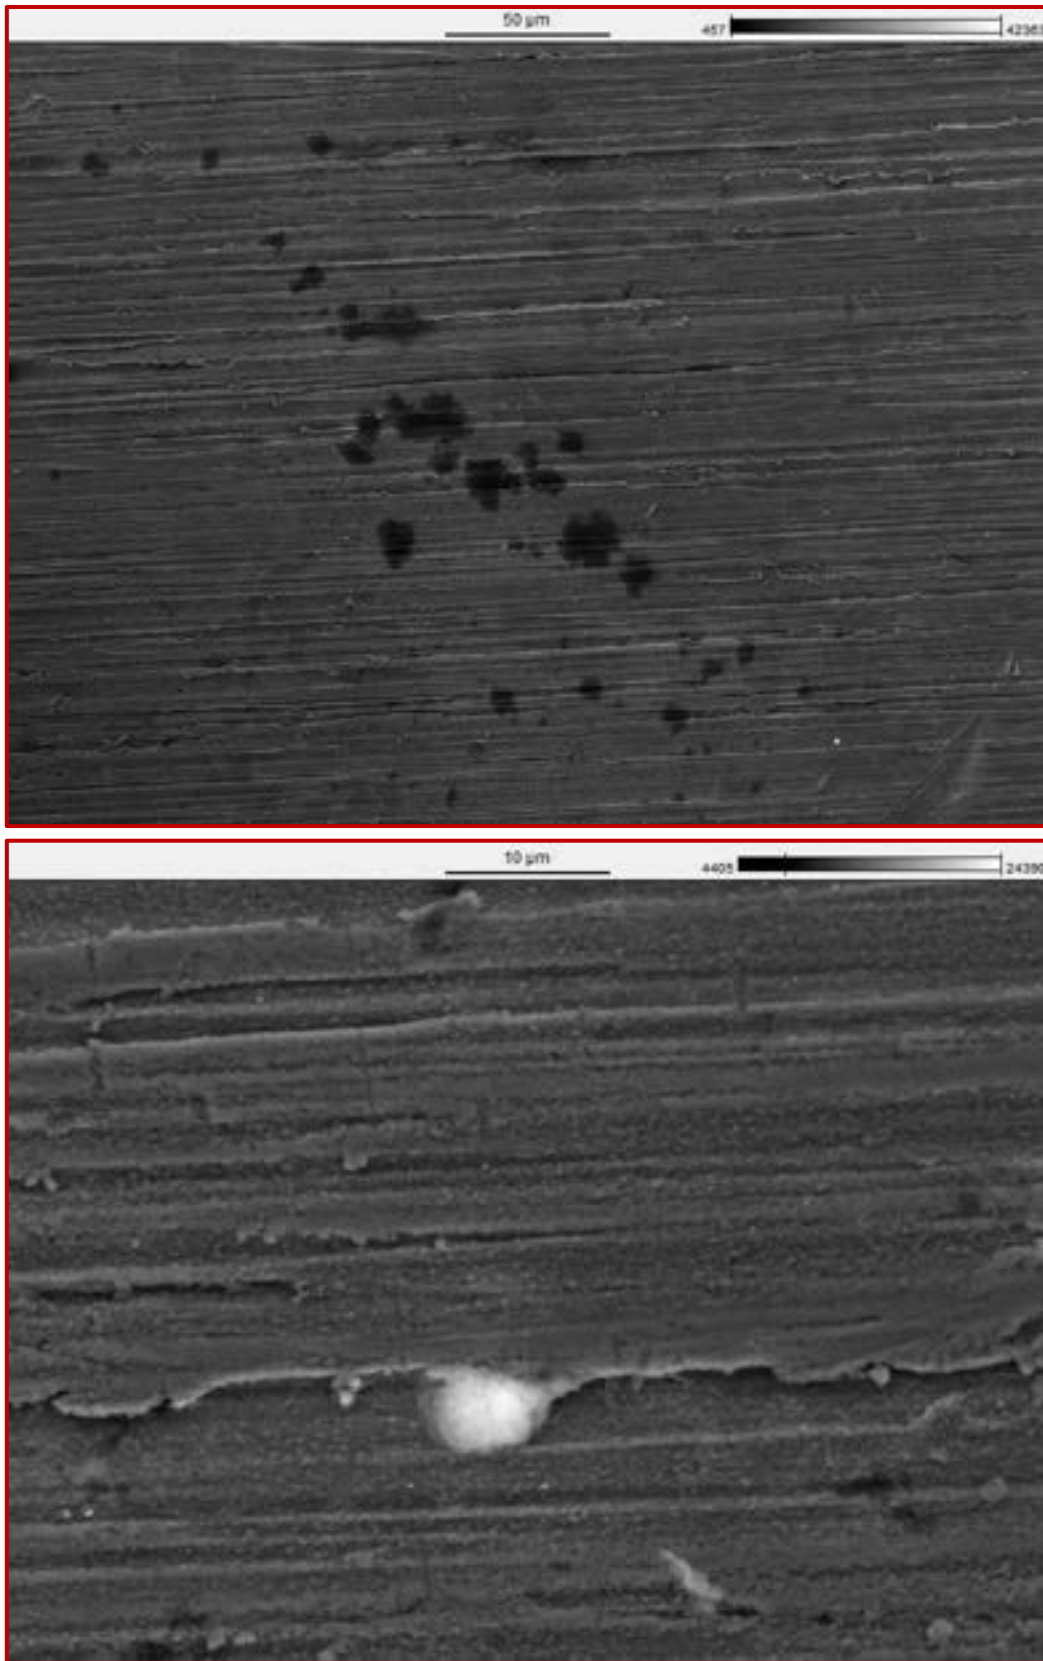
The surface of specimen n°5, at different magnitudes, is instead shown in Figure 21. Apart from the already observed signs of manufacturing, in this sample dark spots and white not conductive corpuscles (high resolution part of Figure 21) are evident. In both cases, the punctual EDS analysis of these specific regions has not indicated meaningful differences respect to the average surface composition (reported in Figure 22 and Table 10). It's possible that these features have organic nature (Carbon and Oxygen are not quantifiable with this kind of analysis) and are due to small contamination after the erosion-corrosion test.

Figure 21: SEM images of specimen n°5 surface (secondary electrons) at different magnitudes. Scale bar above the image.

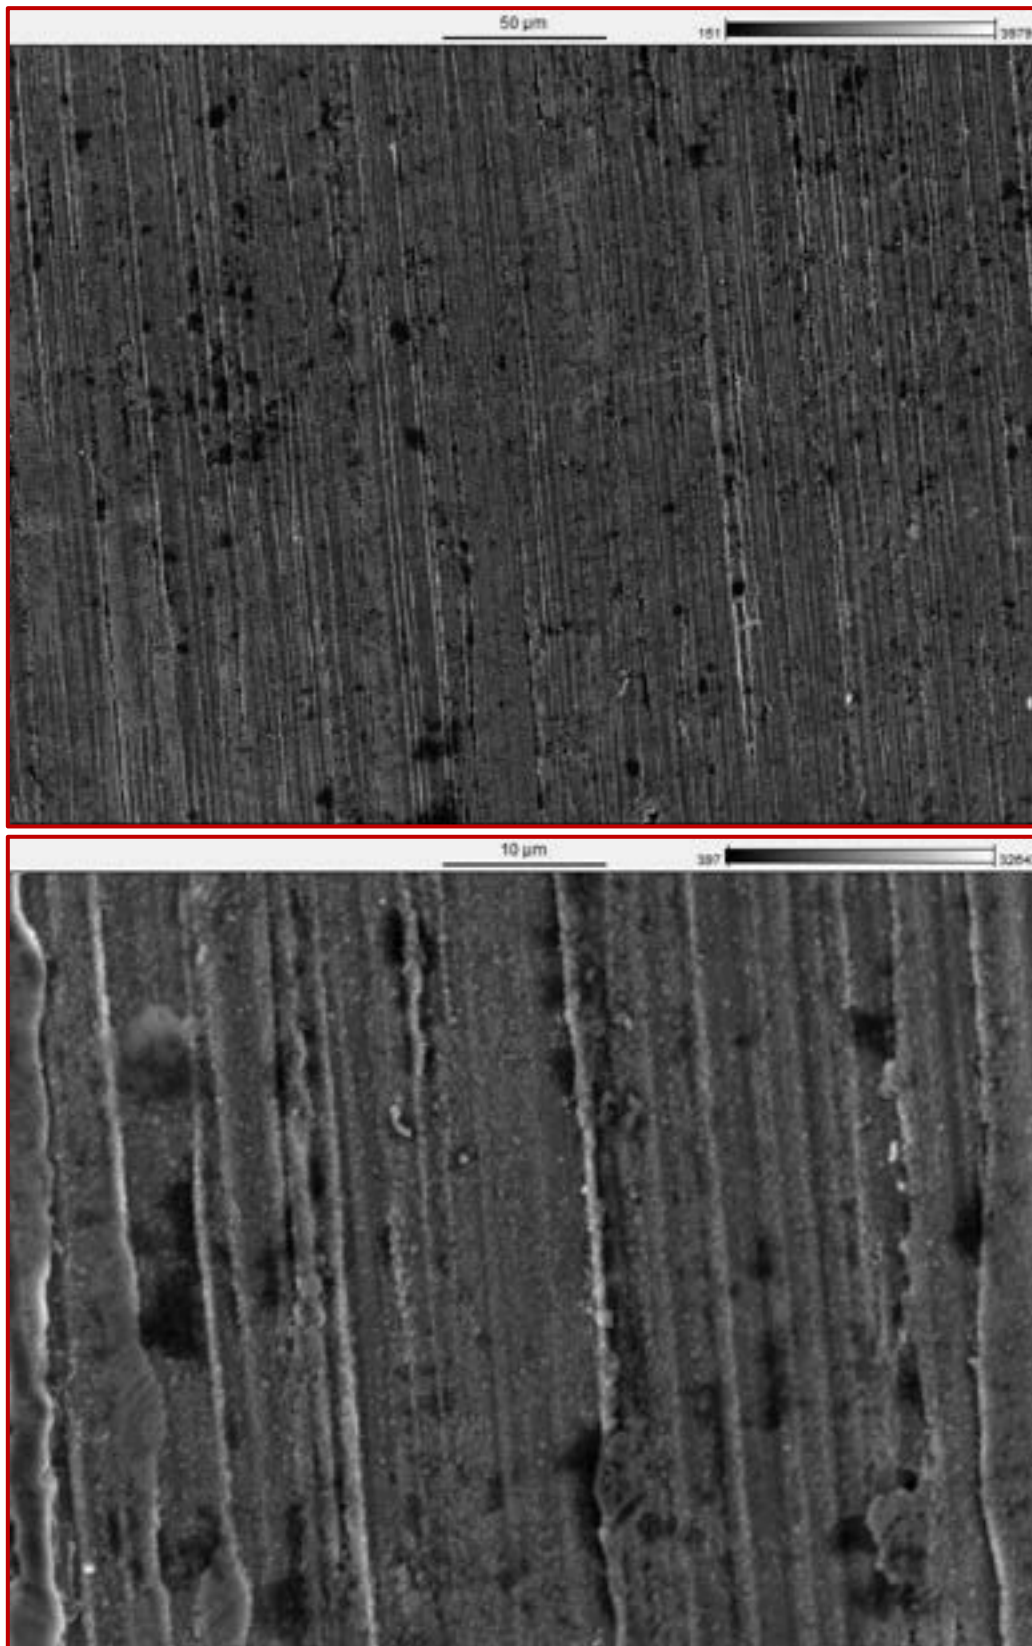
Figure 29 shows, at different magnitudes, the surface of specimen n°24. No substantial alteration of the morphology appears respect to the starting conditions (specimen n°31).

Figure 29: SEM images of specimen n° 24 surface (secondary electrons) at different magnitudes. Scale bar above the image.

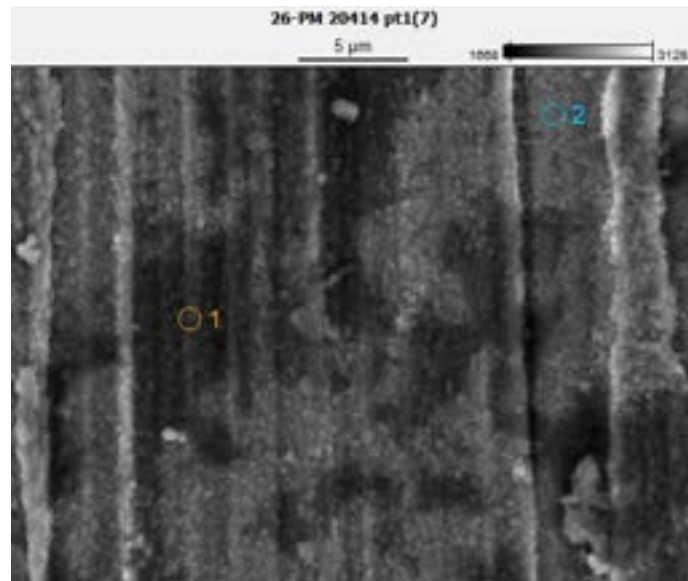
Figure 35: high magnitude image of specimen n°26 surface, highlighting a darker region ('1') and a 'regular' one ('2') (secondary electrons). Scale bar above the image.

Such an Oxygen increase in position '1' might be viewed a consequence of some oxidation process. This process could have occurred during the erosion-corrosion test (by the Oxygen solved in Lithium ?), but it is more likely to have occurred during the cleaning of the specimen, when it was kept for about 45' in boiling water. In any case, the entity of the phenomenon is very small.

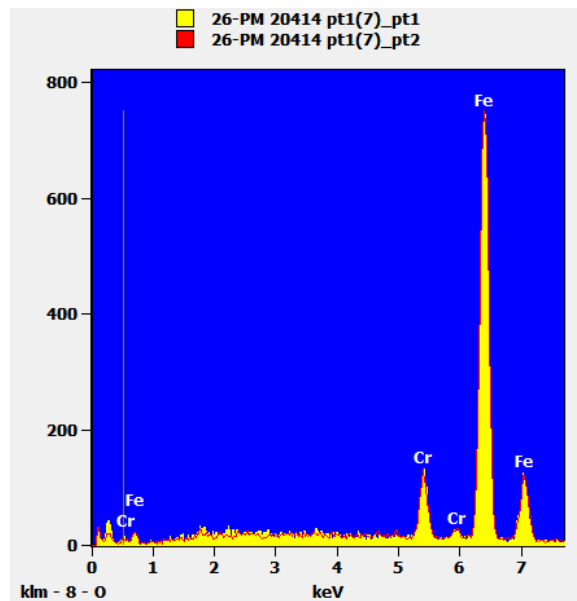
Figure 36: EDS spectrum obtained in correspondence of position '1' and position '2' on the surface of specimen n°26; relative position is indicated in Figure 35.

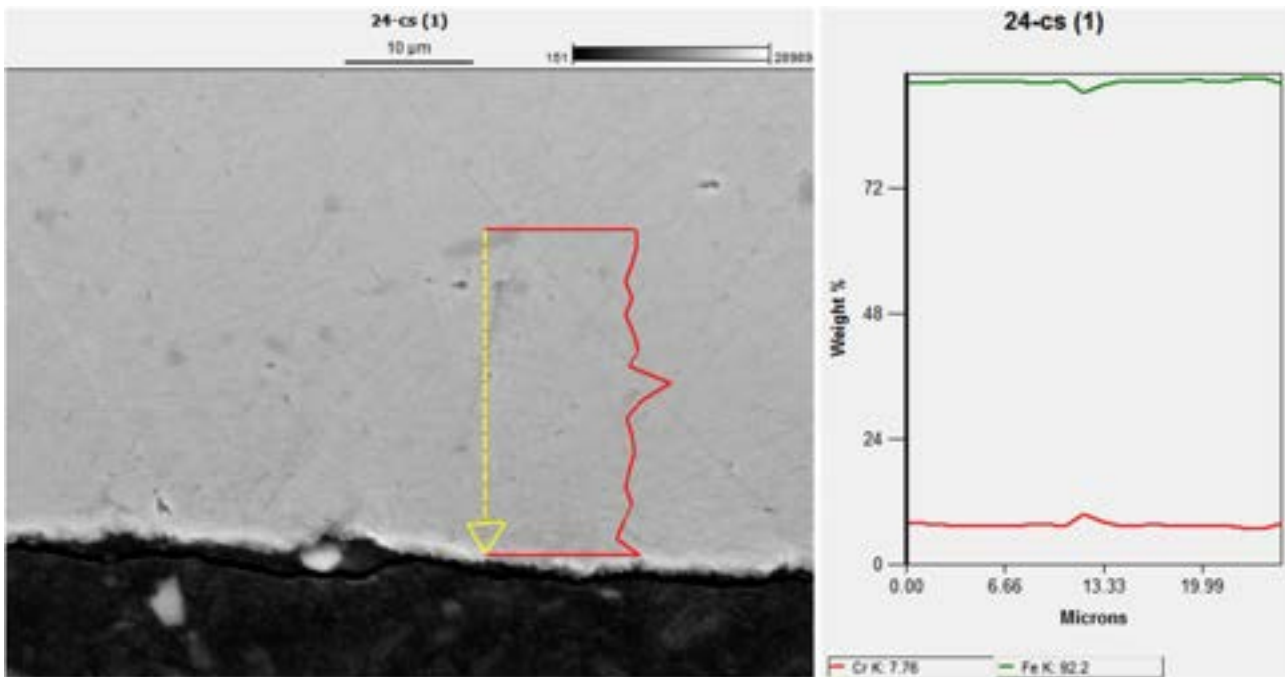
Figure 44 shows on the left a SEM representative image of specimen n° 24 section, with the red Chromium concentration profile overlapped, as determined by the EDS analysis; on the right side is instead reported a graph showing the profiles of both Chromium and Iron elements. The graph meaning and details are the same already described for Figure 37. No internal morphological damage is evident; the concentration profiles are rather flat, with only a small positive peak in Cr concentration at about half path, due to the uncertainty in the EDS analysis result or to a local concentration which is higher by chance. A corresponding peak is visible also in the Fe profile, this time negative, since the sum of the two concentration values is fixed to be always 100%. In any case, no real increasing/decreasing trend appears moving along the direction of the yellow arrow.

Figure 44: left: SEM image and Cr concentration profile (EDS) of specimen n° 24 cross section; right: Cr (red) and Fe (green) concentration profiles along the specimen section.
