## Risultati relativi alla campagna sperimentale di medio termine sui fenomeni di erosione/corrosione da Litio liquido fluente nell'impianto Lifus 6

P. Favuzza, M. Cuzzani, V. Cuzzola, G. Fasano, A. Ventura (ENEA)

Settembre 2017

Progetto: B.3.2 – Attività di Fisica della Fusione Complementari a ITER

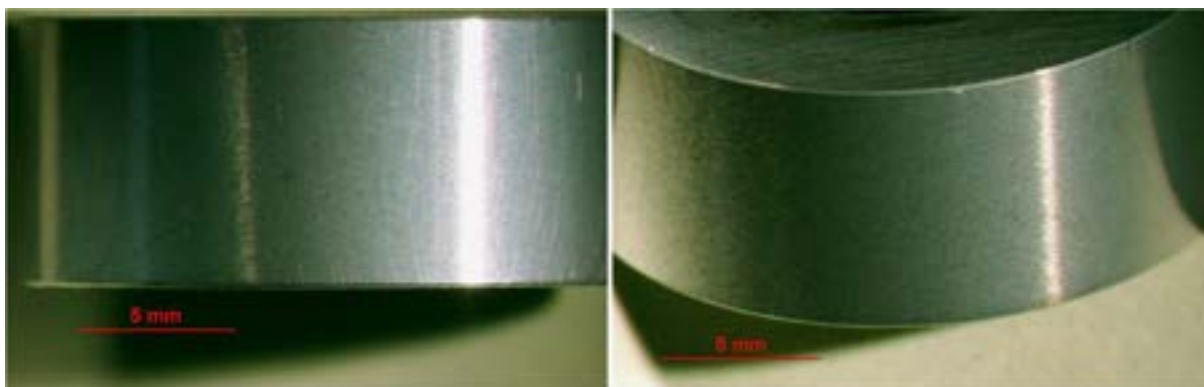
Figure 12 shows 2 different views of the external surface of specimen #12 (Eurofer 97, 2000 hours total exposure, exit of the Test Section) after the test. The surface is smooth and regular. Compared with the appearance of a fresh Eurofer 97 specimen (Fig. 4), no difference is evident, a part from (perhaps) some very light stripes going along the specimen height.

Figure 12: optical stereoscope inspection of the surface of tested specimen #12 (Eurofer 97, 2000 hours).

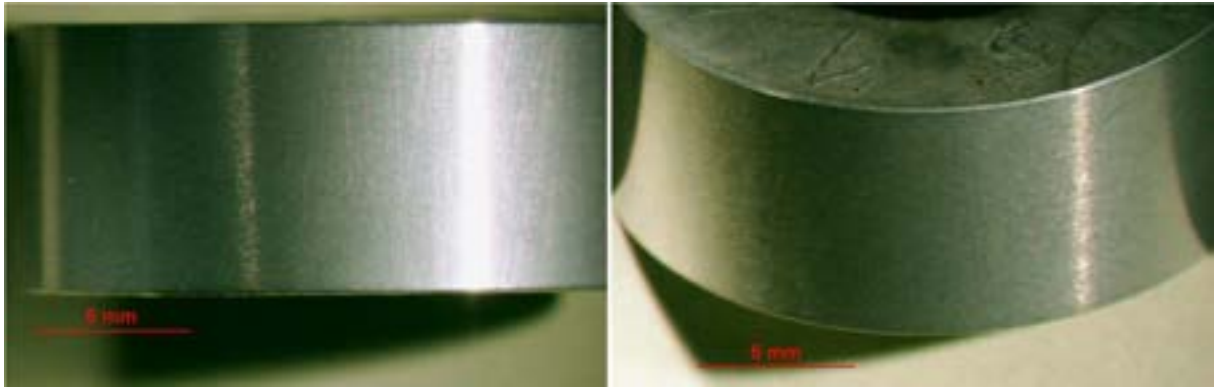
Figure 13 shows instead 2 different views of the external surface of specimen #7 (Eurofer 97 again, but 4000 hours total exposure, inner of the Test Section). The surface is smooth and regular; some very light stripes going along the specimen height can be noted again, which don’t appear, however, more pronounced than for the previous specimen.

Figure 13: optical stereoscope inspection of the surface of tested specimen #7 (Eurofer 97, 4000 hours).

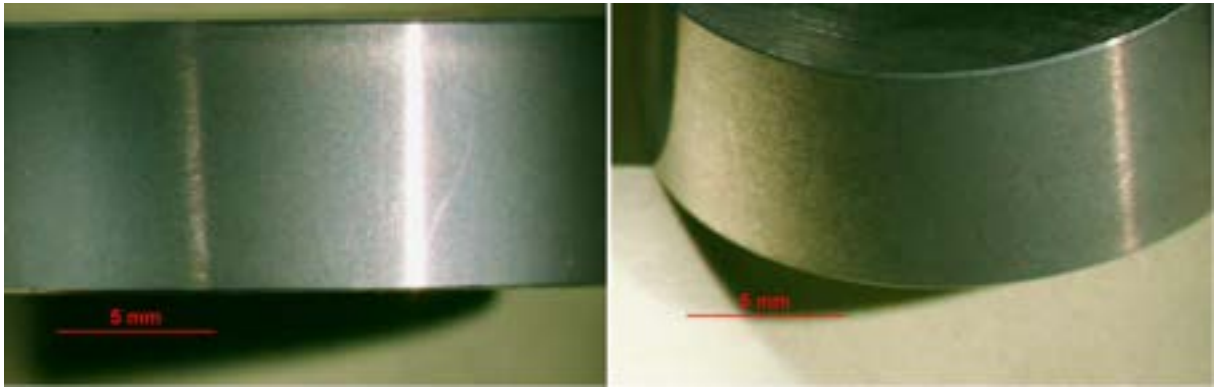
Figure 14 shows 2 different views of the external surface of specimen #34 (F82H, 2000 hours total exposure, entering of the Test Section) after the test. The surface is smooth and regular. Compared with the appearance of a fresh F82H specimen (Fig. 7), no difference is evident, nor even the light stripes seen in the previous specimens.

Figure 14: optical stereoscope inspection of the surface of tested specimen #34 (F82H, 2000 hours).

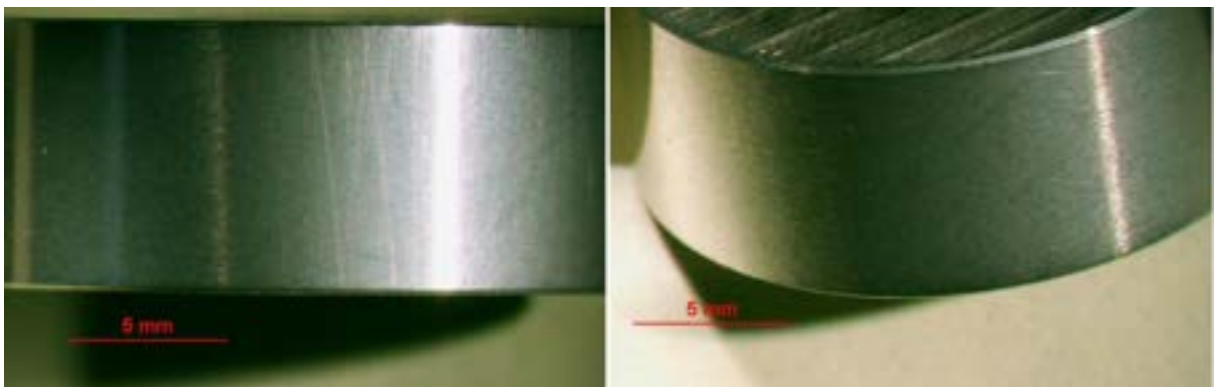
Figure 15 finally shows 2 different views of the external surface of specimen #28 (F82H again, but 4000 hours total exposure, inner of the Test Section). The surface is smooth and regular; some very light stripes going along the specimen height can be noted, a little more pronounced than in the two previous Eurofer 97 specimens.

Figure 15: optical stereoscope inspection of the surface of tested specimen #28 (F82H, 4000 hours).

On the whole, the appearance of the specimens after the test confirms the rather small damage provoked on them by the flowing Lithium. Some doubt remains about the nature of the light stripes visible on the left side of each of the previous figures, whether they result from just visual artifacts or they correspond to a real physical situation: in this case, they could indicate that the mass lost by the specimens is to some extent due also to an erosive effect exerted by the flow of Lithium, since a purely chemical dissolution would have been more isotropic on the specimen surface and would not have marked a specific attack direction.

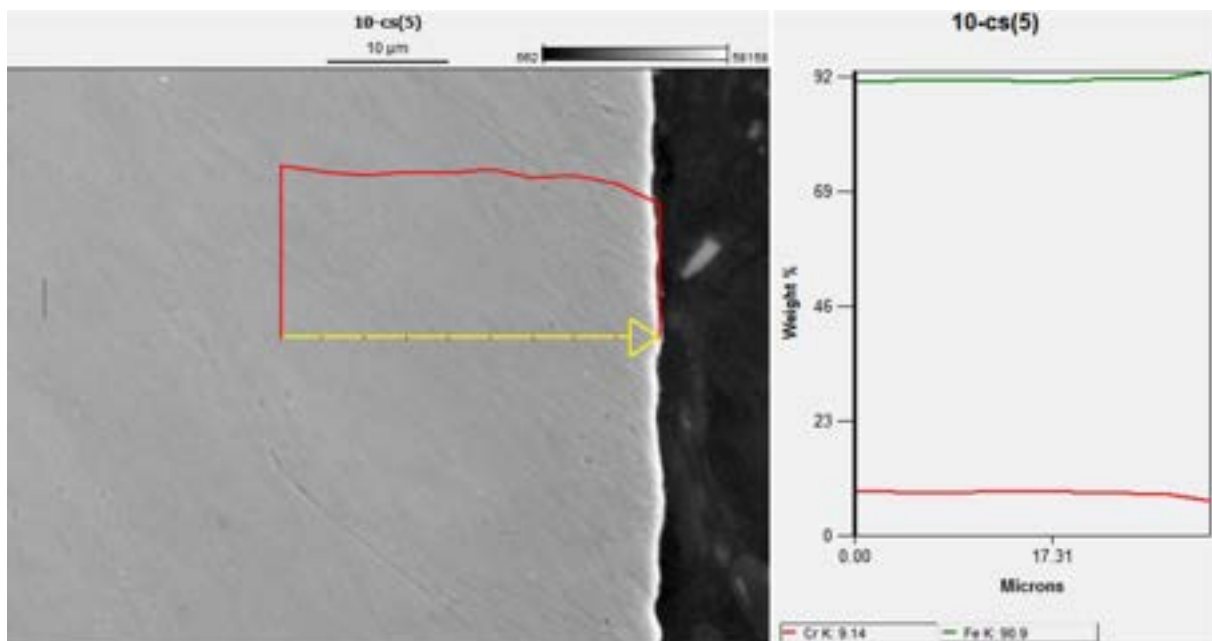
From the observation of Figure 19, it is possible to note that the internal specimen structure is in good condition, with only some sign due to the cut and preparation of the sample, but no erosion-corrosion damage: this is of course what expected, since specimen #10 is an unexposed specimen. The concentration profiles indicate a substantial constancy of values; the minimal value of Cr concentration at the highest value of  $x$  is not physically sure, because this measurement point was too close to the specimen border.

Figure 19: left: SEM image and Cr concentration profile (EDS) of specimen #10 section; right: Cr (red) and Fe (green) concentration profiles along the specimen section.

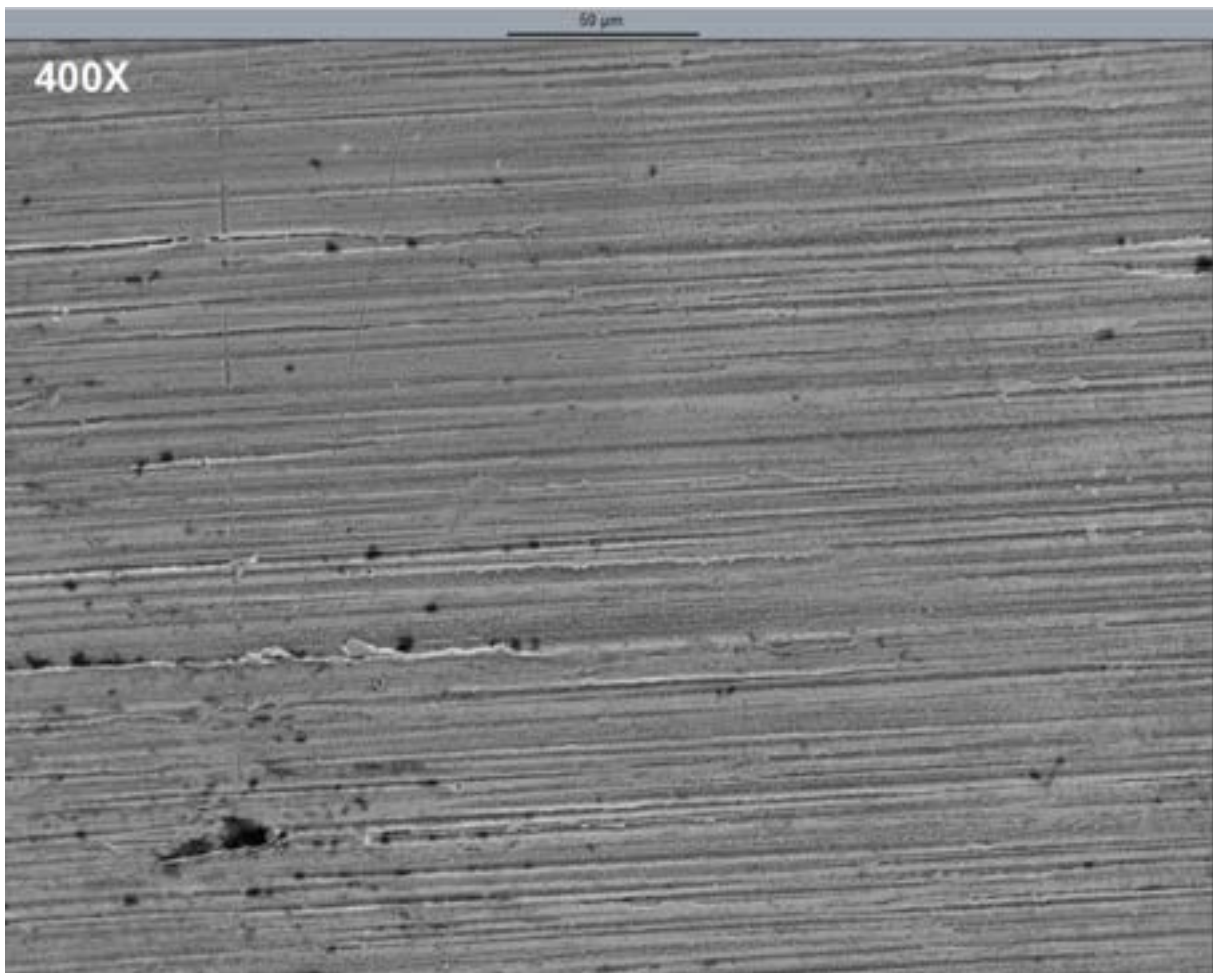
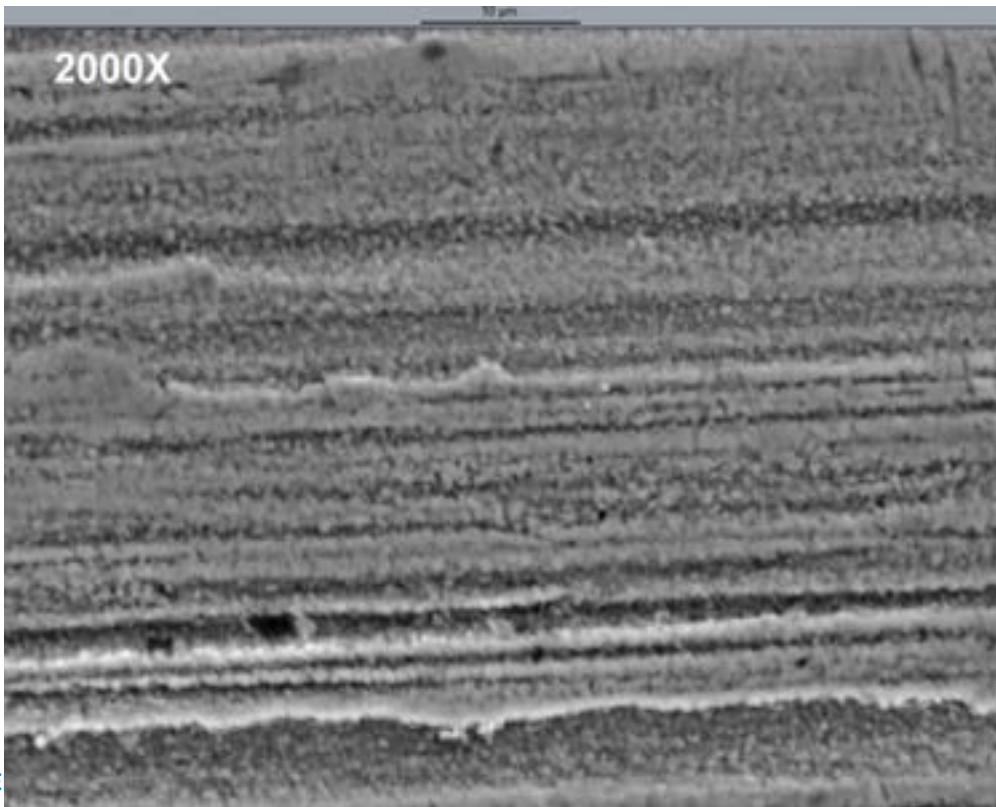
Figures 20 and 21 show, respectively at magnitude 400 and 2000X, a portion of the external surface of this specimen. Apart from the usual stripes produced during the mechanical manufacturing of the sample, no significant morphological alteration, ascribable to corrosion phenomena, is seen.

Figure 20: SEM image of specimen #12 surface (secondary electrons) at magnitude 400 X. Scale bar above the image

Figure 21: SEM image of specimen #12 surface (secondary electrons) at magnitude 2000 X. Scale bar above the image.

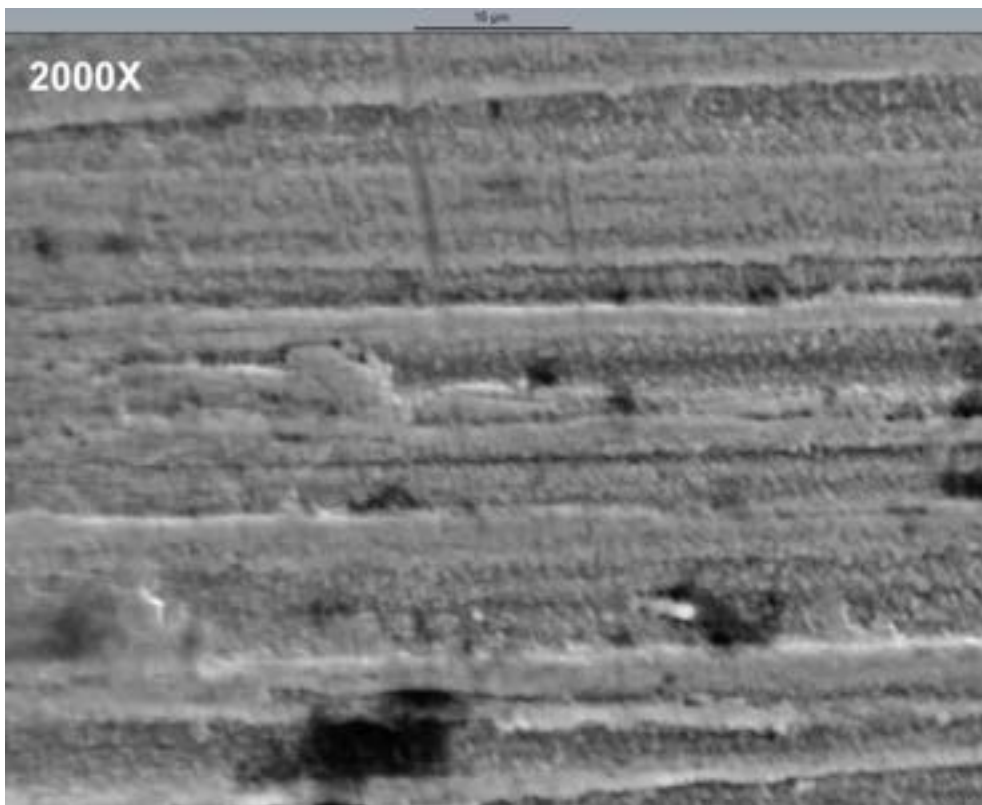
Figure 22 depicts instead, at magnitude 2000X, another different region of the external specimen surface. Also in this region, no corrosion item is detected.

By comparing Figures 21 and 22 with the bottom half of Figure 17 (observations made at the same magnitude) it appears anyway a more 'granulose' profile of the specimen #12 surface compared to the fresh one.

Figure 22: SEM image of another portion of specimen #12 surface (secondary electrons) at magnitude 2000 X. Scale bar above the image.

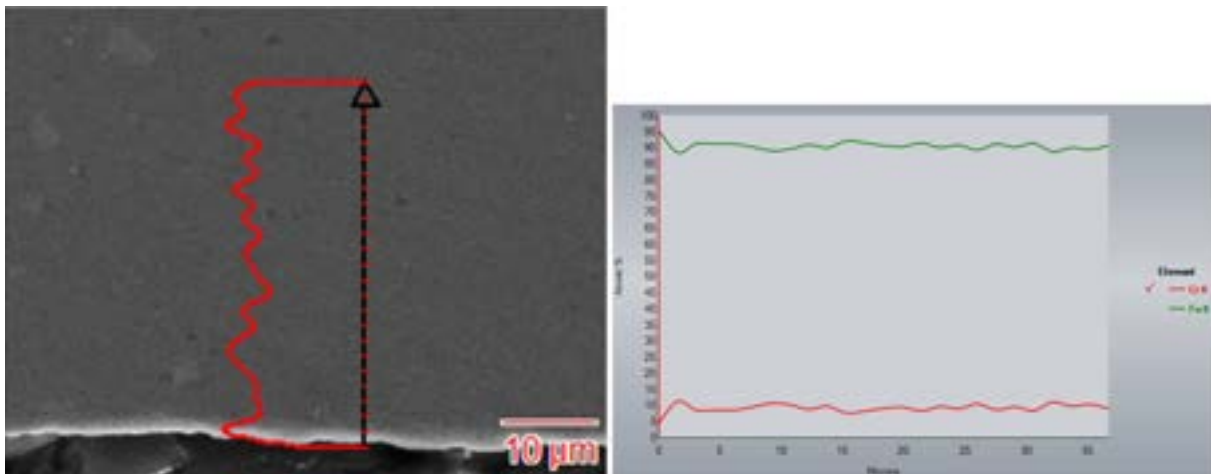
Figure 24 (left) shows instead a SEM image at 2000X of a representative cross section of specimen #12, together with the overlapped Chromium concentration vs depth profile, constructed by the EDS analysis of equidistant points (~ 1.5 μm spaced), in the arrow direction. On the right side of Figure 24 is instead reported a graph showing the profiles of both Chromium and Iron elements along the arrow direction, where y-axis is the atomic % concentration, while x-axis indicates the distance from the surface (the surface position is on the left boundary of the graph, in correspondance of x = 0).

**Figure 24: left: SEM image and Cr concentration profile (EDS) of specimen #12 section; right: Cr (red) and Fe (green) concentration profiles along the specimen section.**

From the observation of Figure 24 left, it is possible to note that the internal specimen structure is in good condition, with no morphological alteration or grain detachment. The concentration profiles on the right indicate a substantial constancy of values, with only small oscillations due to little random deviations from the theoretical alloy composition and/or to the analysis uncertainty (the starting 'red' value, on the left (Cr), must not be misleading; it is characterized by a value of  $\sim 5$ , which is the lowest of all the Cr points, but it is associated to a measurement on the boundary of the sample, so it is not physically meaningful. The first real point is therefore the one of its right, which corresponds to a relative maximum, and from here on Cr concentrations are essentially constant).

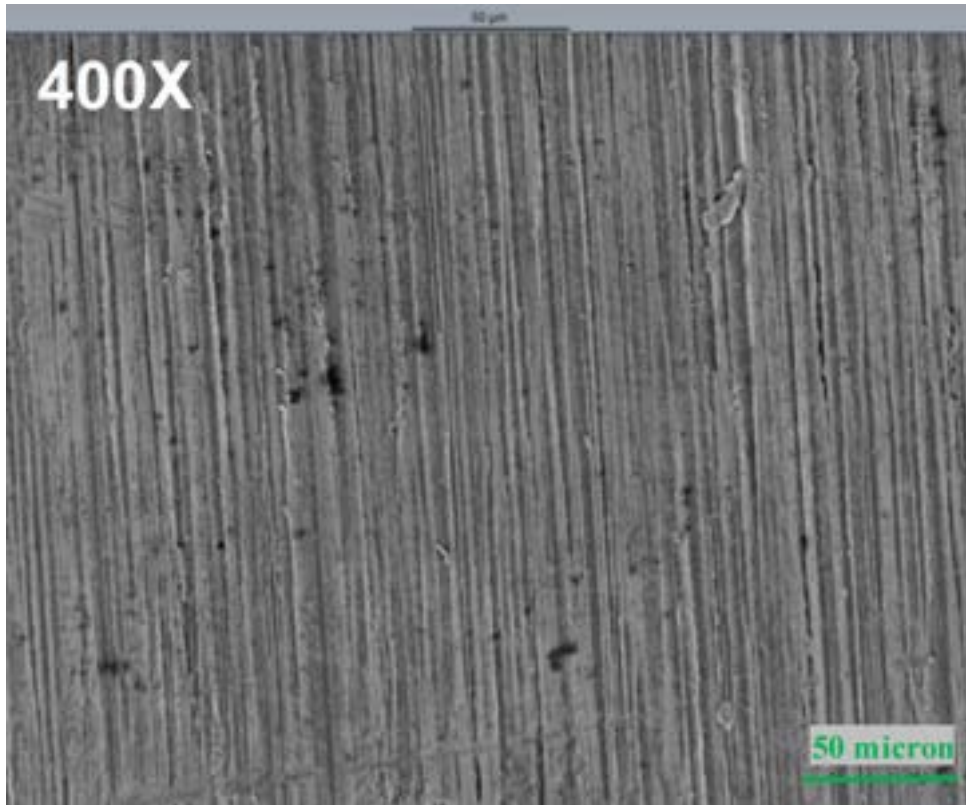
Figures 25 and 26 show, at magnitude 400X, 2 different regions of the external surface of this specimen. Region A (Figure 25) is characterized by the absence of degradative phenomena and is exemplifying of the general surface condition; region B (Figure 26) is instead characterized by the presence of some corrosion items (circled in red), which are anyway uncommon on the surface. When enlarging Figure 26 to Figure 27, it is easier to see that these surface anomalies are compatible with a small pitting phenomenon.

Figure 25: SEM image of region A of specimen #13 surface (secondary electrons) at magnitude 400 X. Scale bar above the image.

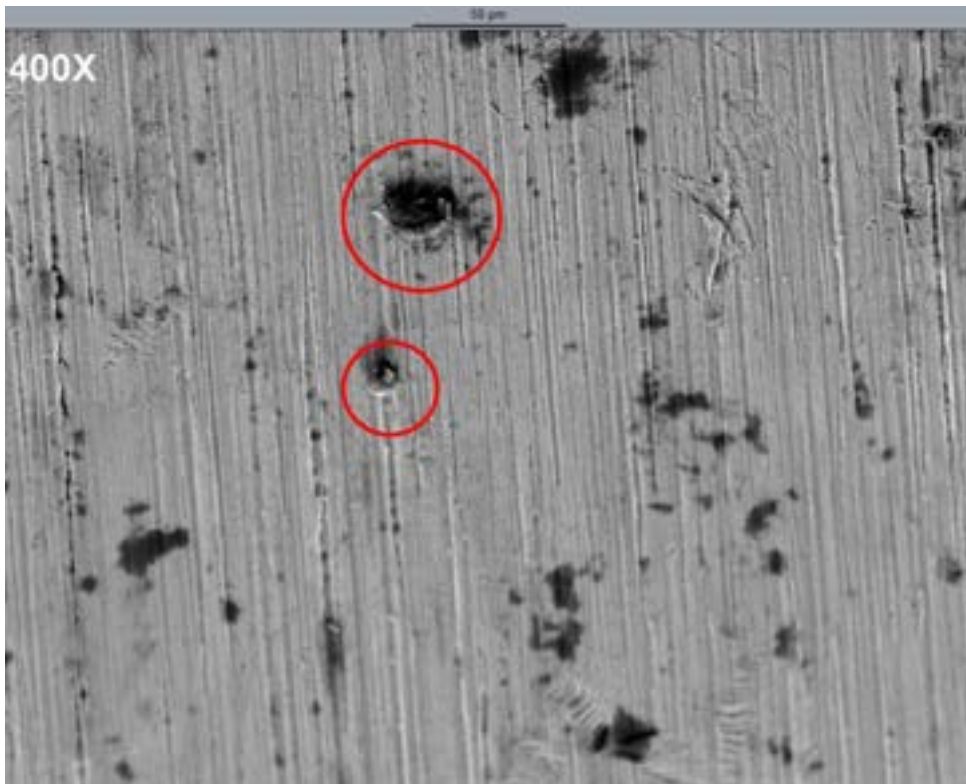
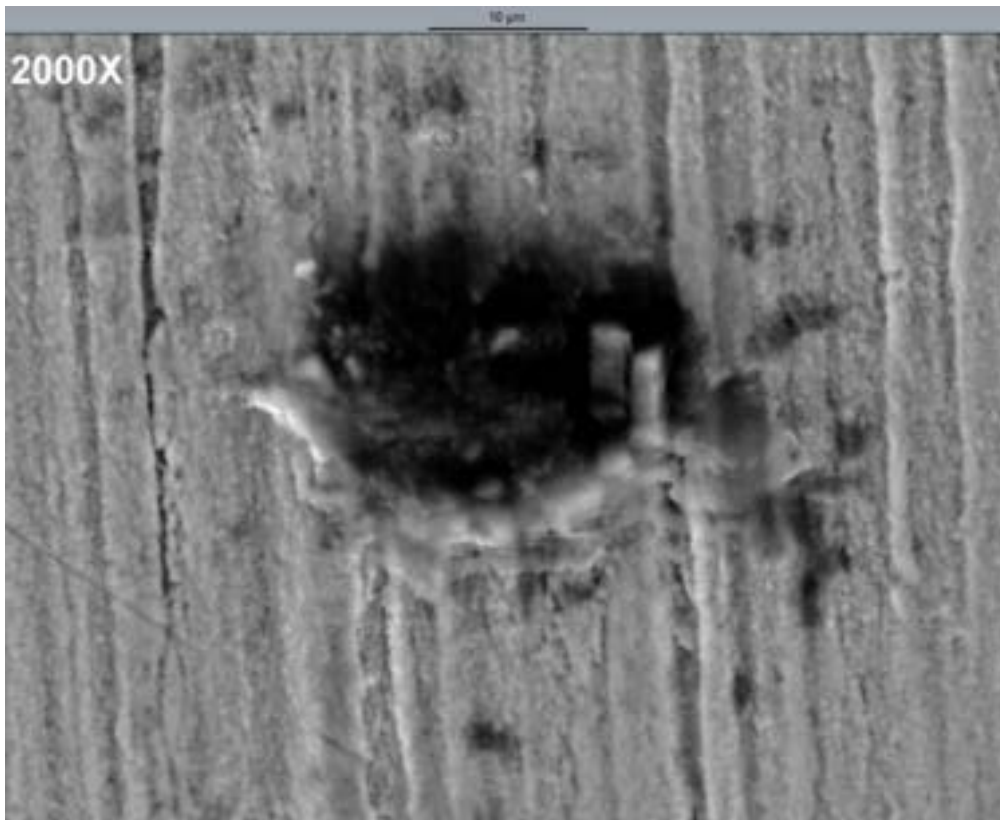
Figure 26: SEM image of region B of specimen #13 surface (secondary electrons) at magnitude 400 X. Scale bar above the image.

Figure 27: SEM image of region B of specimen #13 surface (secondary electrons) at magnitude 2000 X (enlargement of Figure 26). Scale bar above the image.

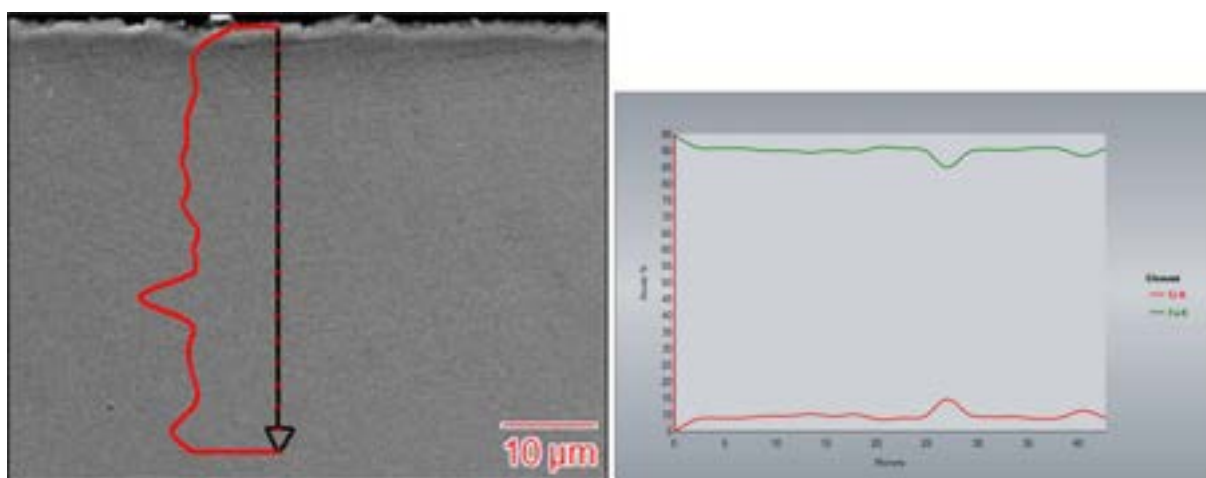
Figure 29 (left) shows a SEM image at 2000X of a representative cross section of specimen #13, together with the overlapped Chromium concentration vs depth profile, constructed by the EDS analysis of equidistant points (~ 2.2 μm spaced), in the arrow direction. On the right side of Figure 29 is instead reported a graph showing the profiles of both Chromium and Iron elements along the arrow direction, where y-axis is the atomic % concentration, while x-axis indicates the distance from the surface (the surface position is on the left boundary of the graph, in correspondence of x = 0). From the observation of Figure 29 left, it is possible to note that the internal specimen structure is in good condition, with no morphological alteration or grain detachment. The concentration profiles on the right indicate no increasing or decreasing trend of values moving inside the specimen; the starting Cr value, on the left (~ 5), must not be misleading, because it is associated to a measurement on the boundary of the sample, so it is not physically meaningful: the first real point is therefore the one of its right. A part from small values fluctuations, a peak in Cr concentration is seen around 27 μm below the surface. This peak describes a real physical situation, maybe corresponding to a local accumulation of Cr in the form of Carbide; such a kind of compound can be present in the specimen also before the test (in the starting steel composition), therefore it is not indicative of a structure alteration produced by the exposure to flowing Lithium.

**Figure 29: left: SEM image and Cr concentration profile (EDS) of specimen #13 section; right: Cr (red) and Fe (green) concentration profiles along the specimen section.**

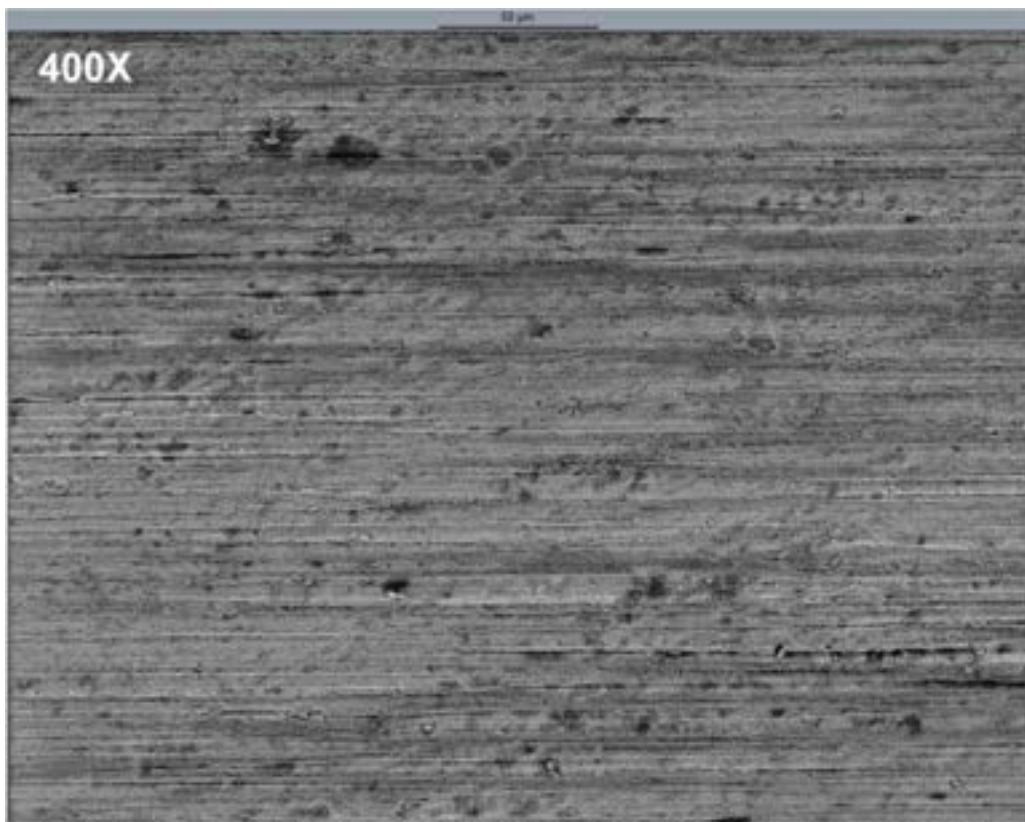
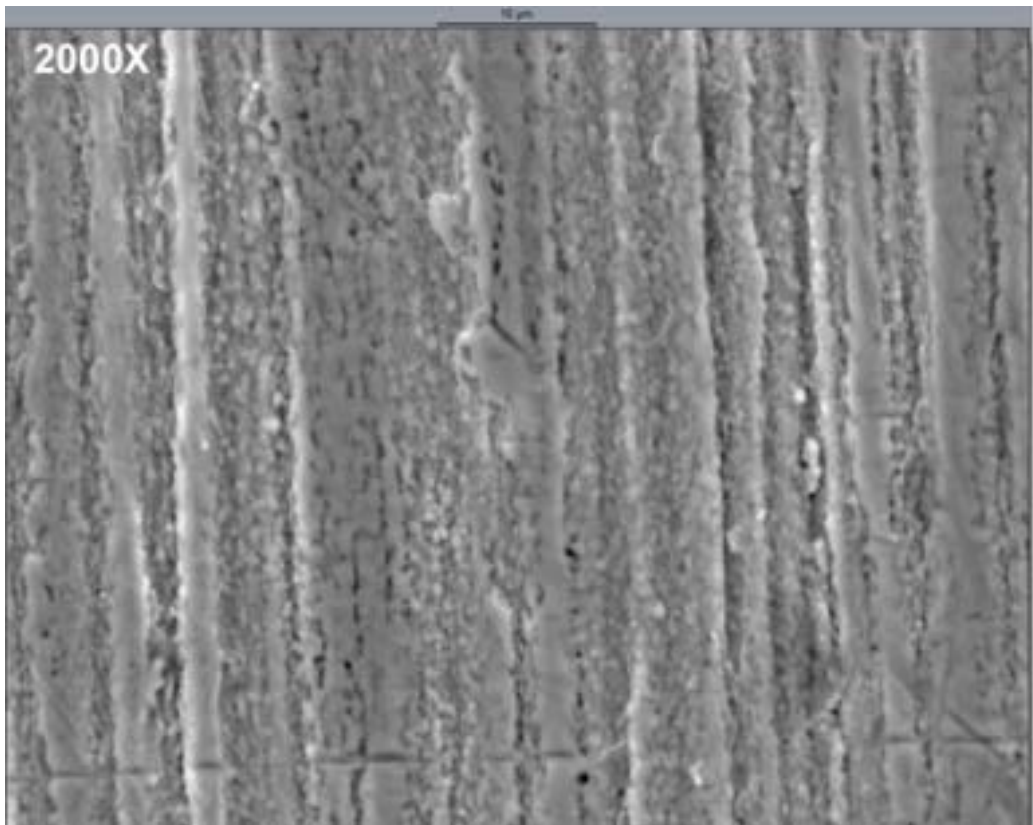
Figures 30 and 31 show, respectively at magnitude 400 and 2000X, 2 portions of the external surface of this specimen. Apart from the usual stripes produced during the mechanical manufacturing of the sample, no significant morphological alteration, ascribable to corrosion phenomena, is seen. The round black spots, which are seen here as well as in any other investigated specimen, are not due to degradative phenomena of the surface but to external organic substances stuck on the surface. By comparing Figures 31 with the bottom half of Figure 17 (observations made at the same magnitude) it appears anyway a more 'granulose' profile of the specimen #7 surface compared to the fresh one.

**Figure 30: SEM image of specimen #7 surface (secondary electrons) at magnitude 400 X. Scale bar above the image.**

Figure 31: SEM image of specimen #7 surface (secondary electrons) at magnitude 2000 X. Scale bar above the image

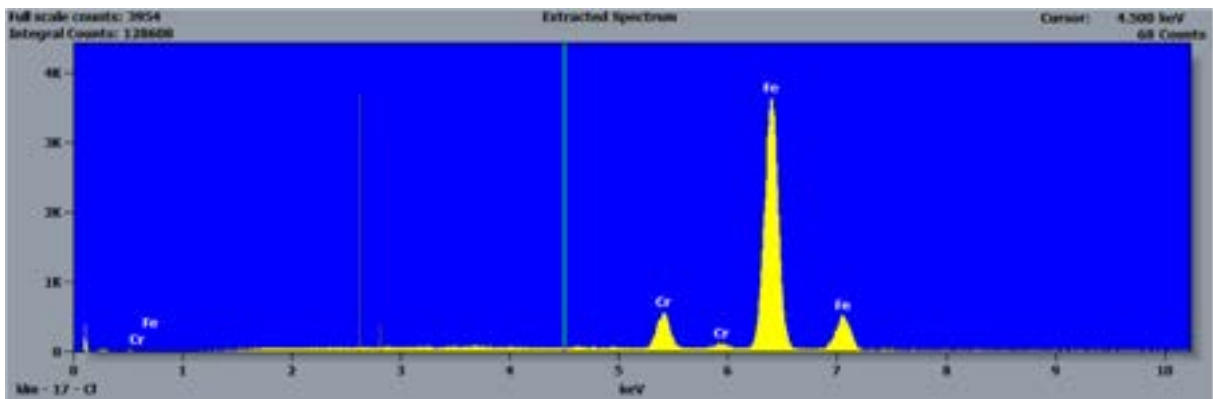
Figure 32 reports instead the average EDS spectrum of a large surface region; Table 8 summarizes the values of the related compositional analysis. By looking at Figure 32, the zeroing of Mn and W is evident. Moreover, by comparing Table 8 with Table 5, the Chromium depletion is observed (-1.2% by weight); Iron content is instead a bit increase, so to compensate for that diminution.

Figure 32: EDS spectrum obtained at specimen #7 surface

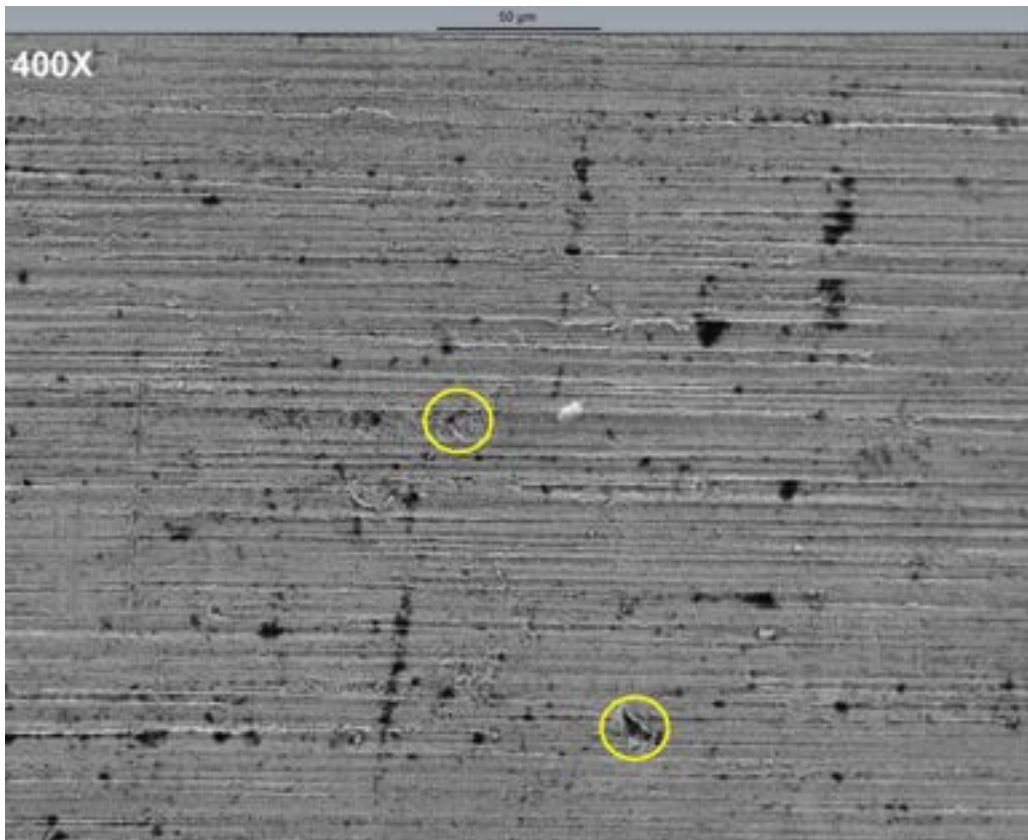
Figure 34 shows, at magnitude 400X, a portion of the external surface of this specimen. The surface presents the usual features already observed in the other investigated specimens, including also the fresh Eurofer 97 (specimen #10): stripes produced during the manufacturing and black spots due to stuck organic substances. No corrosion item is clearly seen, a part, perhaps, the two small anomalies circled in yellow, which appears as shallow cavities.

Figure 34: SEM image of specimen #8 surface (secondary electrons) at magnitude 400 X. Scale bar above the image.

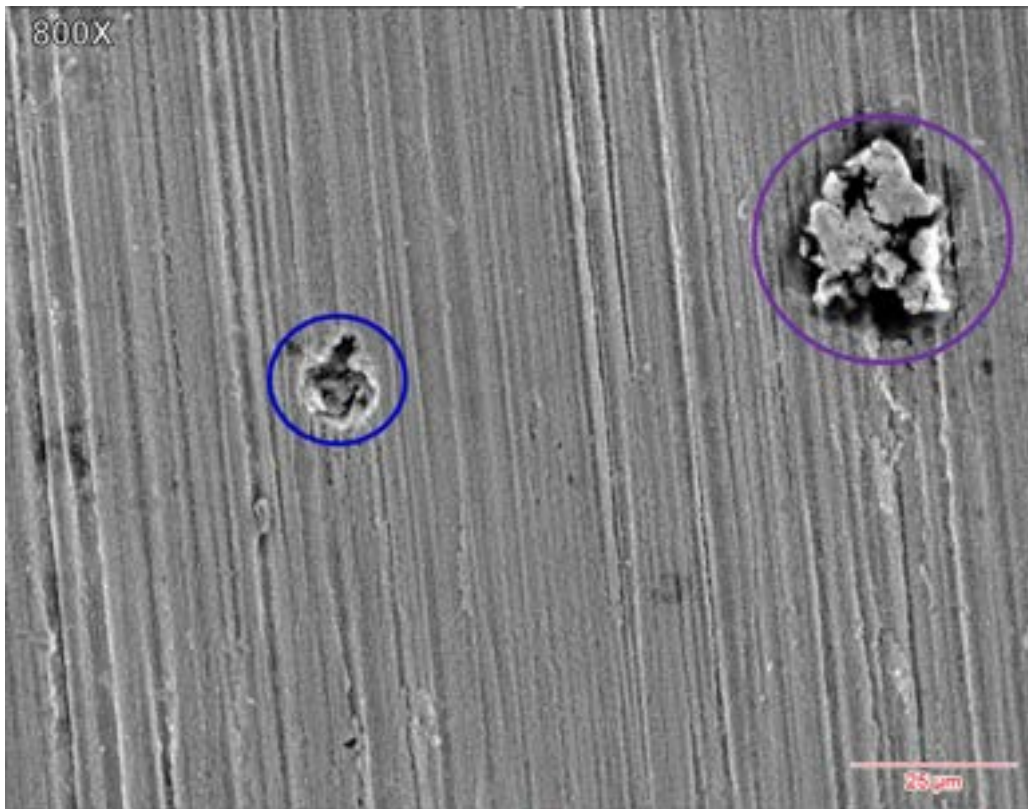
Figure 47: SEM image of specimen #34 surface (secondary electrons) at magnitude 800X, highlighting two surface anomalies. Scale bar above the image.

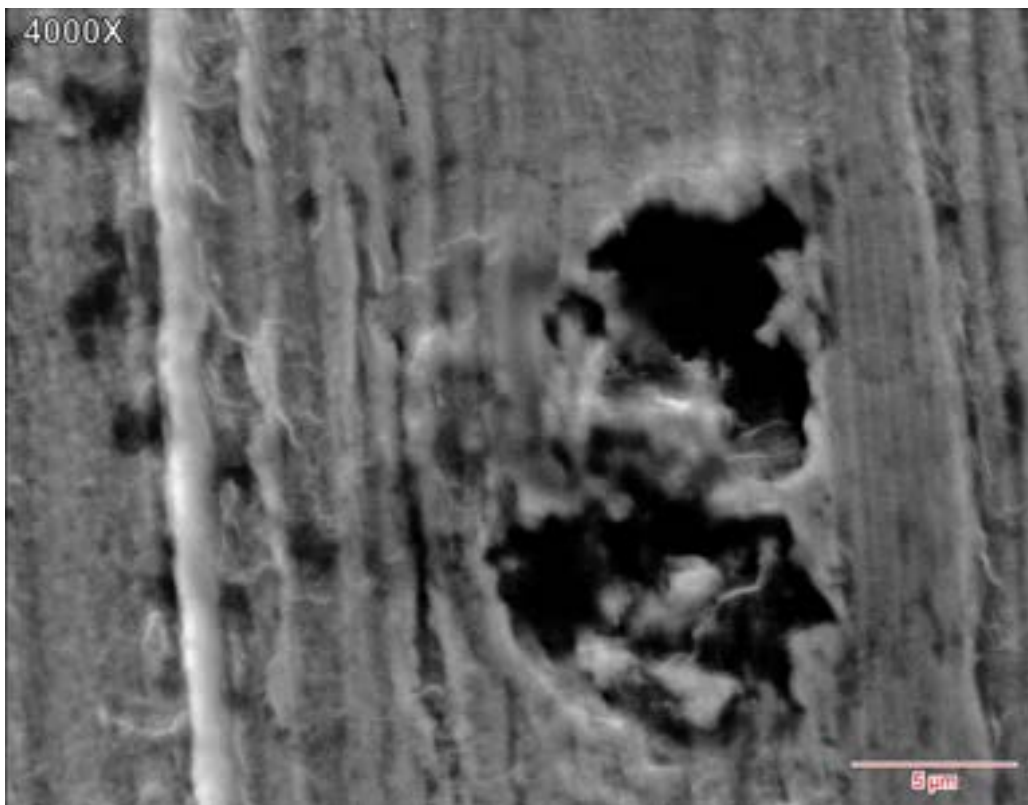
Figure 48: high magnitude (4000X) SEM image of specimen #34 surface (secondary electrons), focused on a riddled surface region. Scale bar above the image.

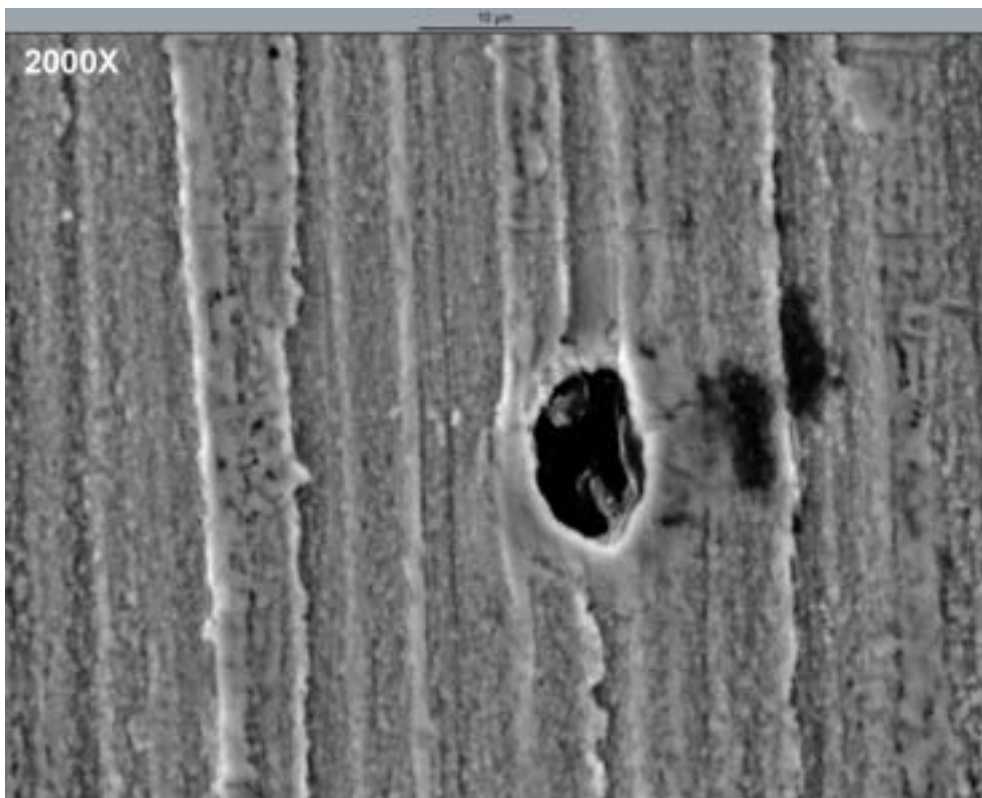
Figure 52: SEM image of specimen #28 surface (secondary electrons) at magnitude 2000X (enlargement of Figure 51 centered on the corrosion item). Scale bar above the image.
