Ricerca di Sistema elettrico

Risultati relativi alle campagne sperimentali di breve e medio termine sui fenomeni di erosione/corrosione da litio liquido fluente nell'impianto Lifus 6

RISULTATI RELATIVI ALLE CAMPAGNE SPERIMENTALI DI BREVE E MEDIO TERMINE SUI FENOMENI DI EROSIONE/CORROSIONE DA LITIO LIQUIDO FLUENTE NELL'IMPIANTO LIFUS 6

Settembre 2016

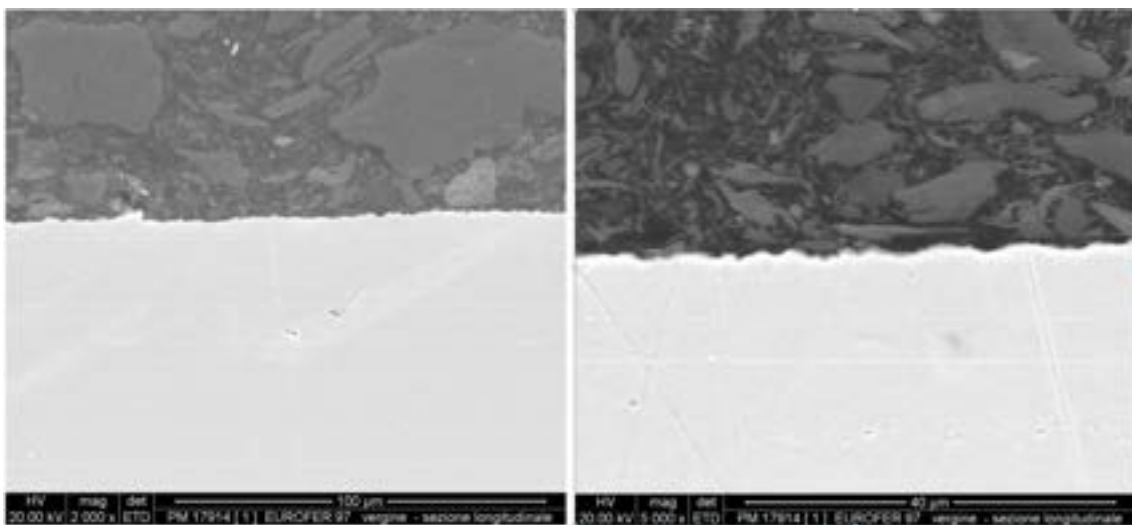
Figure 5: SEM images (secondary electrons) of a representative Eurofer 97 specimen: longitudinal sections. The surface is in good shape (dark region in the top half is due to graphite, where the specimen is mounted in).

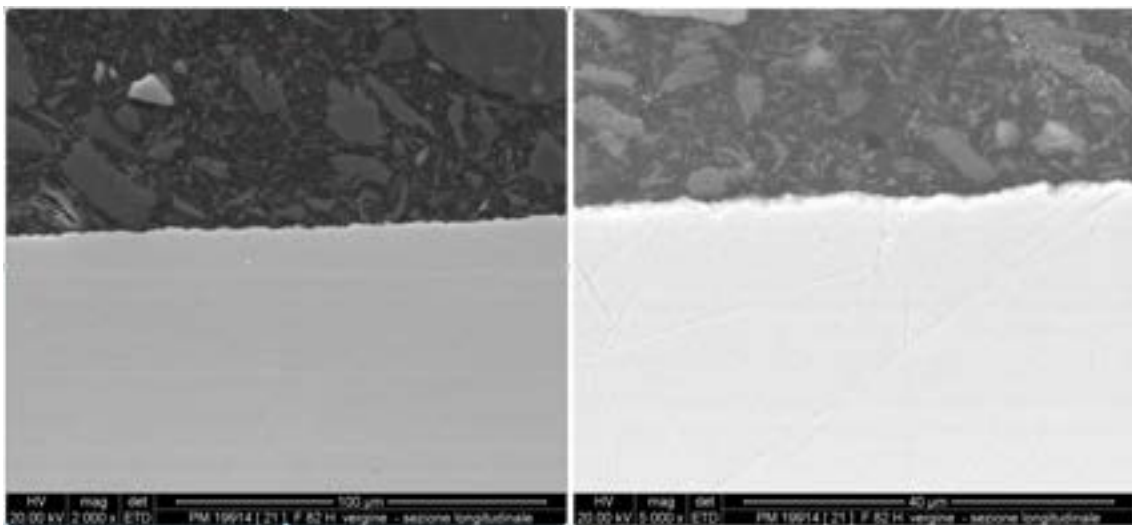
Figure 8: SEM images (secondary electrons) of a representative Eurofer 97 specimen: longitudinal sections. The surface is in good shape (dark region in the top half is due to graphite, where the specimen is mounted in).

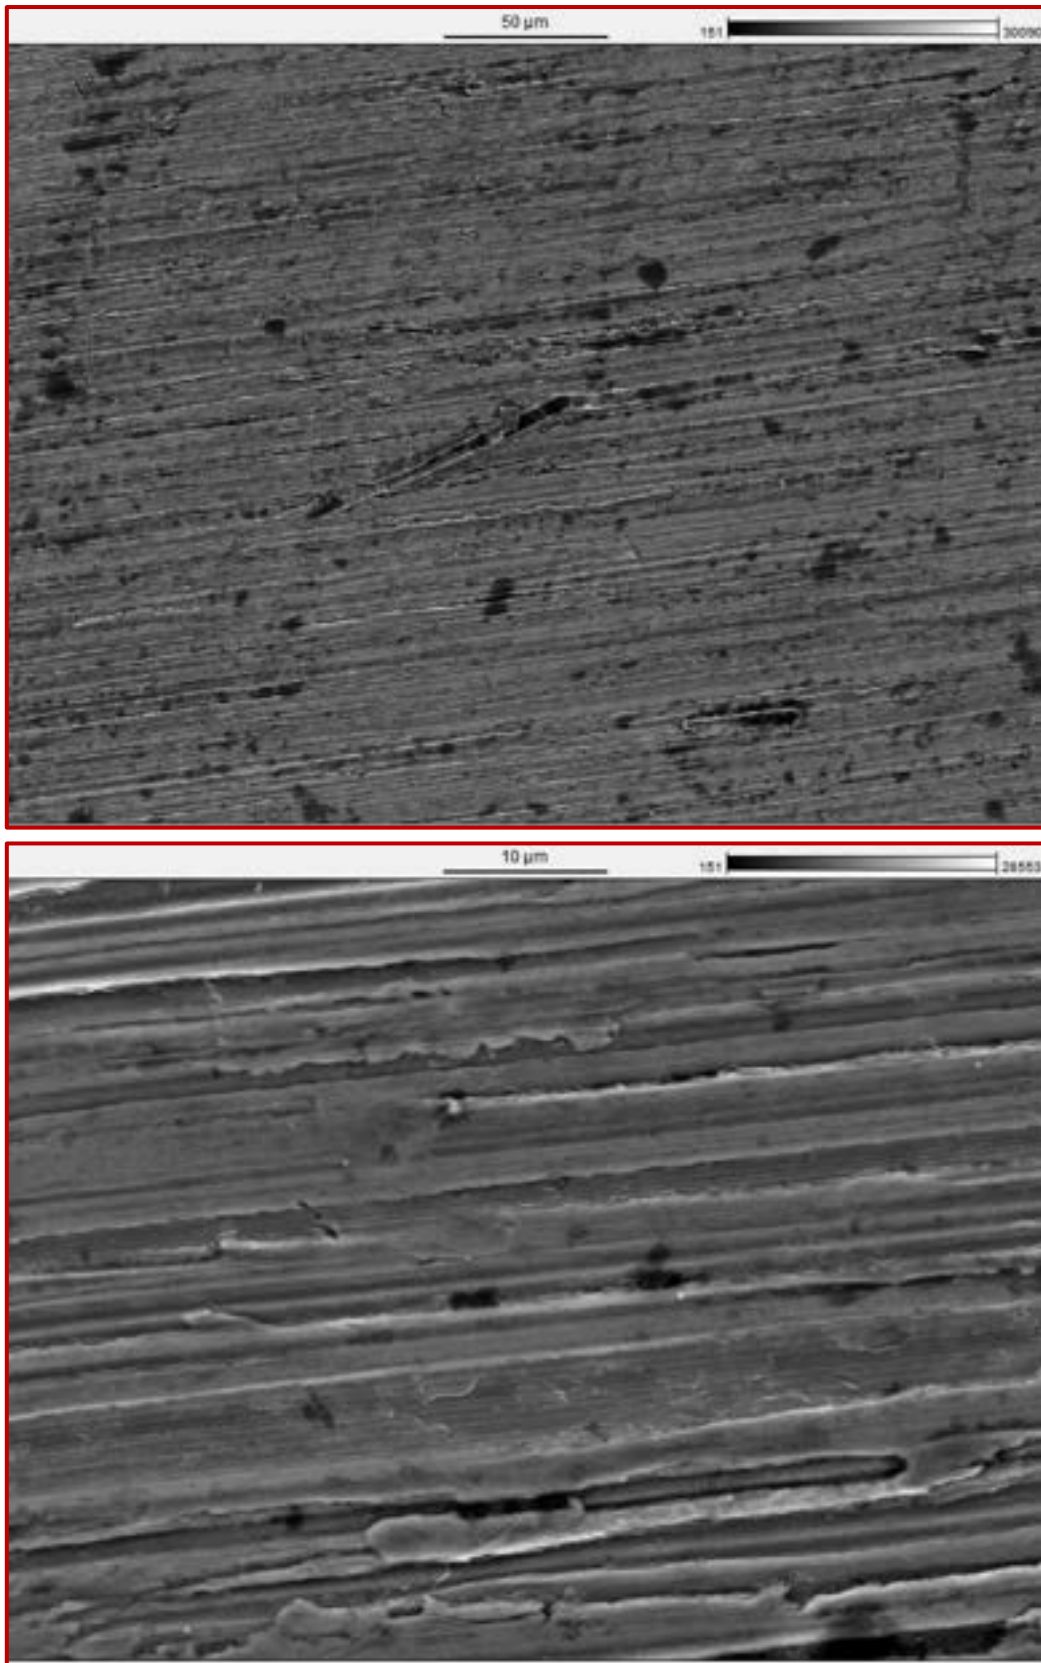
Figure 13 shows, at different magnitudes (400x and 2000x), the surface of a representative region of this specimen: the scrapes of the mechanical manufacturing are clearly visible.

Figure 13: SEM images of specimen n°10 surface (secondary electrons) at different magnitudes. Scale bar above the image.

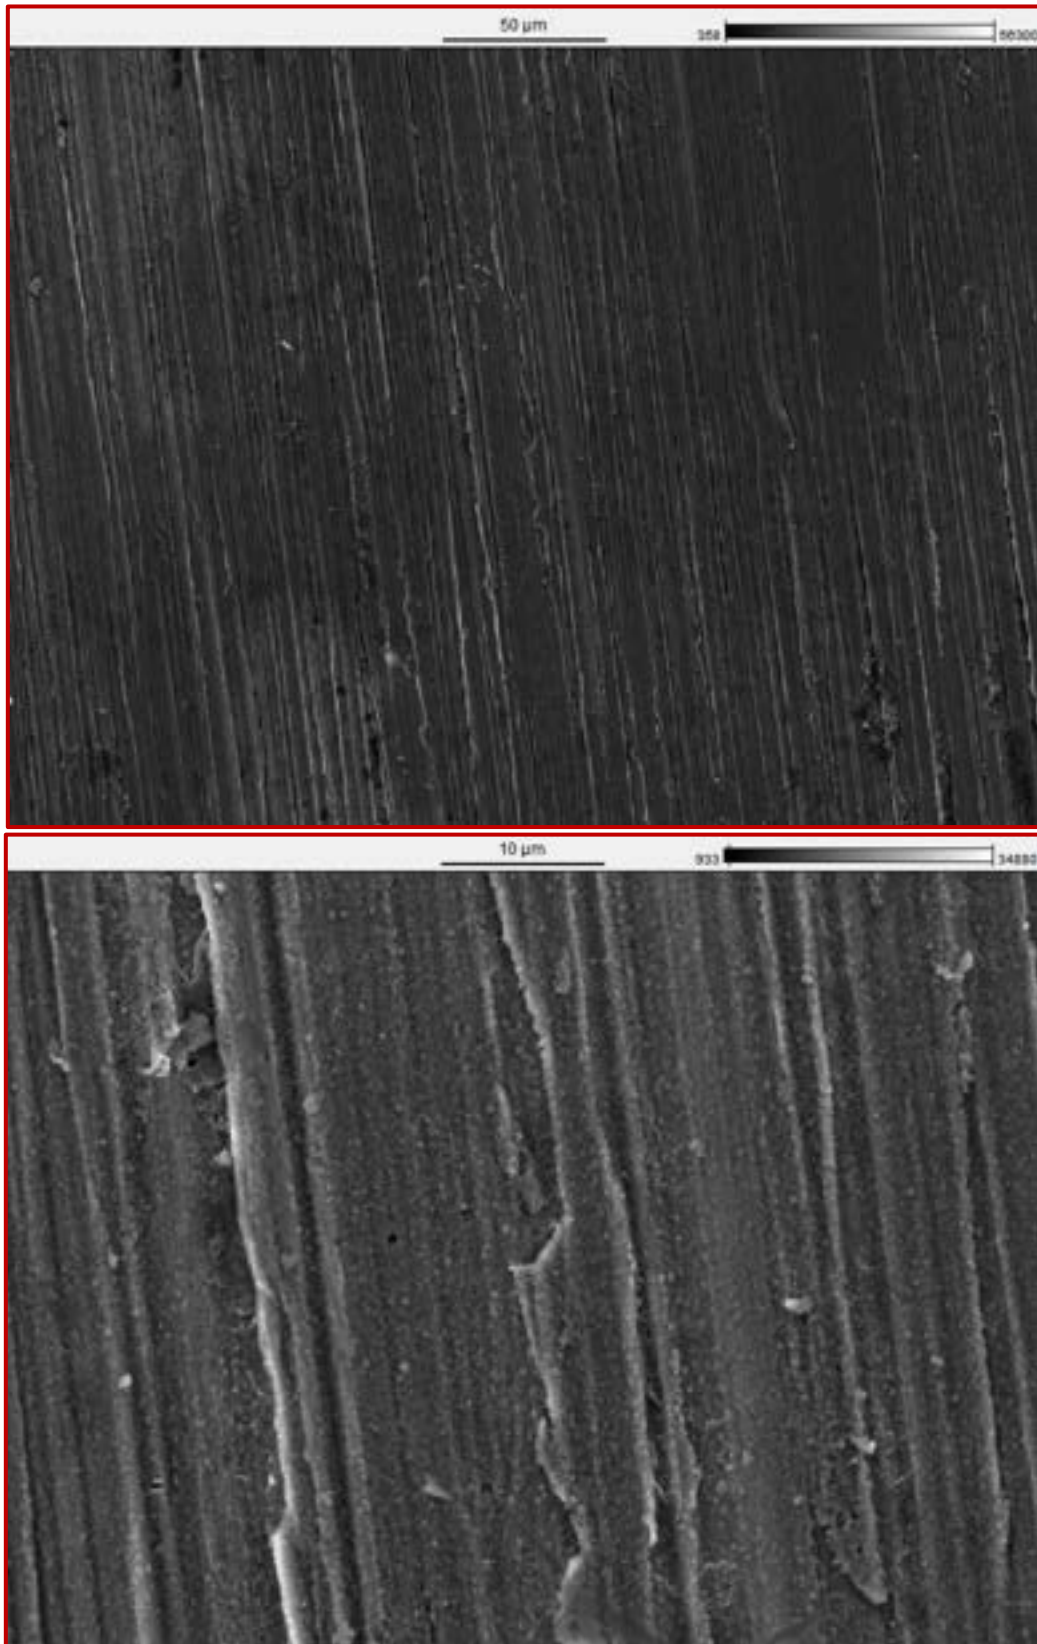
Figure 19 shows, at different magnitudes, the surface of specimen n° 4, after the exposure to flowing Lithium.

Figure 19: SEM images of specimen n°4 surface (secondary electrons) at different magnitudes. Scale bar above the image.

The same considerations made for specimen n°2 and n°3 hold also for specimen n°4.

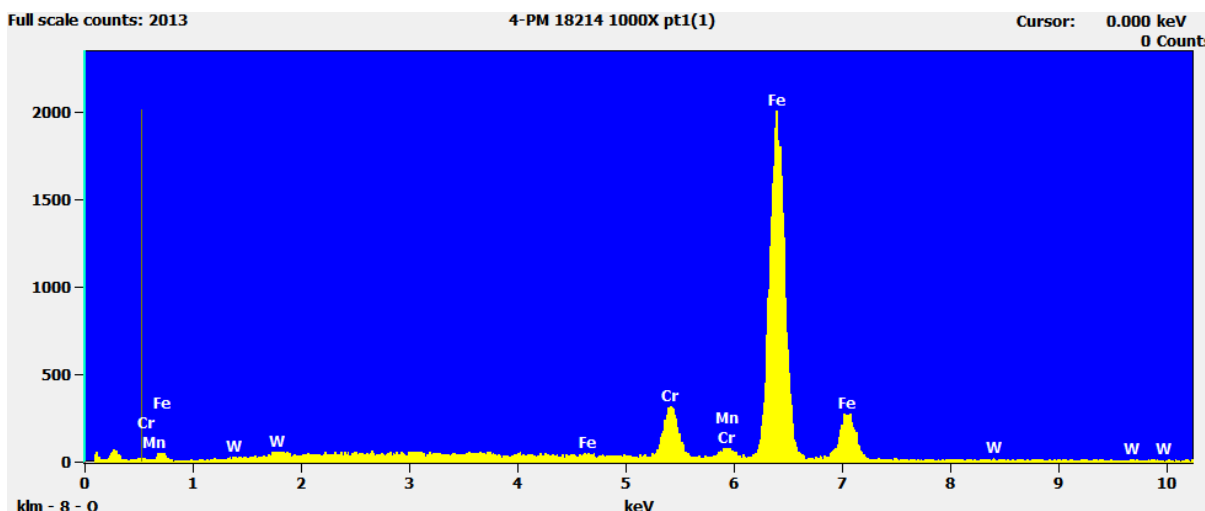
Figure 20 reports the EDS spectrum of specimen n° 4 surface; Table 9 summarizes the values of the related semiquantitative analysis (average composition of the investigated area). Also in this case there seems to be a minimal diminution of Cr concentration at the surface, respect to the unexposed specimen.

Figure 20: EDS spectrum obtained at specimen n°4 surface

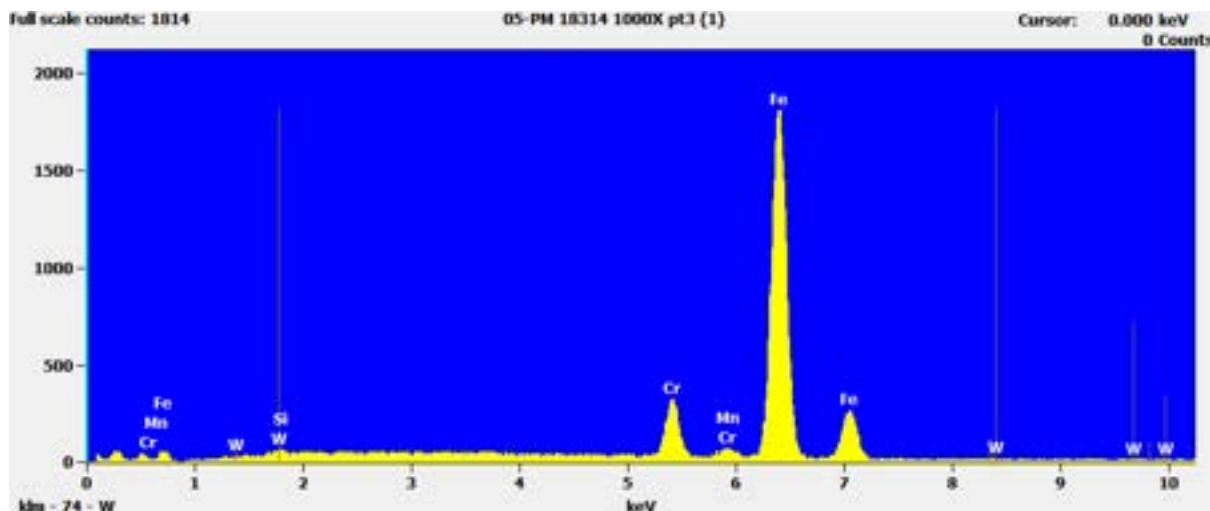
The surface of specimen n°5, at different magnitudes, is instead shown in Figure 21. Apart from the already observed signs of manufacturing, in this sample dark spots and white not conductive corpuscles (high resolution part of Figure 21) are evident. In both cases, the punctual EDS analysis of these specific regions has not indicated meaningful differences respect to the average surface composition (reported in Figure 22 and Table 10). It's possible that these features have organic nature (Carbon and Oxygen are not quantifiable with this kind of analysis) and are due to small contamination after the erosion-corrosion test.

Figure 22: EDS spectrum obtained at specimen n°5 surface

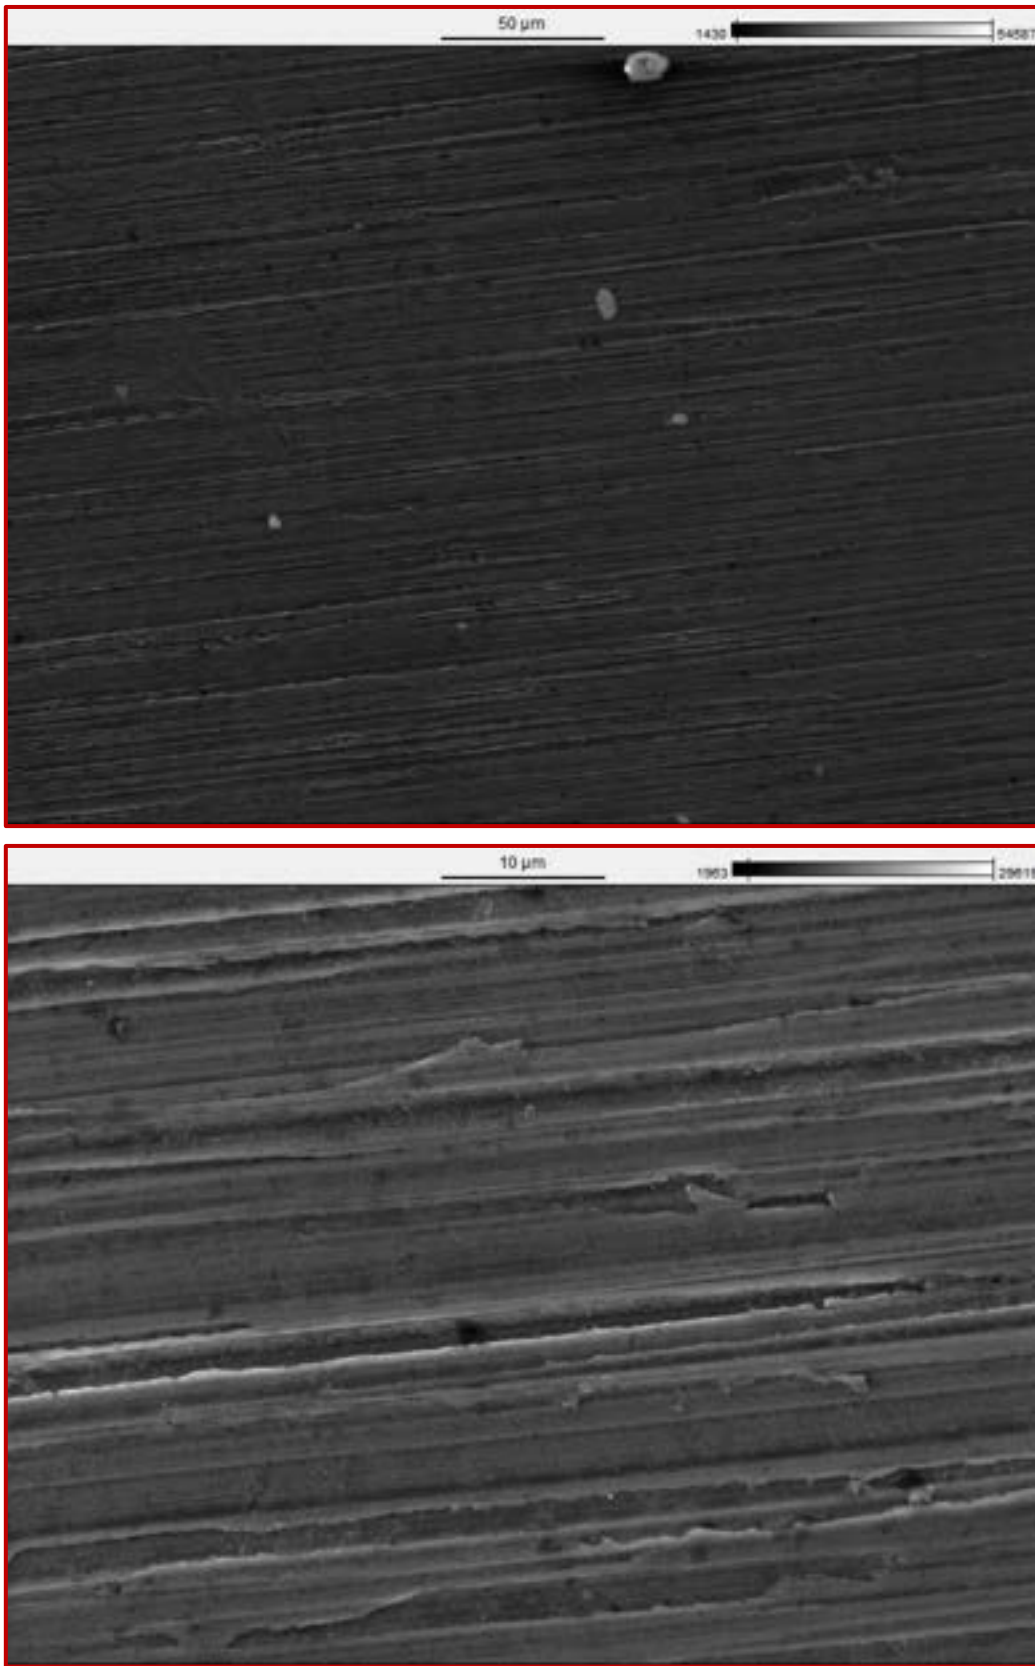
Figure 23 shows, at different magnitudes, the surface of a representative region of this specimen. As already observed for the Eurofer 97 specimens, also here the sample surface is characterized by the presence of signs due to the mechanical manufacturing, while surface alterations due to erosion-corrosion by Lithium are (of course) absent.

Figure 23: SEM images of specimen n° 31 surface (secondary electrons) at different magnitudes. Scale bar above the image.

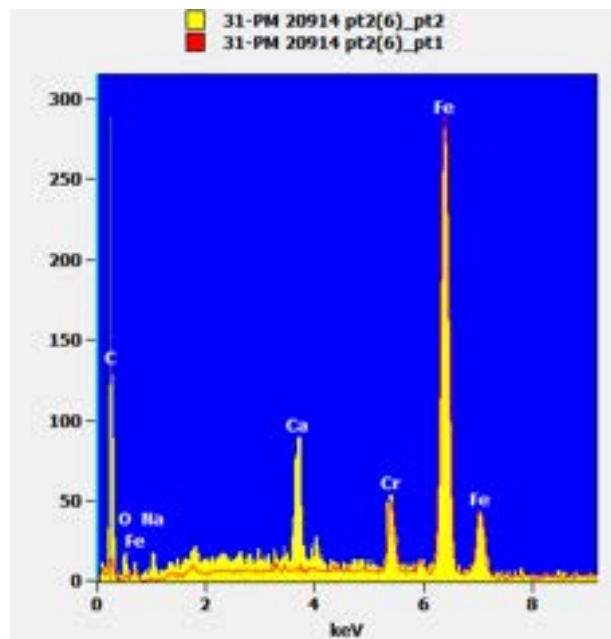
Figure 26 contemporary shows the two EDS spectra (position '1': red plot; position '2': yellow plot), pointing out that the white particle is characterized by a significant concentration of O, Na and mostly C and Ca (maybe some residue of alkaline carbonate). Since specimen n°31 was not exposed to Lithium, surely the presence of the just mentioned elements must be ascribed to the sample handling and its treatment before the execution of the analysis. In any case this conclusion allows to exclude, also for the really exposed specimens, that similar surface anomalies are somehow consequence of the action exerted by the liquid Lithium.

Figure 26: EDS spectrum obtained in correspondence of position '1' and position '2' on the surface of specimen n° 31; relative positions are indicated in Figure 25.

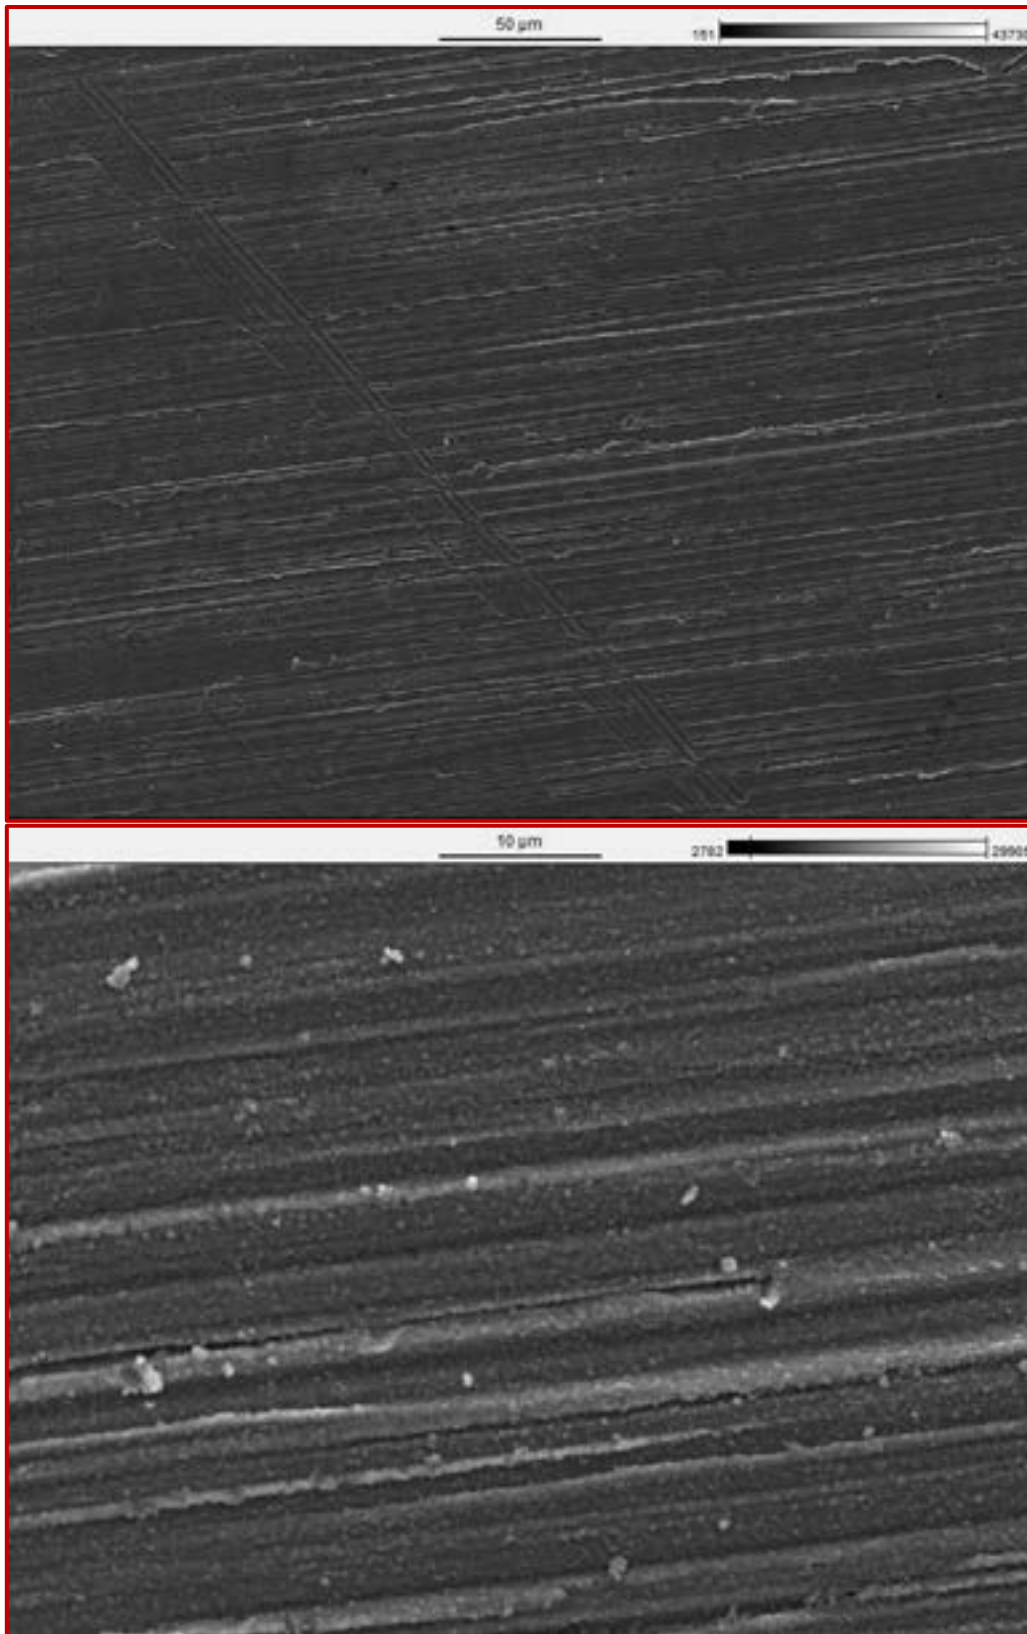
The surface of specimen n°23 is shown, at different magnitudes, in Figure 27. It appears substantially identical to the reference one (specimen n°31).

Figure 27: SEM images of specimen n° 23 surface (secondary electrons) at different magnitudes. Scale bar above the image.

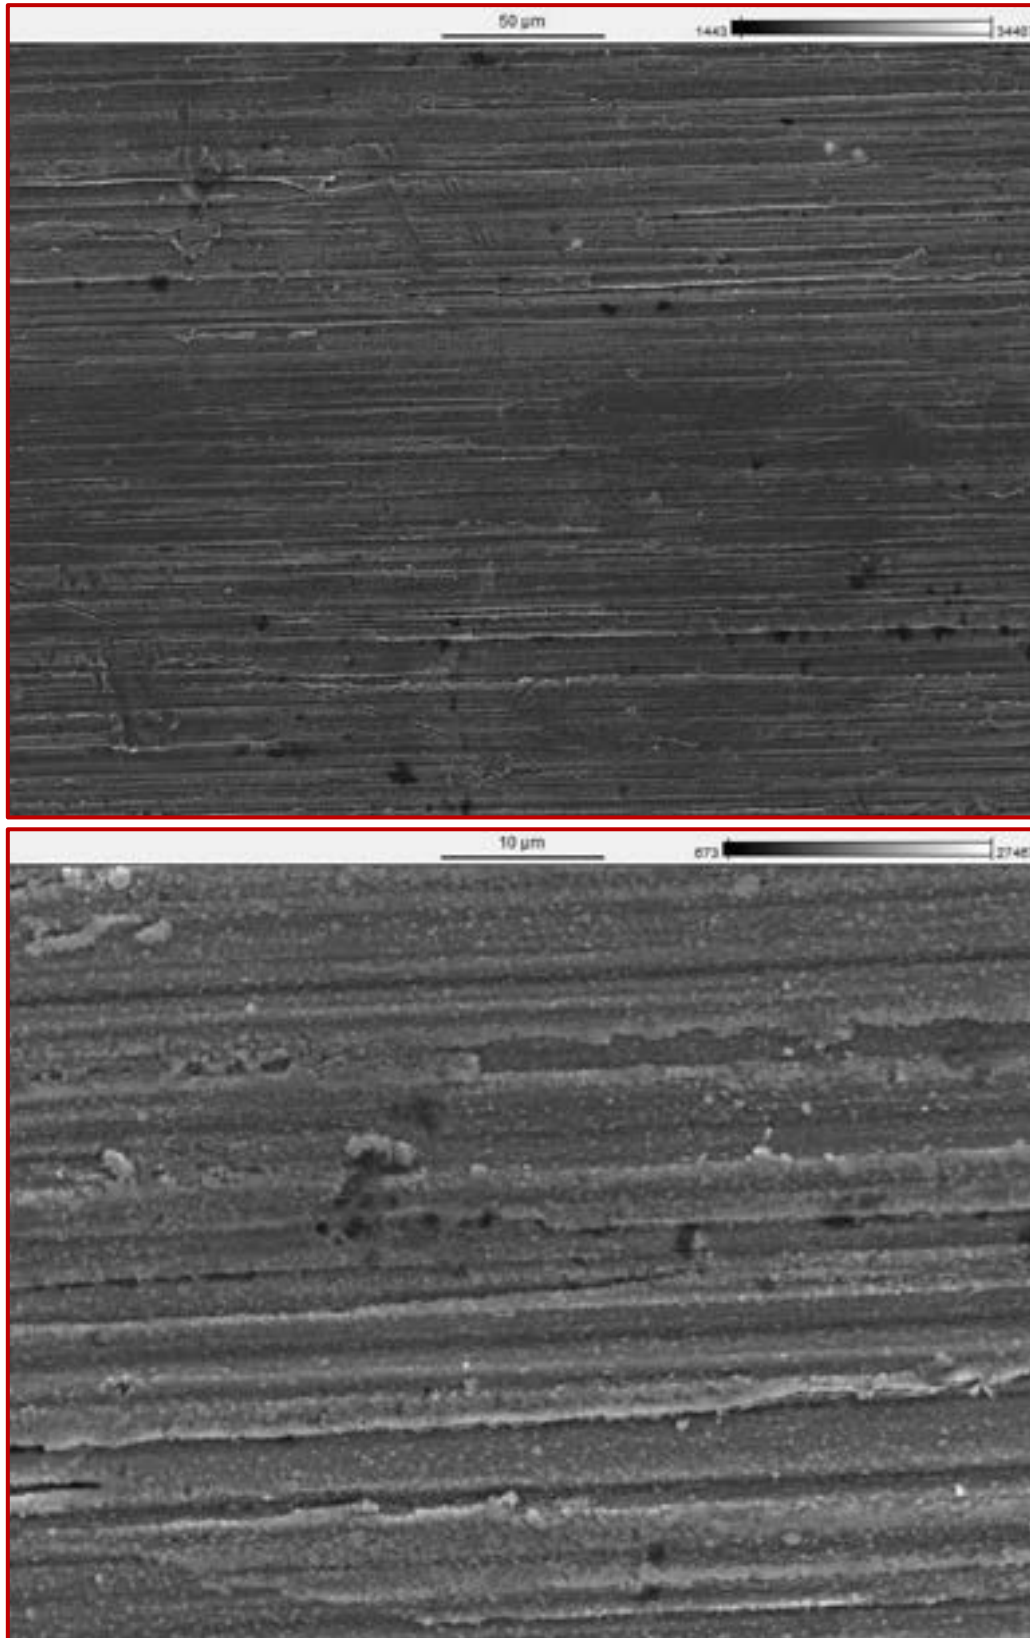
Figure 31 shows, at different magnitudes, the surface of specimen n°25. No substantial alteration of the morphology appears respect to the unexposed specimen (n°31).

Figure 31: SEM images of specimen n° 25 surface (secondary electrons) at different magnitudes. Scale bar above the image.

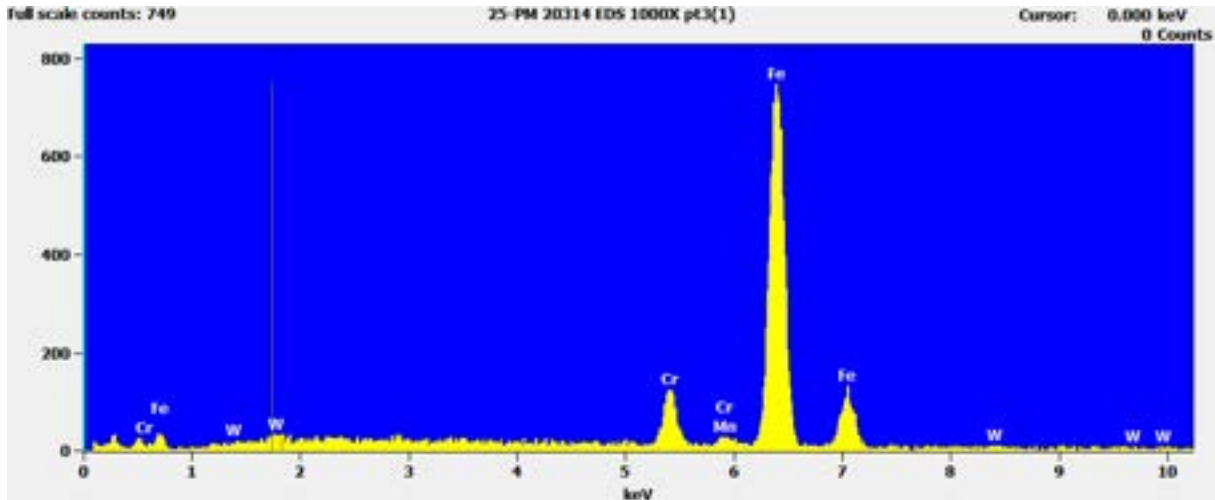
Figure 32: EDS spectrum obtained at specimen n°25 surface

Comparing the above values with the ones in Table 11, a small decrease of Cr and W concentration can be noted.

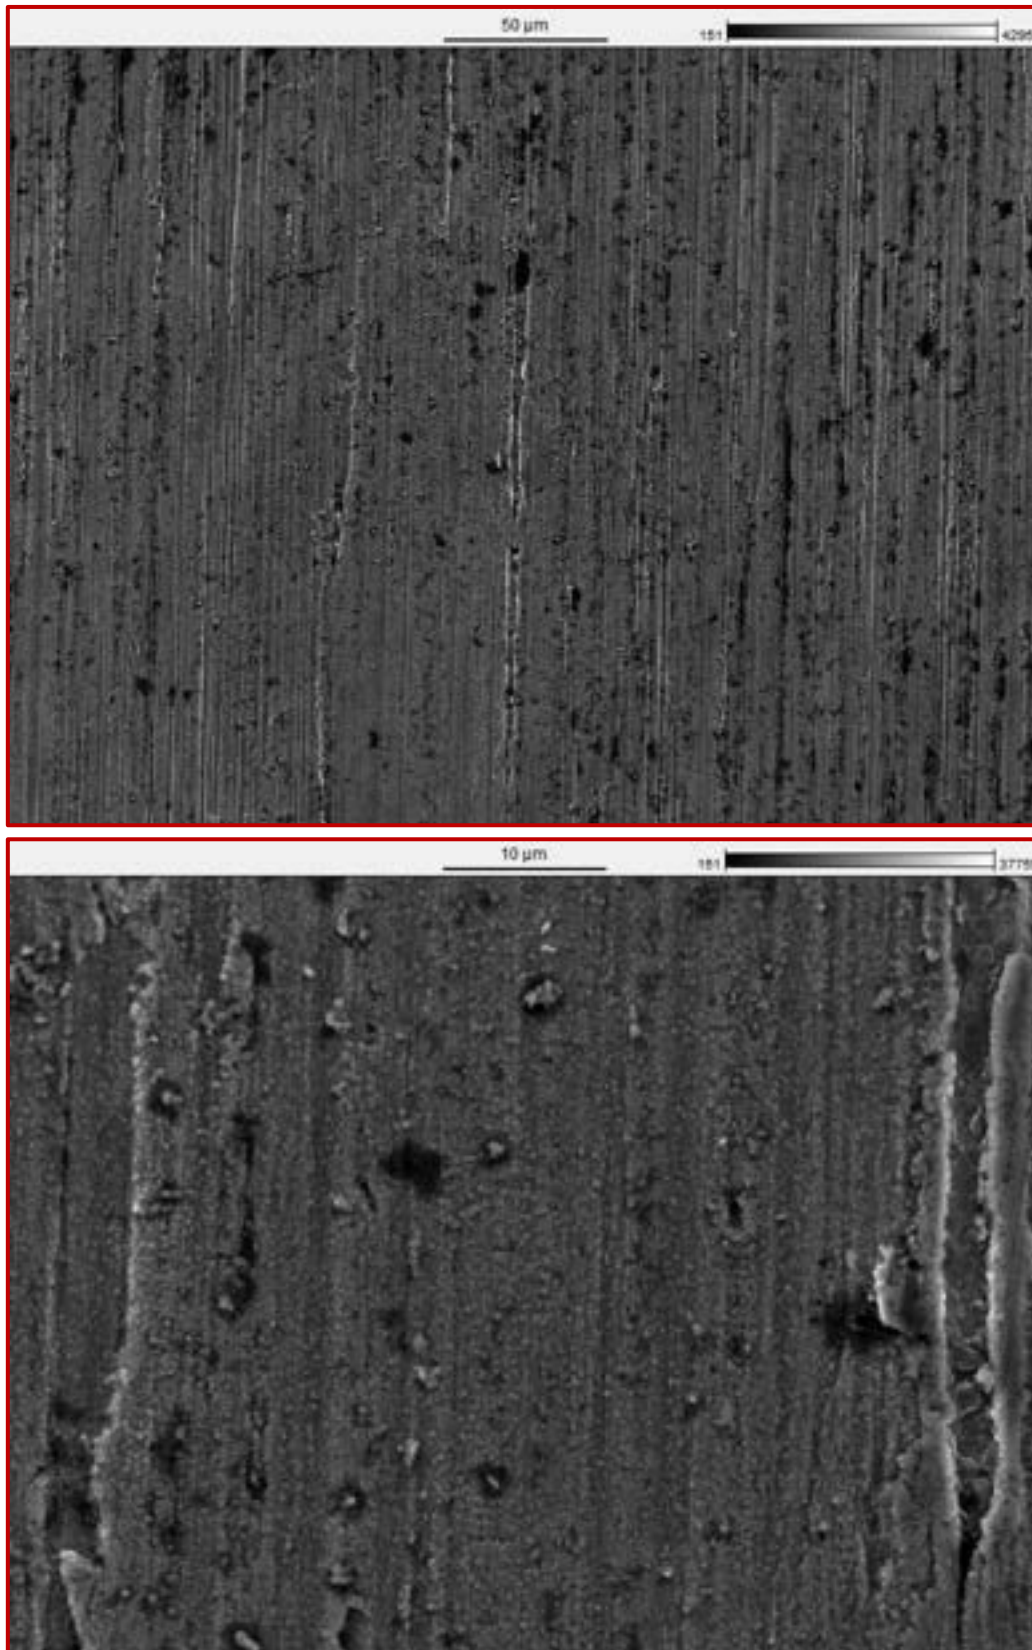
Figure 33: SEM images of specimen n° 26 surface (secondary electrons) at different magnitudes. Scale bar above the image.

Looking at Figure 33, we don't note morphological alterations of the surface respect to the unexposed one (specimen n°31). Anyway, many small black spots can be seen. In order to better investigate the nature of this black spots, two additional EDS spectrum were performed, the first investigating the position indicated by '1' (dark region) in Figure 35 (higher magnitude image of surface specimen), the second investigating the position indicated by '2' (surface matrix), to compare the concentrations of the elements in the two different locations.

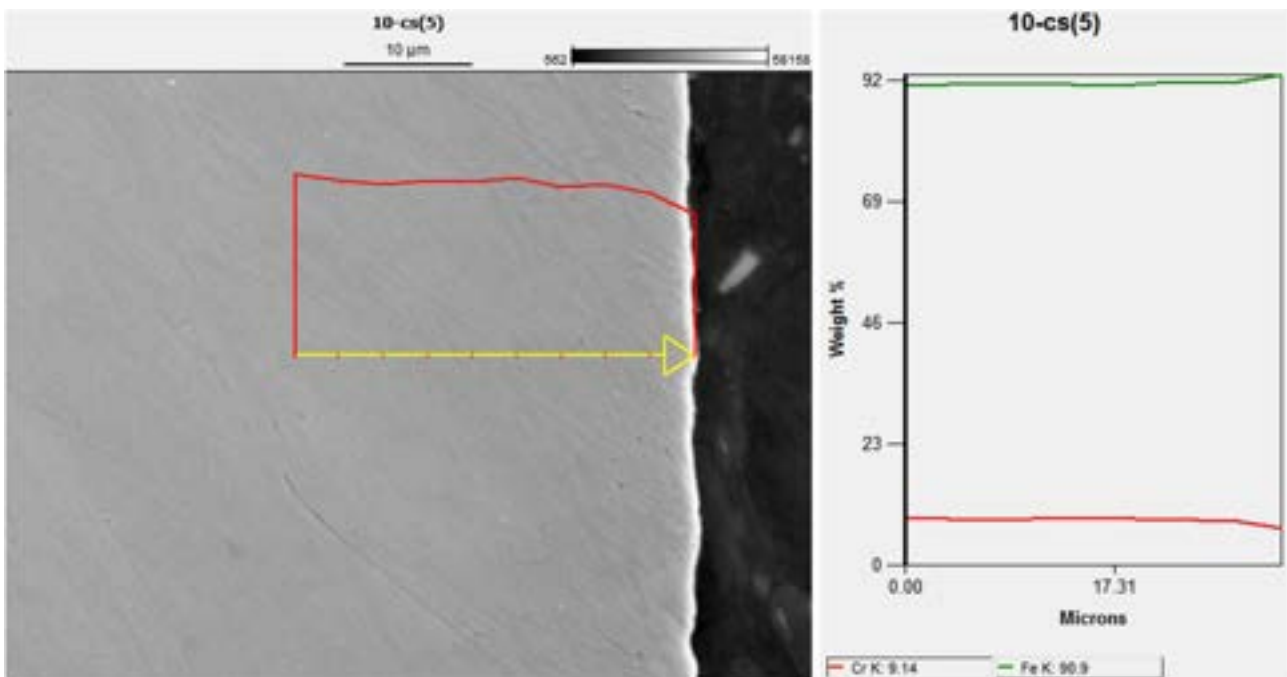
From the observation of the Figure, it is possible to note that the internal specimen structure is in good condition, with only some sign due to the cut and preparation of the sample, but no erosion-corrosion damage: this is of course what expected, since specimen n° 10 is an unexposed specimen. The concentration profiles indicate a substantial constancy of values, with perhaps only a minimal decrease of Cr concentration in the first microns below the surface.

Figure 37: left: SEM image and Cr concentration profile (EDS) of specimen n°10 cross section; right: Cr (red) and Fe (green) concentration profiles along the specimen section.

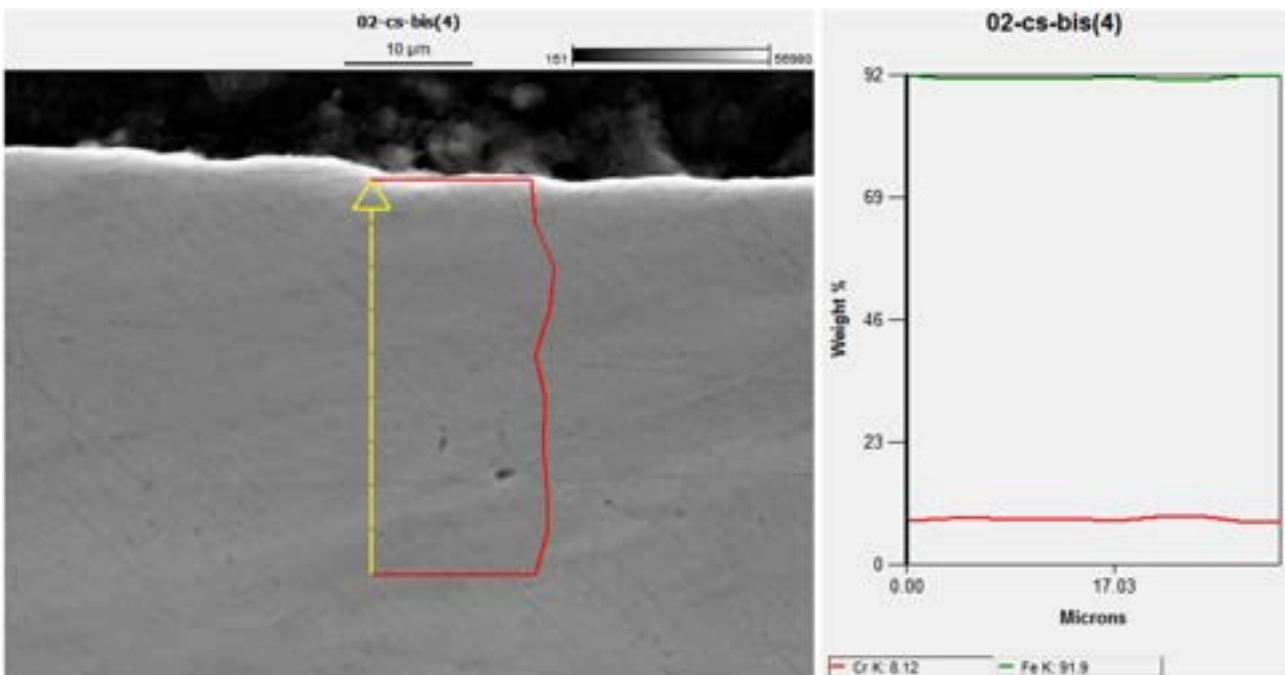
Let's consider now the Eurofer 97 specimens tested in Lifus 6 plant. Figure 38 shows on the left a SEM representative image of specimen n° 2 section, with the red Chromium concentration profile overlapped, as determined by the EDS analysis; on the right side is instead reported a graph showing the profiles of both Chromium and Iron elements. The graph meaning and details are the same already described for Figure 37. A part from the signs due to the cut and preparation of the sample, no erosion-corrosion damage is shown by the SEM image: the appearance of the specimens section is quite similar to the one in Figure 37. For what concerns the concentration profiles, they are rather flat (small oscillations can be related to uncertainty in the EDS analysis result), even if in the case of Cr the concentration values seem to be slightly smaller than in specimen n° 10.

Figure 38: left: SEM image and Cr concentration profile (EDS) of specimen n°2 cross section; right: Cr (red) and Fe (green) concentration profiles along the specimen section.

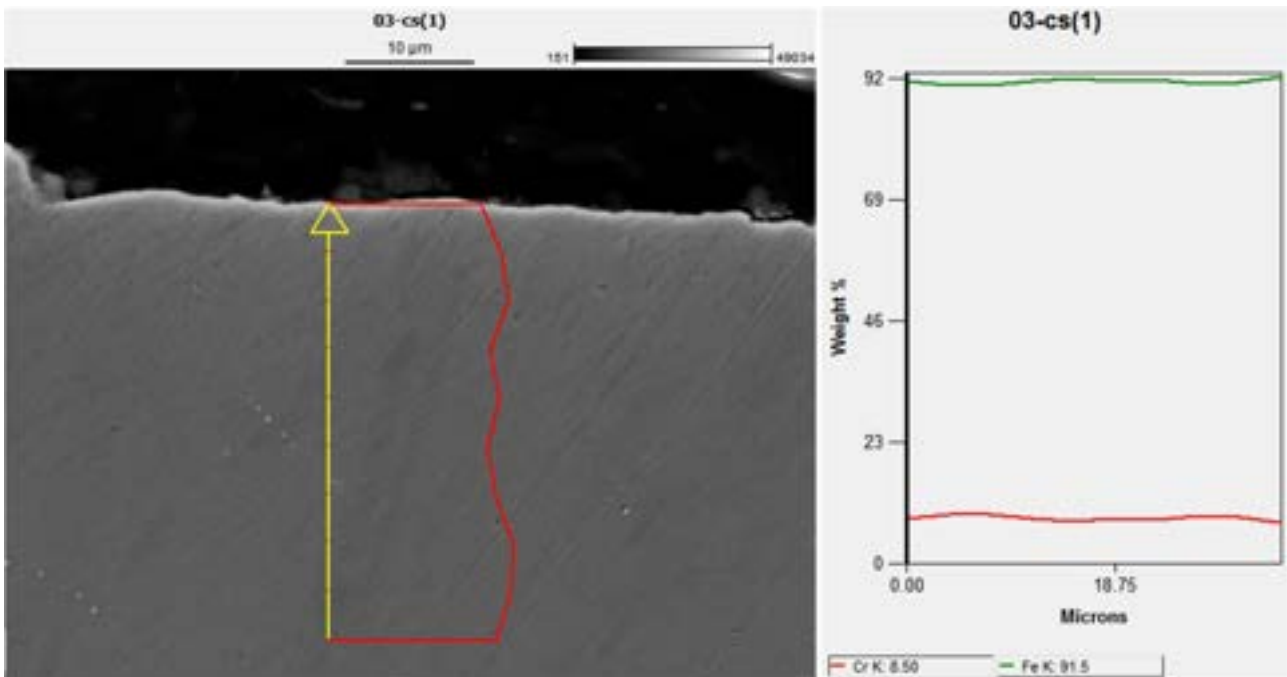
Figure 39 shows on the left a SEM representative image of specimen n° 3 section, with the red Chromium concentration profile overlapped, as determined by the EDS analysis; on the right side is instead reported a graph showing the profiles of both Chromium and Iron elements. The graph meaning and details are the same already described for Figure 37. No internal morphological damage is evident; the concentration profiles are rather flat, a part from some small oscillations due to the uncertainty in the EDS analysis result.

Figure 39: left: SEM image and Cr concentration profile (EDS) of specimen n°3 cross section; right: Cr (red) and Fe (green) concentration profiles along the specimen section.

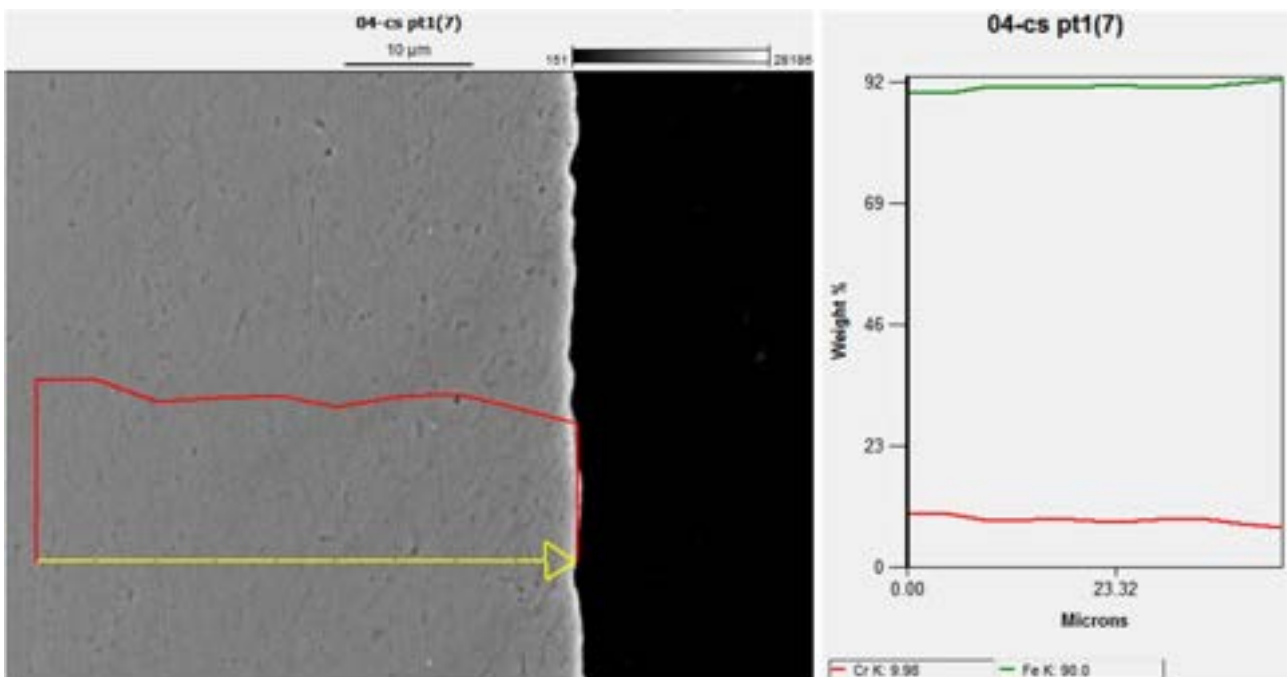
Figure 40 shows on the left a SEM representative image of specimen n° 4 section, with the red Chromium concentration profile overlapped, as determined by the EDS analysis; on the right side is instead reported a graph showing the profiles of both Chromium and Iron elements. The graph meaning and details are the same already described for Figure 37. No internal morphological damage is evident; the concentration profiles are rather flat, with perhaps a minimal Cr concentration decrease in the first microns below the surface; small fluctuations are anyway due to the uncertainty in the EDS analysis result.

Figure 40: left: SEM image and Cr concentration profile (EDS) of specimen n°4 cross section; right: Cr (red) and Fe (green) concentration profiles along the specimen section.

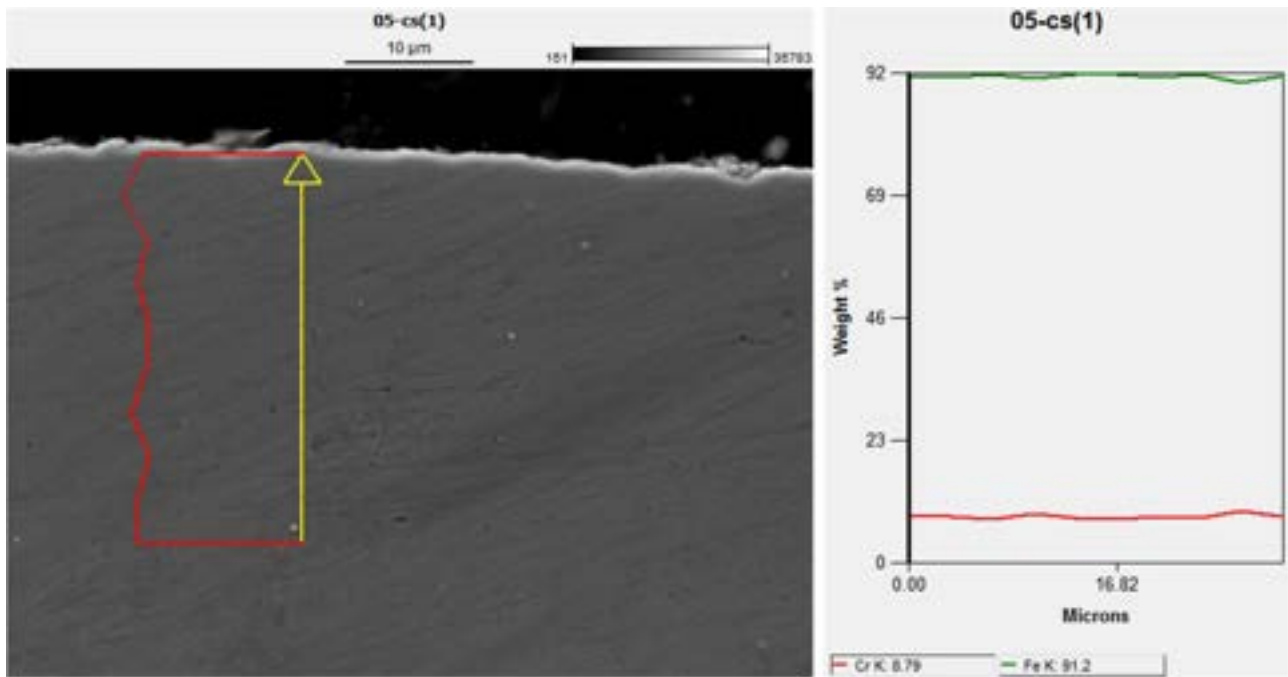
Finally, Figure 41 shows on the left a SEM representative image of specimen n° 5 section, with the red Chromium concentration profile overlapped, as determined by the EDS analysis; on the right side is instead reported a graph showing the profiles of both Chromium and Iron elements. The graph meaning and details are the same already described for Figure 37. No internal morphological damage is evident; the concentration profiles are rather flat, with small fluctuations due to the uncertainty in the EDS analysis result.

Figure 41: left: SEM image and Cr concentration profile (EDS) of specimen n°5 cross section; right: Cr (red) and Fe (green) concentration profiles along the specimen section.

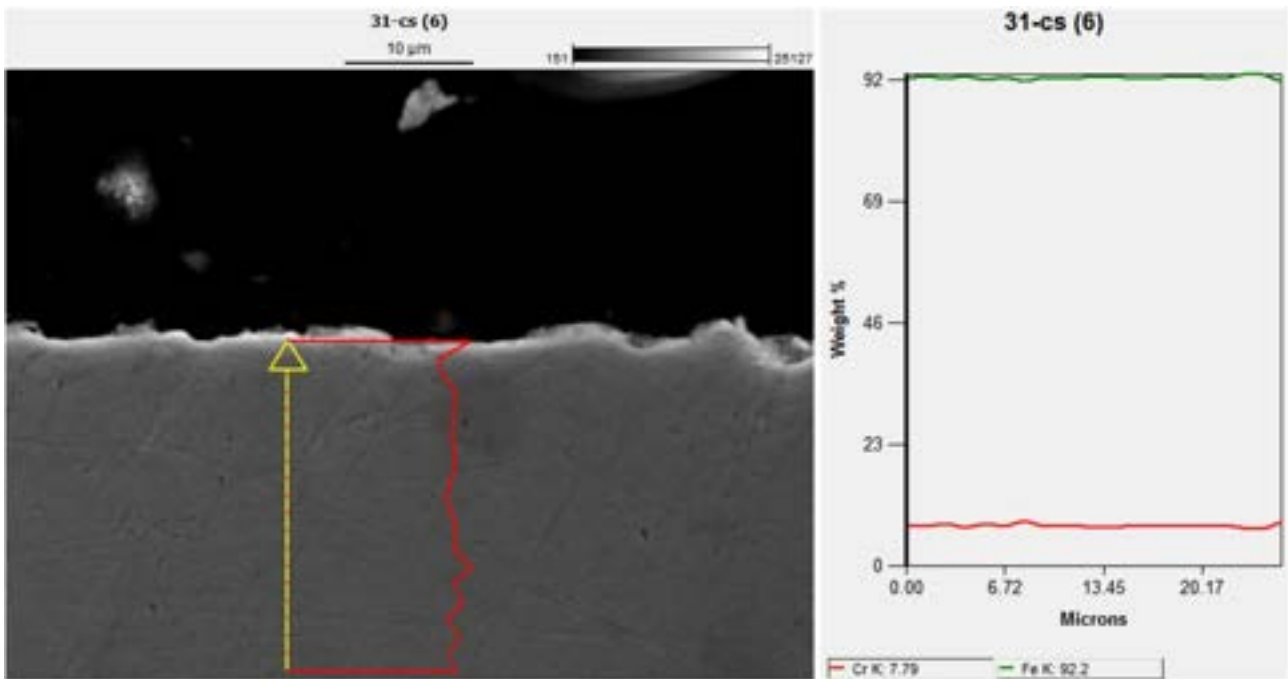
Figure 42 shows on the left a SEM representative image of specimen n° 31 section, with the red Chromium concentration profile overlapped, as determined by the EDS analysis; on the right side is instead reported a graph showing the profiles of both Chromium and Iron elements. The graph meaning and details are the same already described for Figure 37.

From the observation of the Figure, it is possible to note that the internal specimen structure is in good condition, with only some sign due to the cut and preparation of the sample, but no erosion-corrosion damage: this is of course what expected, since specimen n° 31 is an unexposed specimen. The concentration profiles indicate a substantial constancy of values, with minimal fluctuations due to the uncertainty in the EDS analysis result.

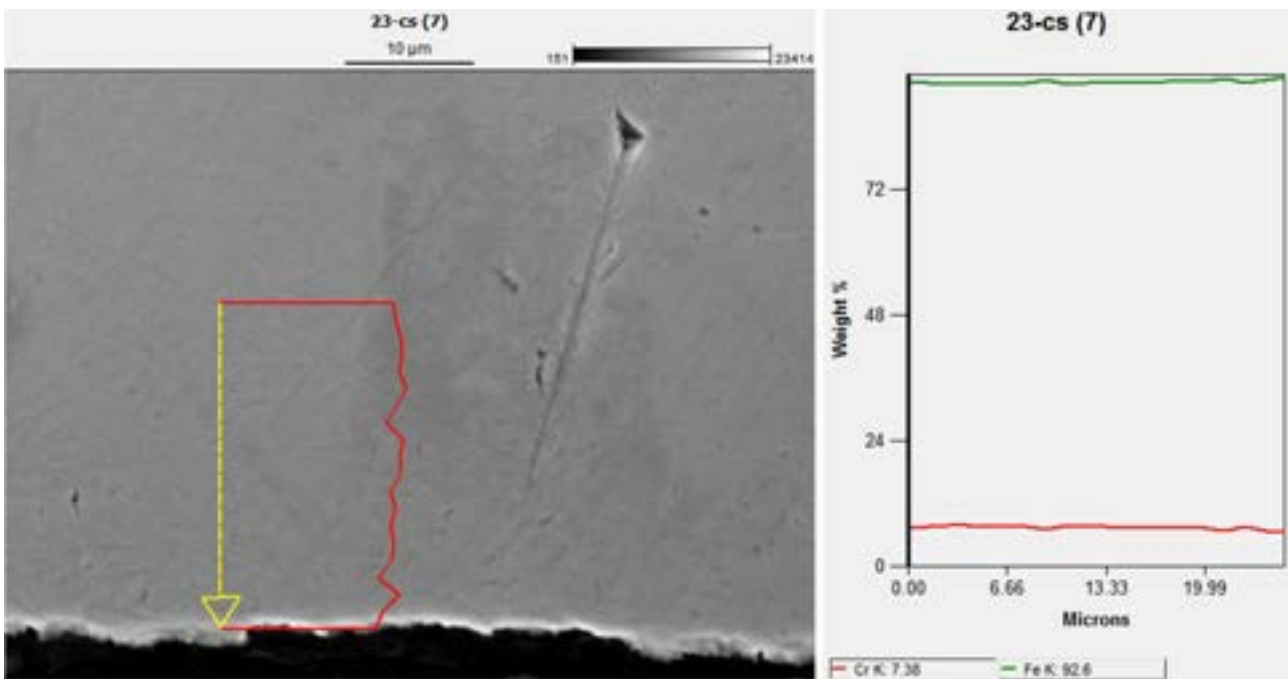
Figure 43 shows on the left a SEM representative image of specimen n° 23 section, with the red Chromium concentration profile overlapped, as determined by the EDS analysis; on the right side is instead reported a graph showing the profiles of both Chromium and Iron elements. The graph meaning and details are the same already described for Figure 37. No internal morphological damage is evident; the concentration profiles are rather flat, with small oscillations due to the uncertainty in the EDS analysis result.
