Ricerca di Sistema elettrico

Risultati relativi alle campagne sperimentali di breve e medio termine sui fenomeni di erosione/corrosione da litio liquido fluente nell'impianto Lifus 6

RISULTATI RELATIVI ALLE CAMPAGNE SPERIMENTALI DI BREVE E MEDIO TERMINE SUI FENOMENI DI EROSIONE/CORROSIONE DA LITIO LIQUIDO FLUENTE NELL'IMPIANTO LIFUS 6

Settembre 2016

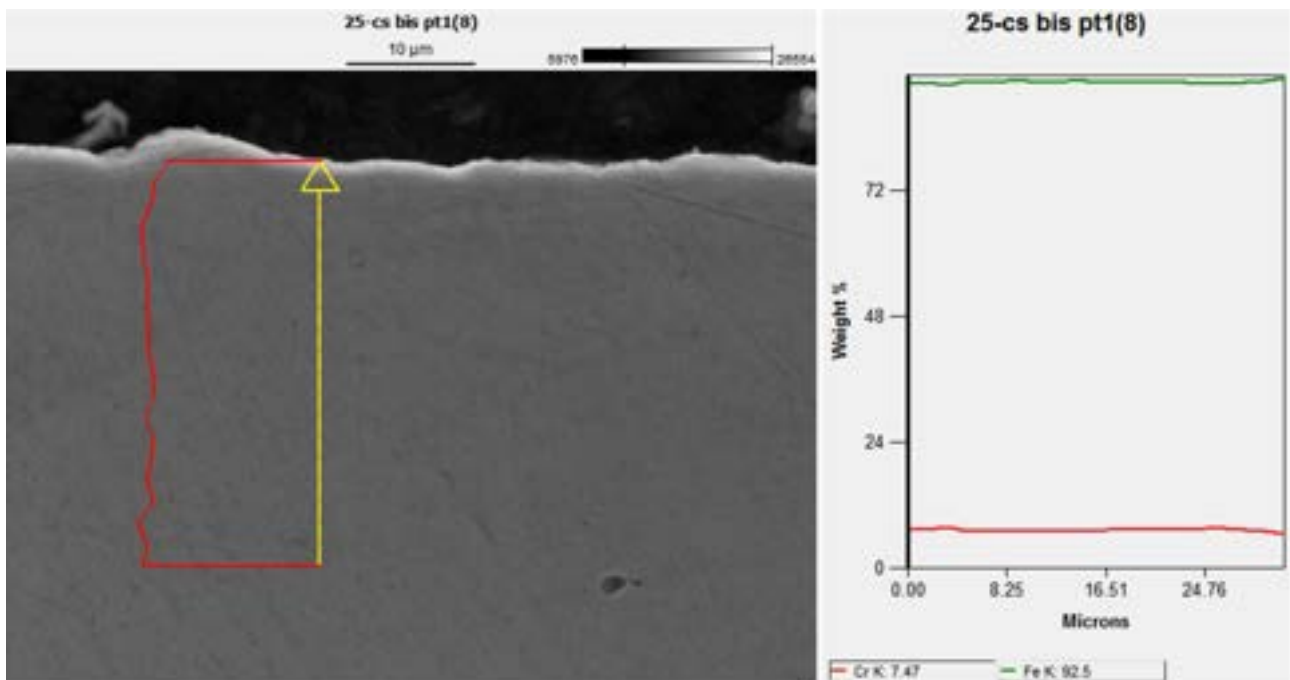
Figure 45 shows on the left a SEM representative image of specimen n° 25 section, with the red Chromium concentration profile overlapped, as determined by the EDS analysis; on the right side is instead reported a graph showing the profiles of both Chromium and Iron elements. The graph meaning and details are the same already described for Figure 37. No internal morphological damage is evident; the concentration profiles are rather flat, with minimal oscillations due to the uncertainty in the EDS analysis result.

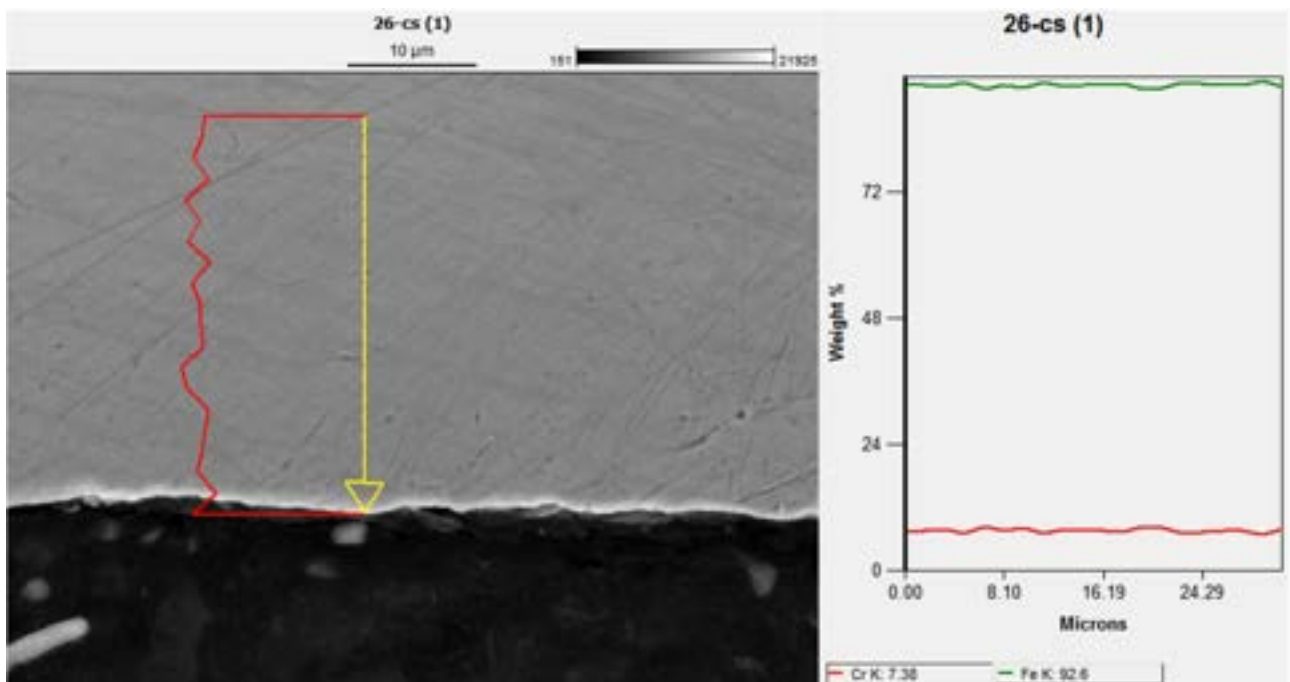
Finally, Figure 46 shows on the left a SEM representative image of specimen n° 26 section, with the red Chromium concentration profile overlapped, as determined by the EDS analysis; on the right side is instead reported a graph showing the profiles of both Chromium and Iron elements. The graph meaning and details are the same already described for Figure 37. Apart from the signs produced during the cut and the preparation of the sample, no internal morphological damage is evident; the concentration profiles are rather flat, with small oscillations due to the uncertainty in the EDS analysis result.

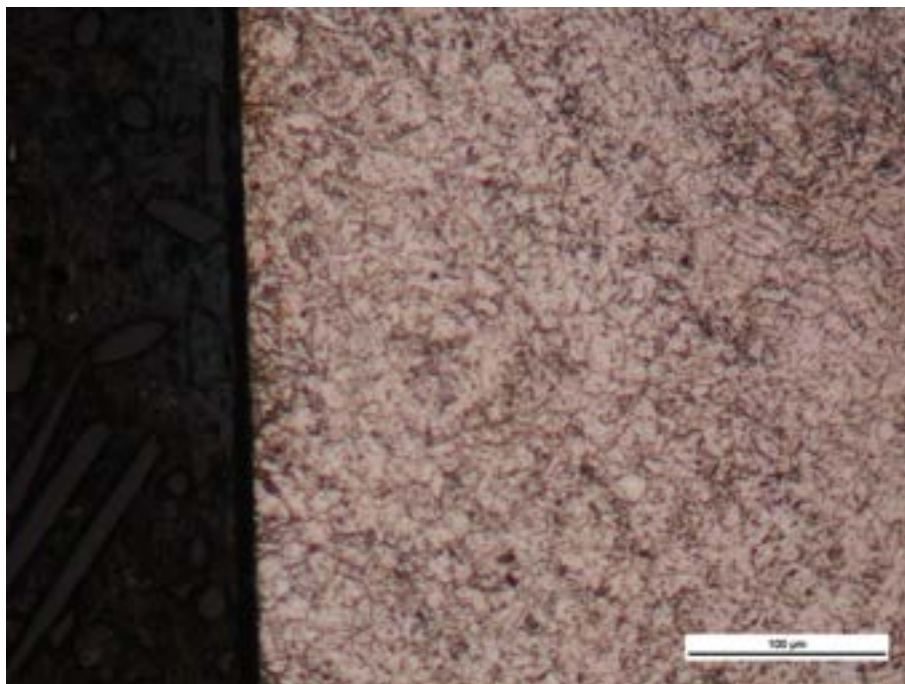
First of all, let's consider the Eurofer 97 specimens, starting with the one not submitted to the erosion-corrosion action by the flowing liquid Lithium (fresh specimens, n° 10). Figure 47 is an optical microscope image of the section, obtained in a region close to the exposed surface.

The material presents a fine, equigranular structure, with grains having dimensions on the order of 10 μm . This value agrees with the expected (commonly reported in literature) one. No meaningful differences appear between the inner region and the region close to the surface.

Figure 47: optical microscope image of the specimen n°10 cross section, after the chemical etching: detail of a region close to the exposed surface (black area on the left is the supporting resin).

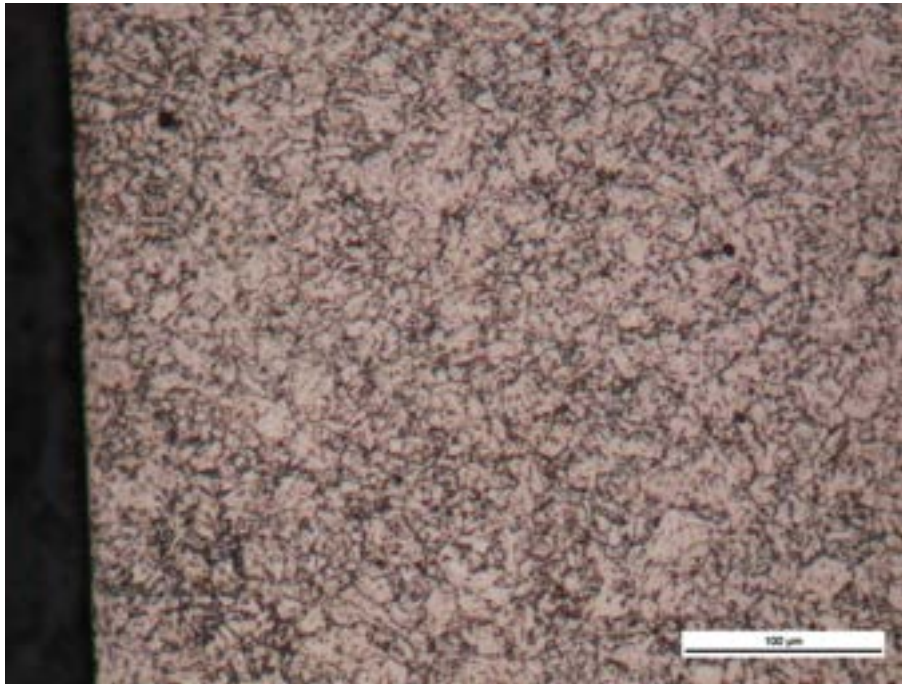
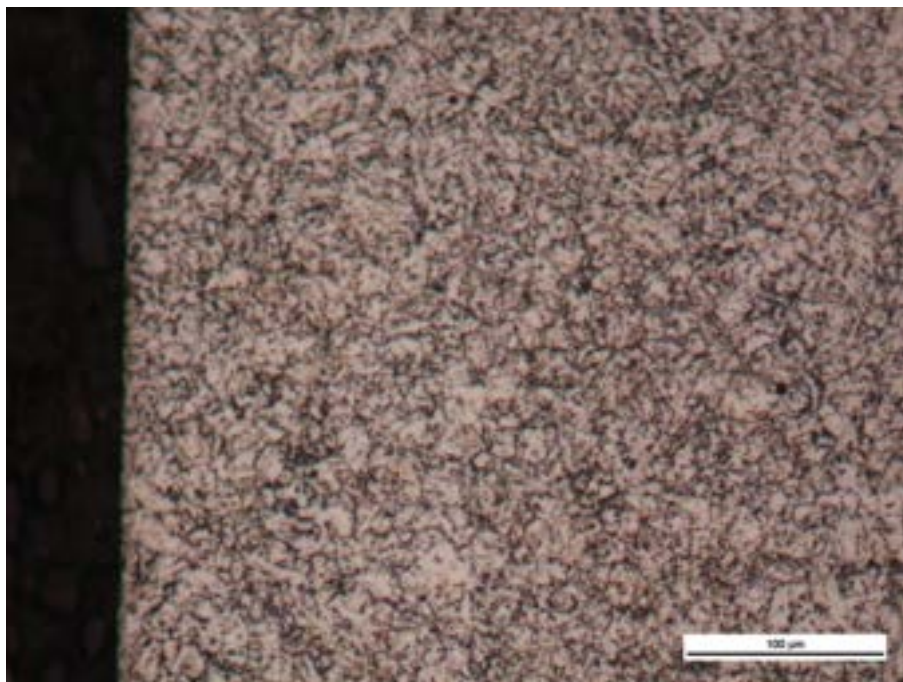
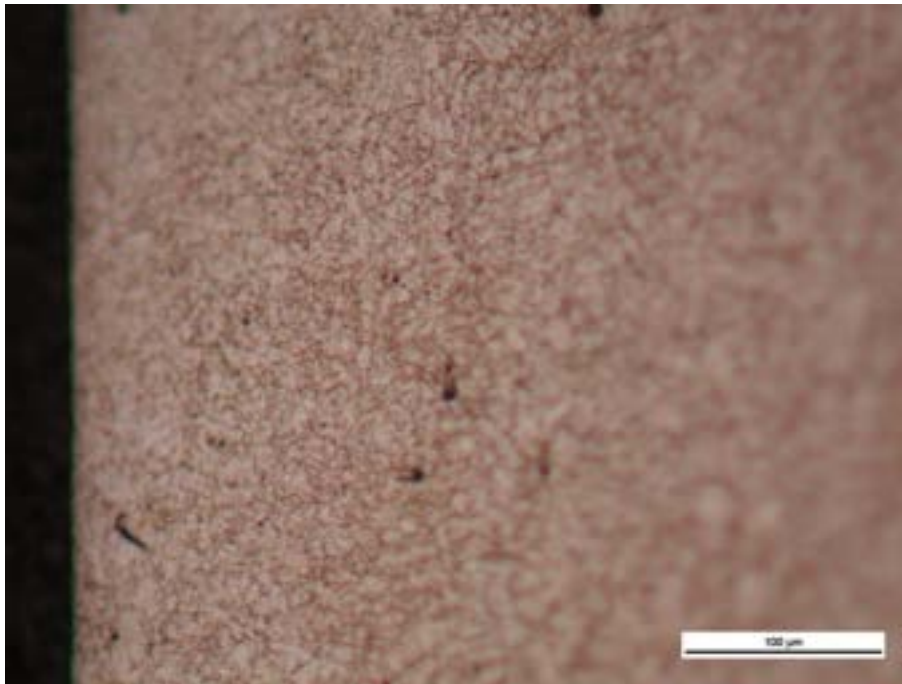
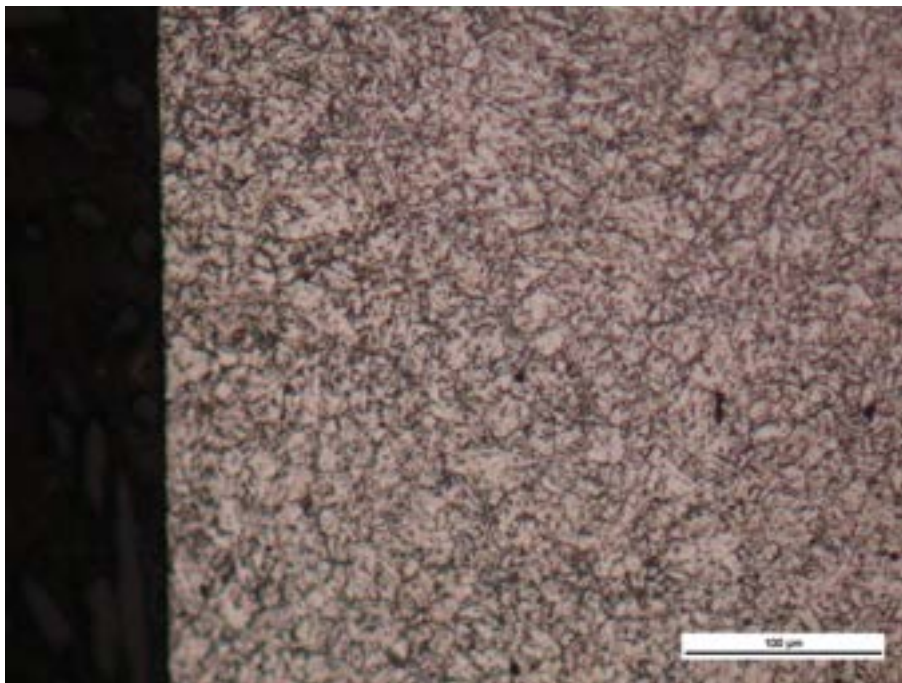
Next Figures 48 to 51 report instead the optical microscope images of the tested Eurofer 97 specimens (n° 2, n° 3, n° 4, n° 5). By comparing these images with the ones of the unexposed specimen, it can be stated that the grain structure of the tested specimen was not significantly affected by the 1222 hours of exposure to flowing Lithium. Particularly, the grains at the surfaces were not removed or evidently modified.

Figure 48: optical microscope image of the specimen n° 2 cross section, after the chemical etching: detail of a region close to the exposed surface (black area on the left is the supporting resin).

Figure 49: optical microscope image of the specimen n° 3 cross section, after the chemical etching: detail of a region close to the exposed surface (black area on the left is the supporting resin).

Figure 50: optical microscope image of the specimen n° 4 cross section, after the chemical etching: detail of a region close to the exposed surface (black area on the left is the supporting resin).

Figure 51: optical microscope image of the specimen n° 5 cross section, after the chemical etching: detail of a region close to the exposed surface (black area on the left is the supporting resin).

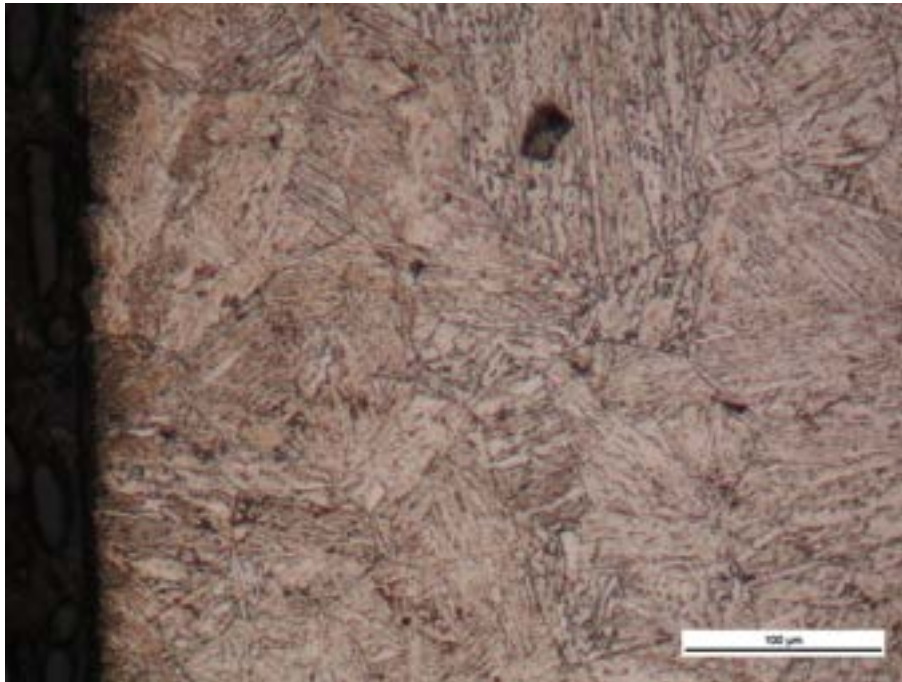
Let's consider now the F82H specimens, starting with the one not submitted to the erosion-corrosion action by the flowing liquid Lithium (fresh specimens, n° 31). Figure 52 is the optical microscope image of the section, obtained in a region close to the exposed surface of the sample.

The material presents a granular structure different from Eurofer 97 one, being characterized on average by much larger grains (about 50-100 μm), which result, therefore, more clearly visible. Such a grain structure agrees with what expected for the F82H material. No meaningful differences appear between the inner region and the region close to the surface.

Figure 52: optical microscope image of the specimen n° 31 cross section, after the chemical etching: detail of a region close to the exposed surface (black area on the left is the supporting resin).

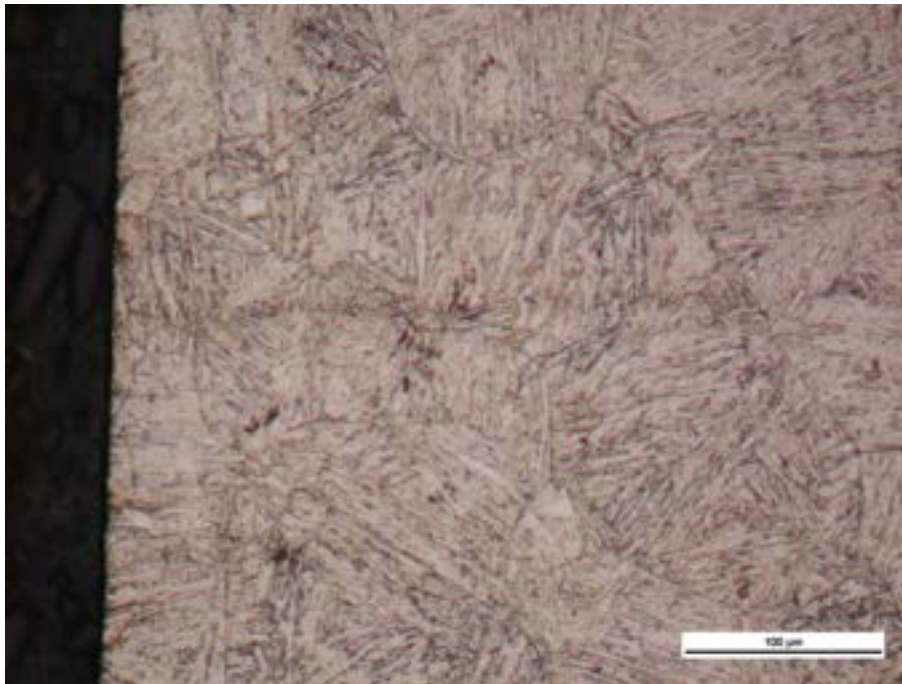
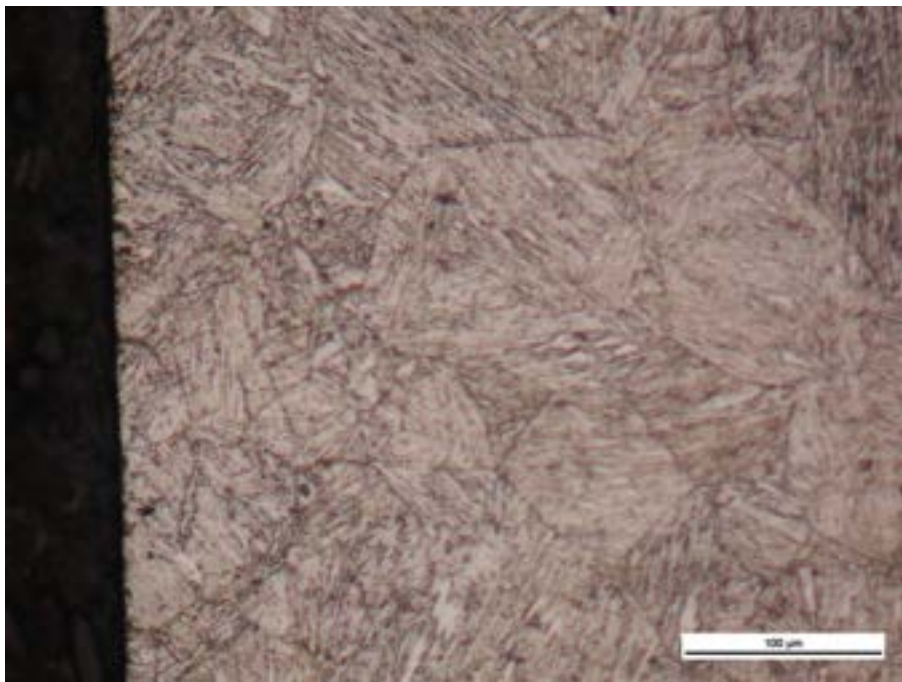
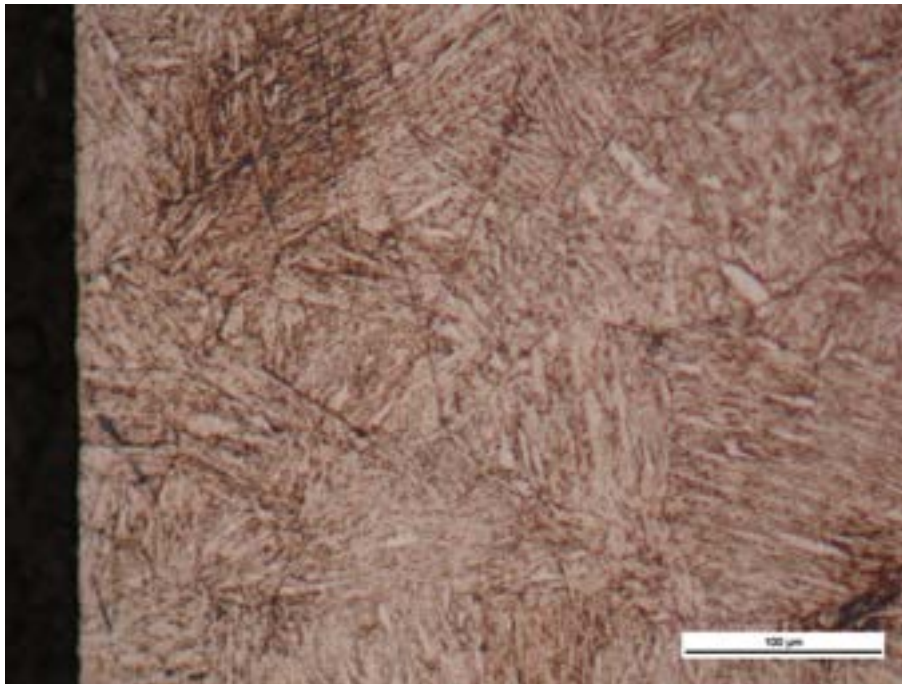
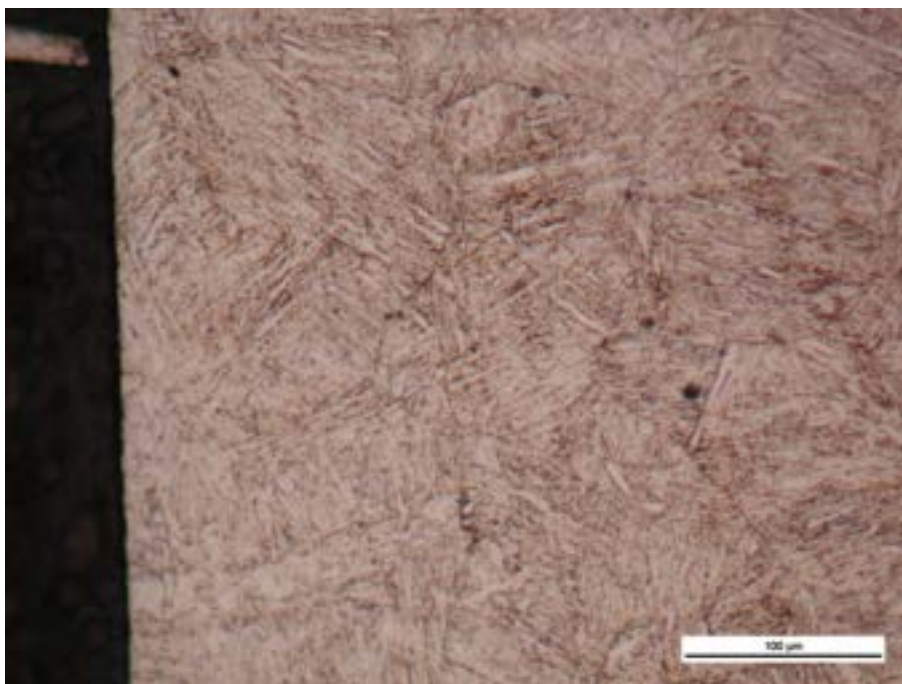
Next Figures 53 to 56 report instead the optical microscope images of the tested F82H specimens (n° 23, n° 24, n° 25, n° 26). By comparing these images with the ones of the unexposed specimen, it can be stated that the grain structure of the tested specimen was not significantly affected by the 1222 hours of exposure to flowing Lithium. Particularly, the grains at the surfaces were not removed or evidently modified.

Figure 53: optical microscope image of the specimen n° 23 cross section, after the chemical etching: detail of a region close to the exposed surface (black area on the left is the supporting resin).

Figure 54: optical microscope image of the specimen n° 24 cross section, after the chemical etching: detail of a region close to the exposed surface (black area on the left is the supporting resin).

Figure 55: optical microscope image of the specimen n° 25 cross section, after the chemical etching: detail of a region close to the exposed surface (black area on the left is the supporting resin).

Figure 56: optical microscope image of the specimen n° 26 cross section, after the chemical etching: detail of a region close to the exposed surface (black area on the left is the supporting resin).
