## Risultati relativi alla campagna sperimentale di medio termine sui fenomeni di erosione/corrosione da Litio liquido fluente nell'impianto Lifus 6

P. Favuzza, M. Cuzzani, V. Cuzzola, G. Fasano, A. Ventura (ENEA)

Settembre 2017

Progetto: B.3.2 – Attività di Fisica della Fusione Complementari a ITER

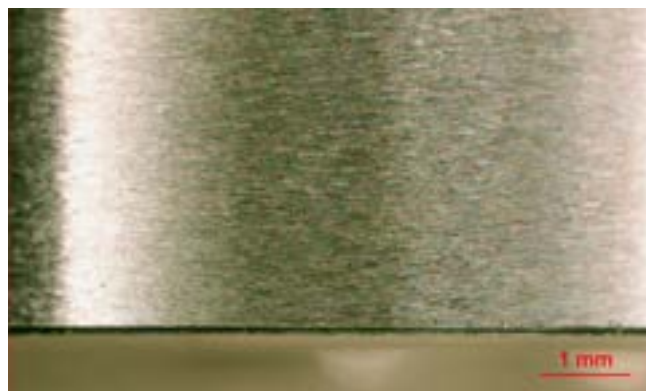
Figure 4: stereoscope image of a representative Eurofer 97 specimen: curved external surface, viewed from the top. The surface is in good shape.

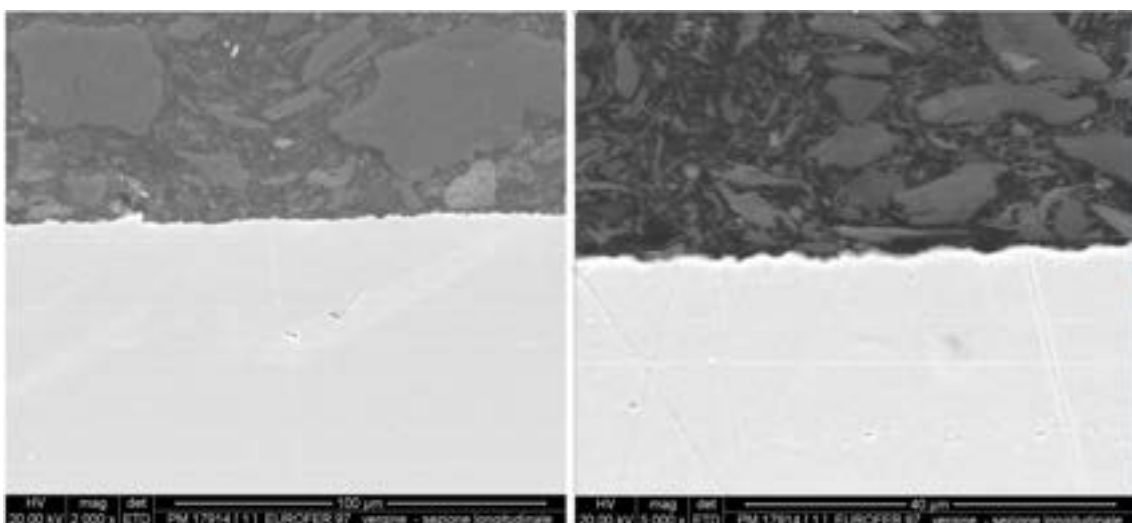
Figure 5: SEM images (secondary electrons) of a representative Eurofer 97 specimen: longitudinal sections. The surface is in good shape (dark region in the top half is due to graphite, where the specimen is mounted in).

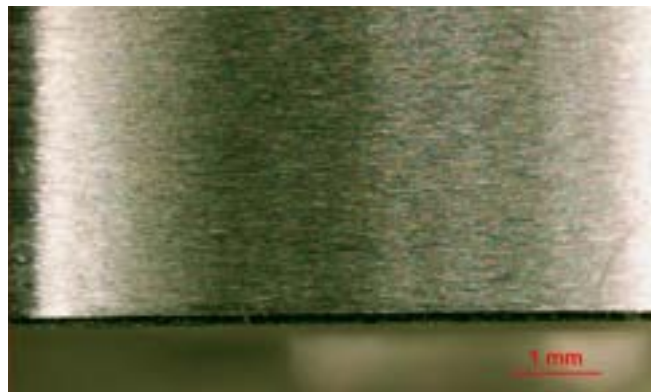
Figure 7: stereoscope image of a representative F82H specimen: curved external surface, viewed from the top. The surface is in good shape.

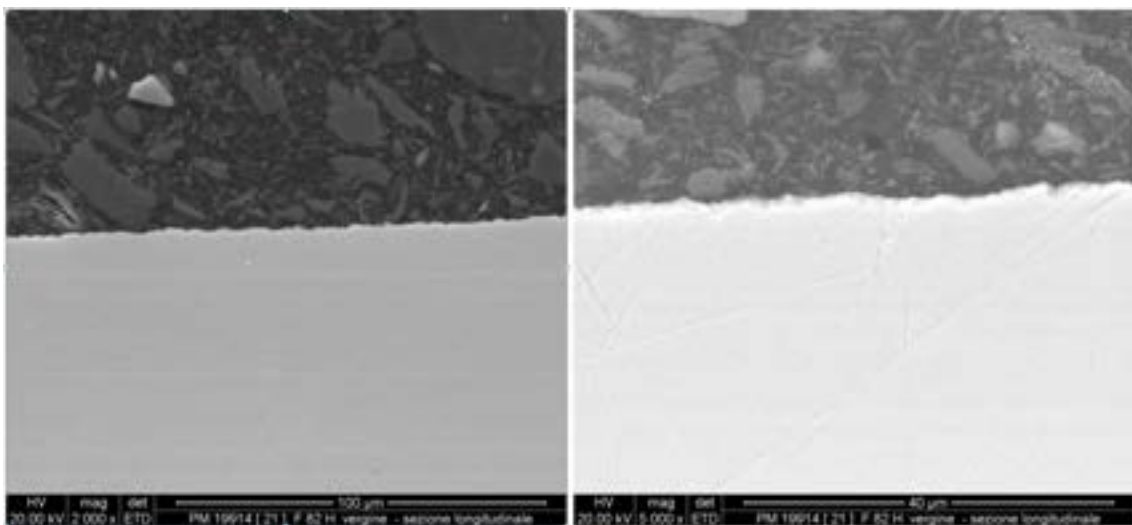
Figure 8: SEM images (secondary electrons) of a representative F82H specimen: longitudinal sections. The surface is in good shape (dark region in the top half is due to graphite, where the specimen is mounted in).

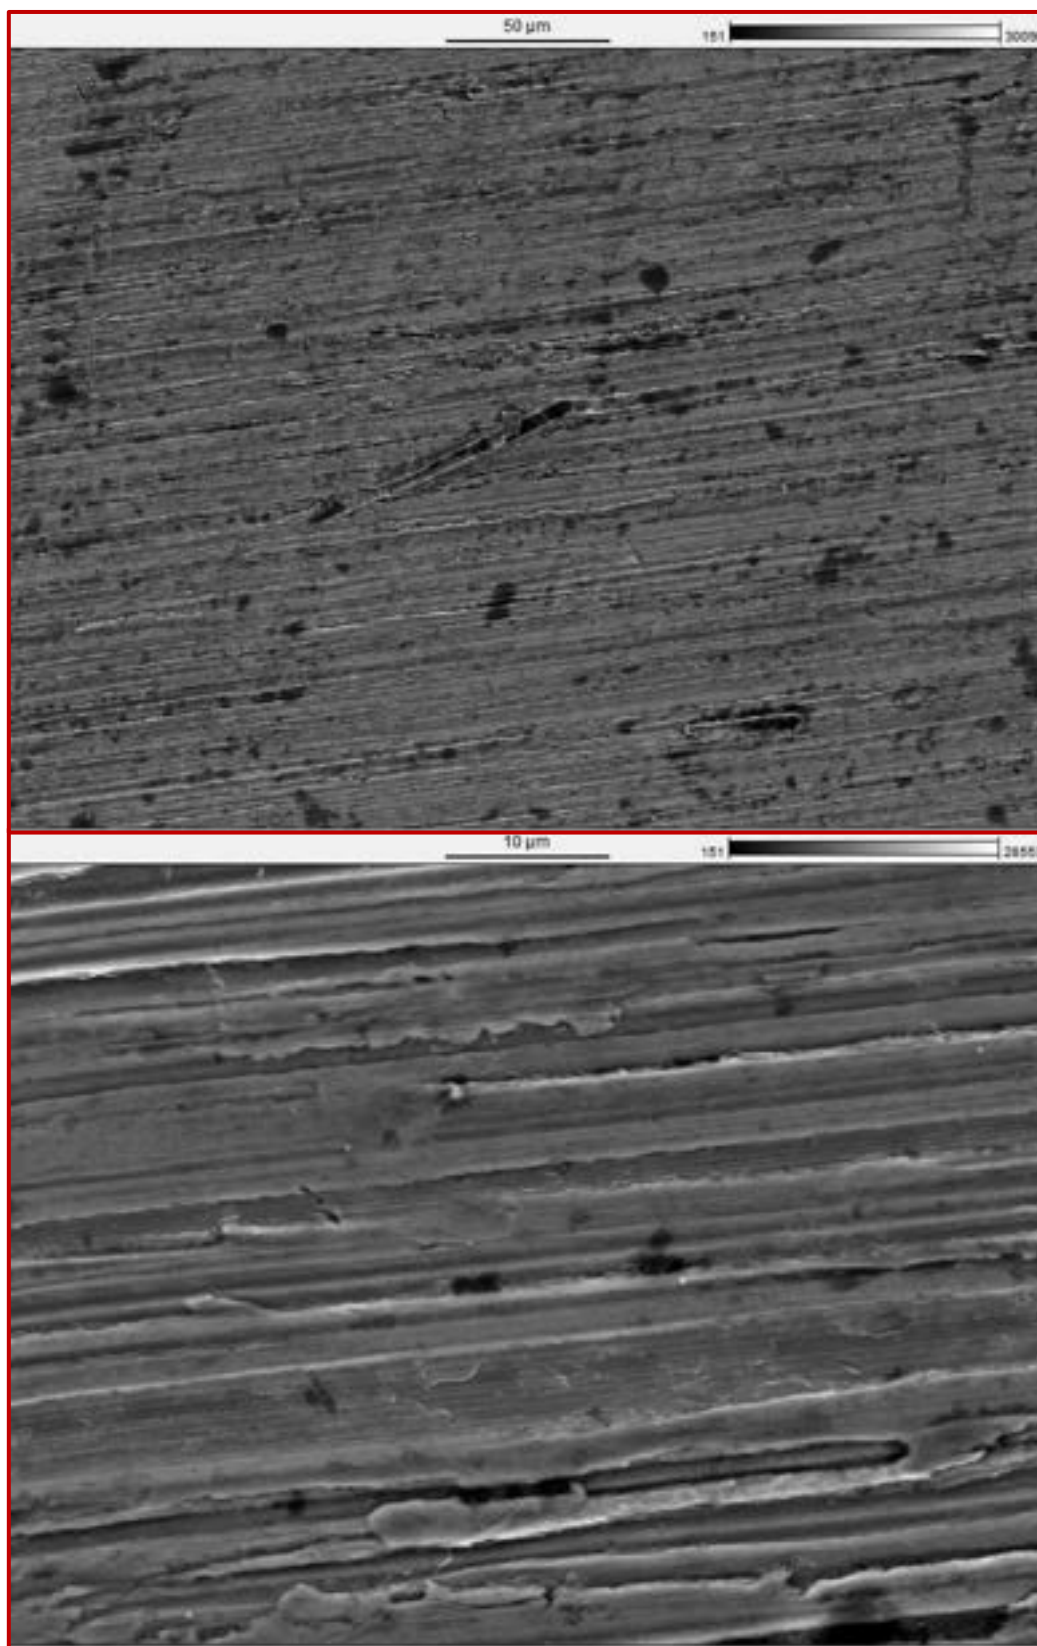
Figure 17: SEM images of specimen #10 surface (secondary electrons) at magnitude 400 X (top) and 2000 X (bottom). Scale bars above the images.

By comparing Figures 21 and 22 with the bottom half of Figure 17 (observations made at the same magnitude) it appears anyway a more 'granulose' profile of the specimen #12 surface compared to the fresh one.

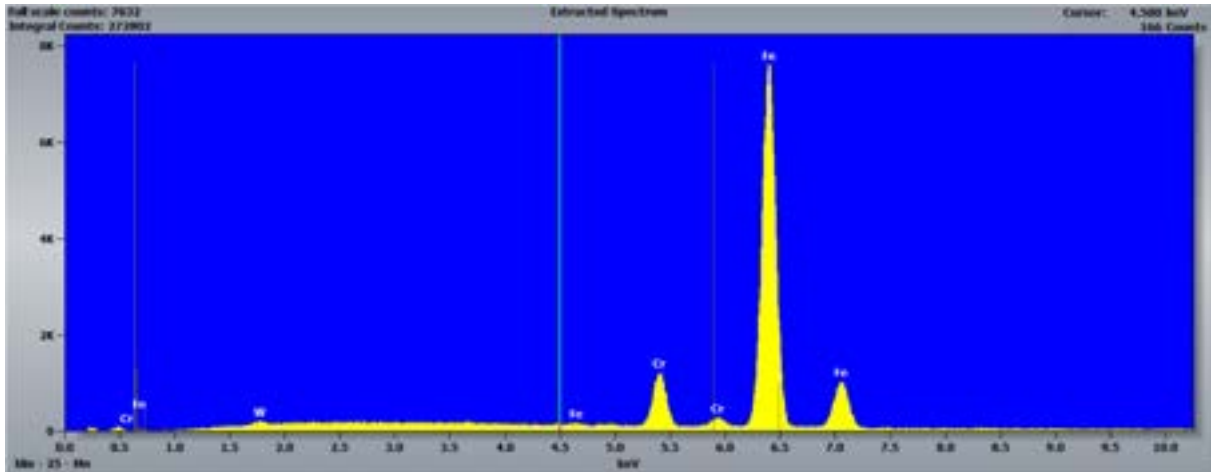
Figure 23: EDS spectrum obtained at specimen #12 surface

From the comparison with Table 5 values, it appears that Mn disappeared at the surface. A W peak is seen in Figure 23 spectrum, but it is very little and under the quantification limit, because almost indistinguishable from the background noise; it was therefore approximated as 0 in the table, indicating again a decrease from the unexposed specimen (#10) value. A depletion is finally measured also in Chromium content (-0.8% by weight). Iron is instead a bit increased, to compensate other elements diminutions.

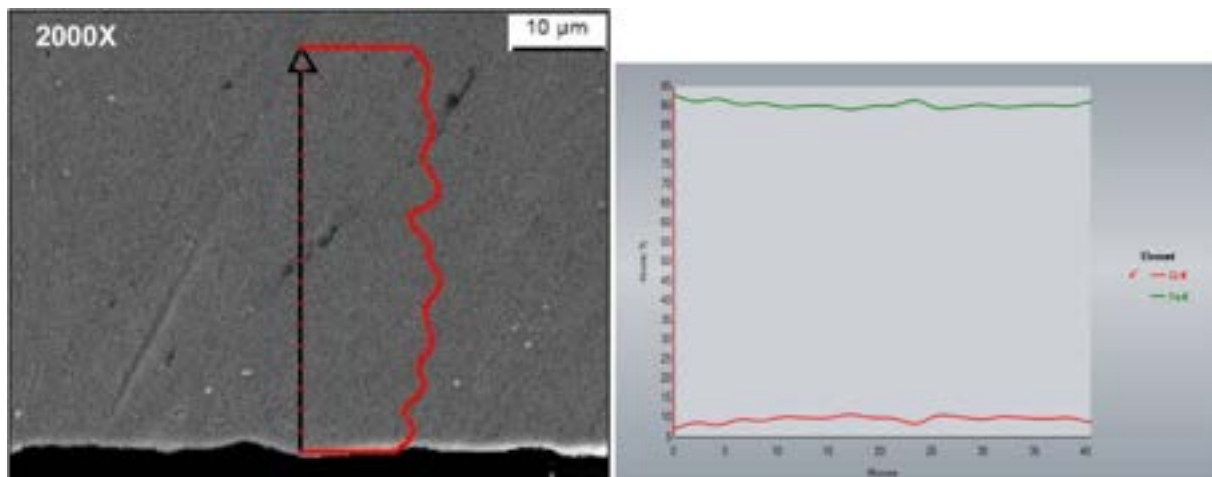
Finally, Figure 33 (left) shows a SEM image at 2000X of a representative cross section of specimen #7, together with the overlapped Chromium concentration vs depth profile, constructed by the EDS analysis of equidistant points (~ 2.0  $\mu\text{m}$  spaced), in the arrow direction. On the right side of Figure 33 is instead reported a graph showing the profiles of both Chromium and Iron elements along the arrow direction, where y-axis is the atomic % concentration, while x-axis indicates the distance from the surface (the surface position is on the left boundary of the graph, in correspondence of  $x = 0$ ). From the observation of Figure 33 left, it is possible to note that the internal specimen structure is in good condition, with no morphological alteration or grain detachment. The concentration profiles on the right indicate no increasing or decreasing trend of values moving inside the specimen; again, the first Cr value, on the left, results smaller than all the other, but only because it is associated to a measurement on the boundary of the sample, which is not physically meaningful. Small oscillations in Cr concentration are due to little local deviations from the theoretical alloy composition and/or to the analysis uncertainty; they are reflected by similar fluctuations of Iron concentrations, since, being other elements absent, Cr+Fe sum always makes 100.

**Figure 33: left: SEM image and Cr concentration profile (EDS) of specimen #7 section; right: Cr (red) and Fe (green) concentration profiles along the specimen section.**

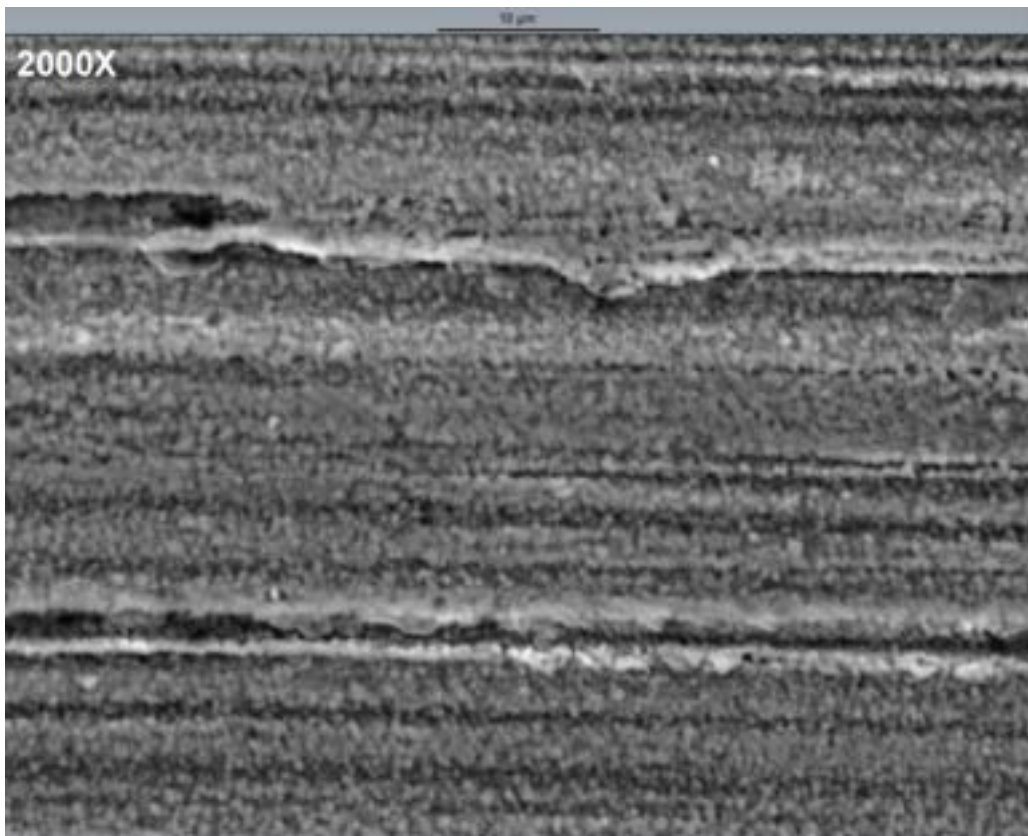
Figure 35 is instead a higher magnitude image (2000X) of another surface region. No alteration ascribable to corrosion phenomenon is detected here; it is however possible to note the general aspect of the surface, which results more granulose than before the exposure to the flowing liquid Lithium (by comparing with specimen #10 surface: Figure 17).

Figure 35: SEM image of specimen #8 surface (secondary electrons) at magnitude 400 X. Scale bar above the image.

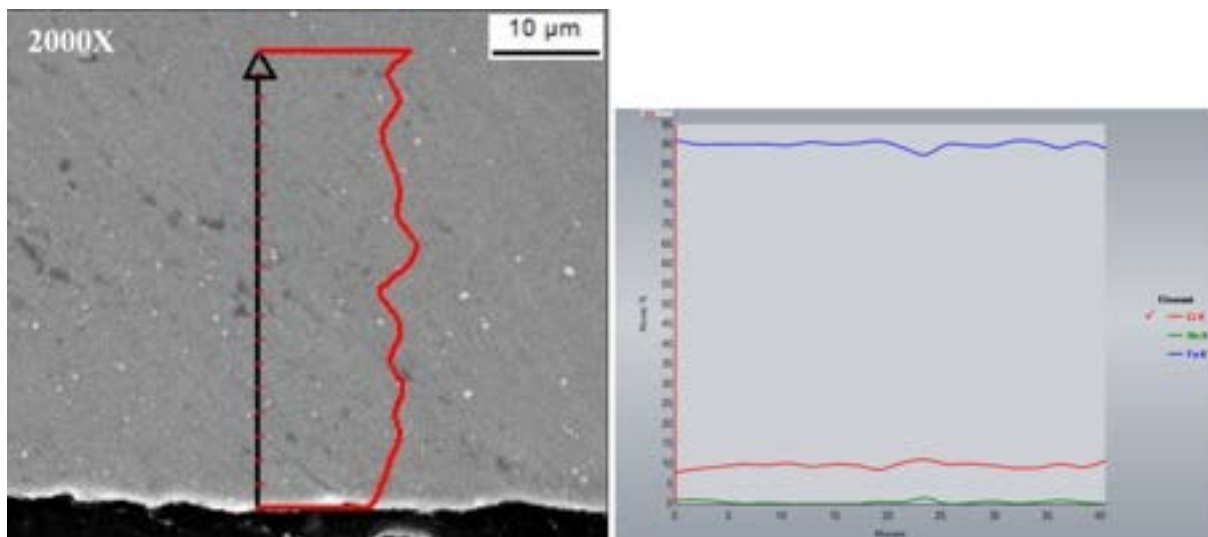
Finally, Figure 37 (left) shows a SEM image at 2000X of a representative cross section of specimen #8, together with the overlapped Chromium concentration vs depth profile, constructed by the EDS analysis of equidistant points (~ 2.2 μm spaced), in the arrow direction. On the right side of Figure 37 is instead reported a graph showing the profiles of Chromium, Iron and (this time) also Mn elements along the arrow direction, where y-axis is the atomic % concentration, while x-axis indicates the distance from the surface (the surface position is on the left boundary of the graph, in correspondence of x = 0). From the observation of Figure 37 left, it is possible to note that the internal specimen structure is in good condition, with no morphological alteration or grain detachment. The concentration profiles on the right indicate no increasing or decreasing trend of values moving inside the specimen. Small oscillations in Cr concentration are due to little local deviations from the theoretical alloy composition and/or to the analysis uncertainty; Mn concentration assumes of course very small values, according to the theoretical alloy composition and only in few cases it can be considered different from 0.

Figure 37: left: SEM image and Cr concentration profile (EDS) of specimen #8 section; right: Cr (red), Fe (blue) and Mn (green) concentration profiles along the specimen section.

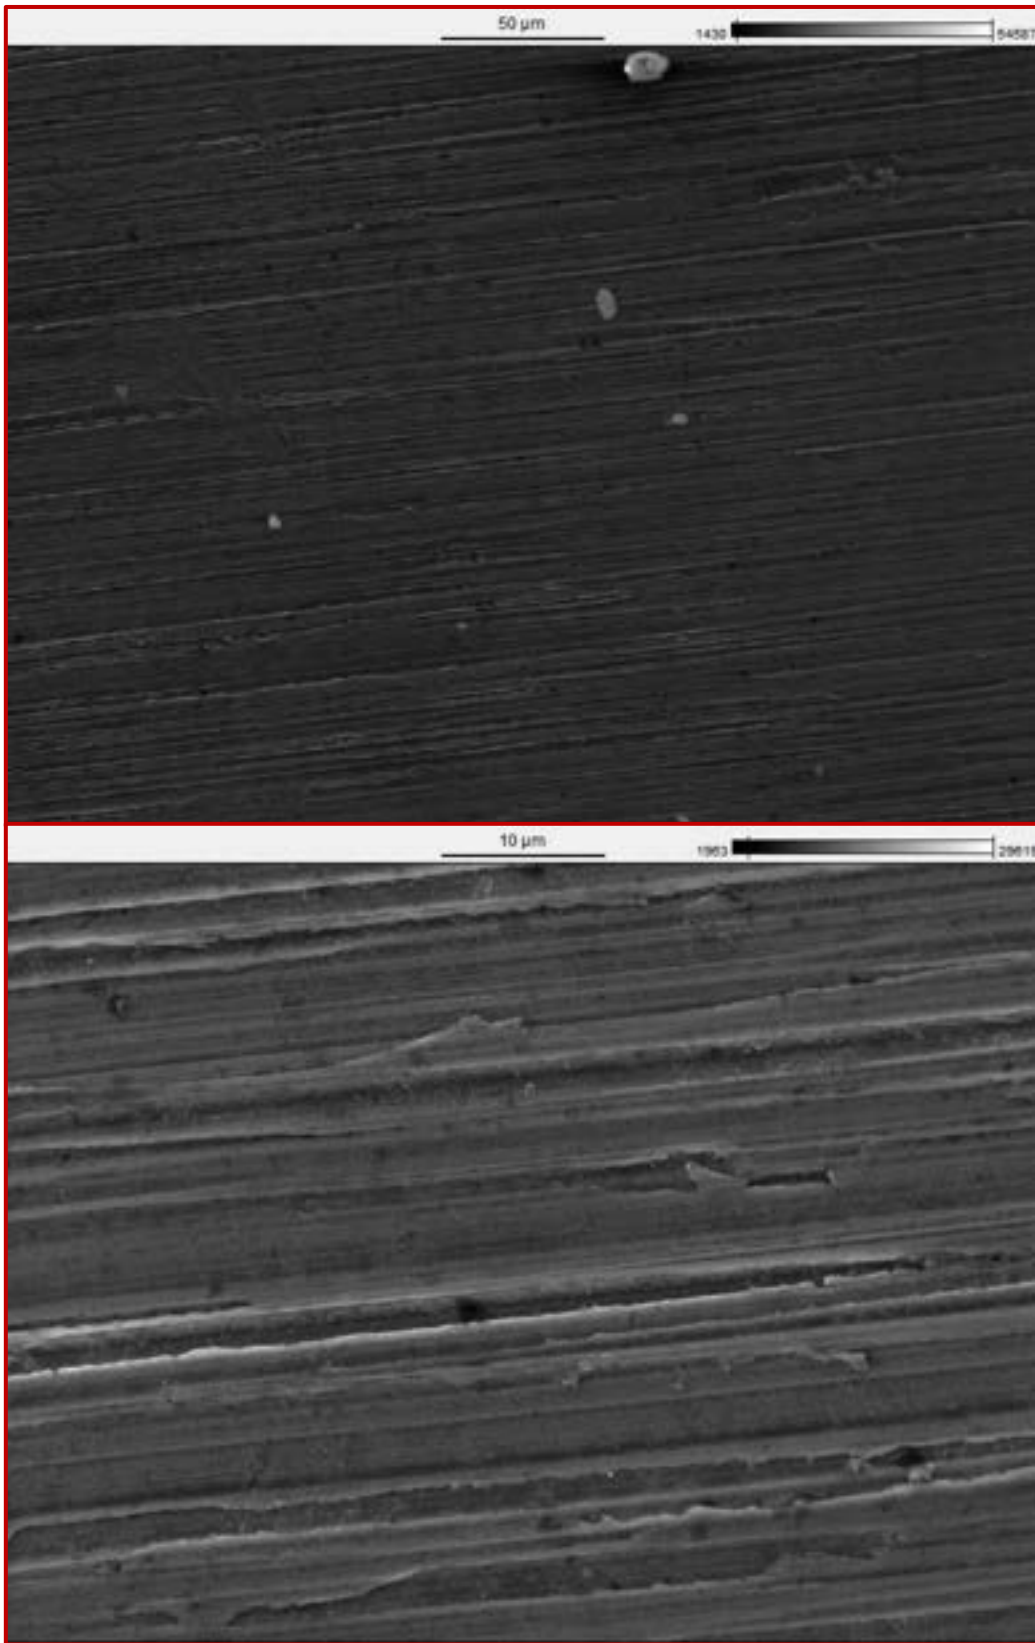
Figure 38 shows, at different magnitudes, the surface of a representative region of this specimen. As already observed for the Eurofer 97 specimens, also here the sample surface is characterized by the presence of signs due to the mechanical manufacturing, while surface alterations due to erosion-corrosion by Lithium are (of course) absent.

In [3] it was also shown that, differently from the above average composition, white particles like the ones visible in the top part of Figure 38 are characterized by a significant concentration of O, Na and mostly C and Ca (maybe some residue of alkaline carbonate). Since specimen #31 was not exposed to Lithium, surely the presence of the just mentioned elements must be ascribed to the sample handling and its treatment before the execution of the analysis. In any case this conclusion allows to exclude, also for the following, exposed specimens, that similar surface anomalies are somehow consequence of the action exerted by the liquid Lithium.

Figure 38: SEM images of specimen #31 surface (secondary electrons) at magnitude 400X (top) and 2000X (bottom). Scale bars above the images.

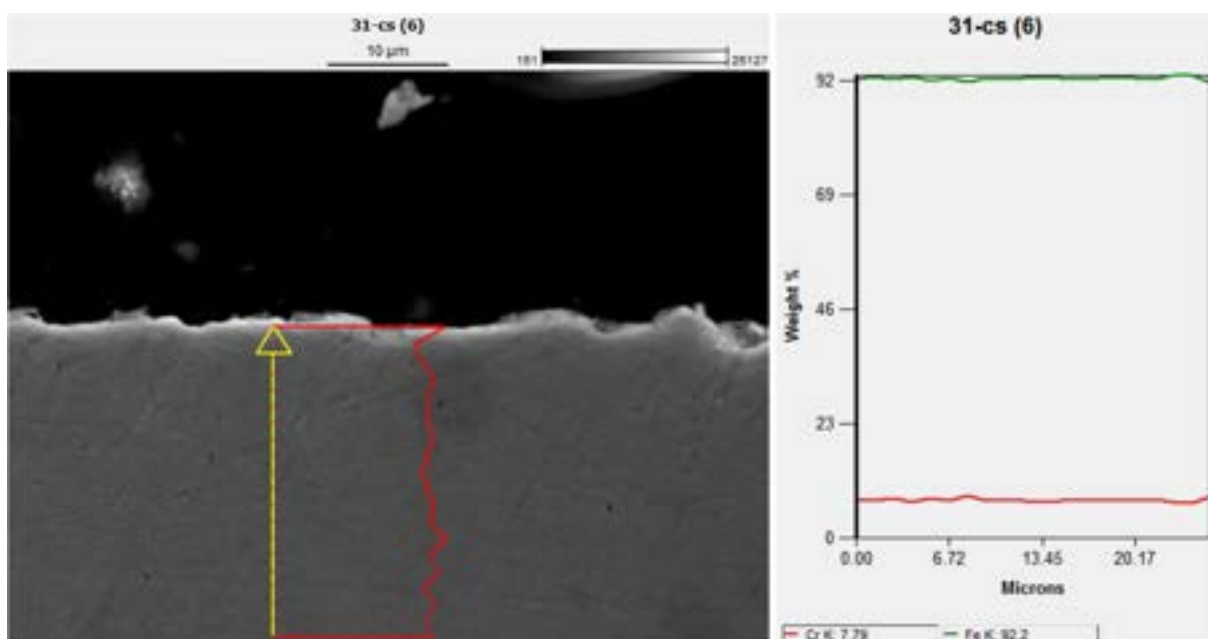
From the observation of the Figure, it is possible to note that the internal specimen structure is in good condition, with only some sign due to the cut and preparation of the sample, but no erosion-corrosion damage: this is of course what expected, since specimen #31 is an unexposed specimen. The concentration profiles indicate a substantial constancy of values, with minimal fluctuations due to the uncertainty in the EDS analysis result.

Figure 40: left: SEM image and Cr concentration profile (EDS) of specimen #31 cross section; right: Cr (red) and Fe (green) concentration profiles along the specimen section.

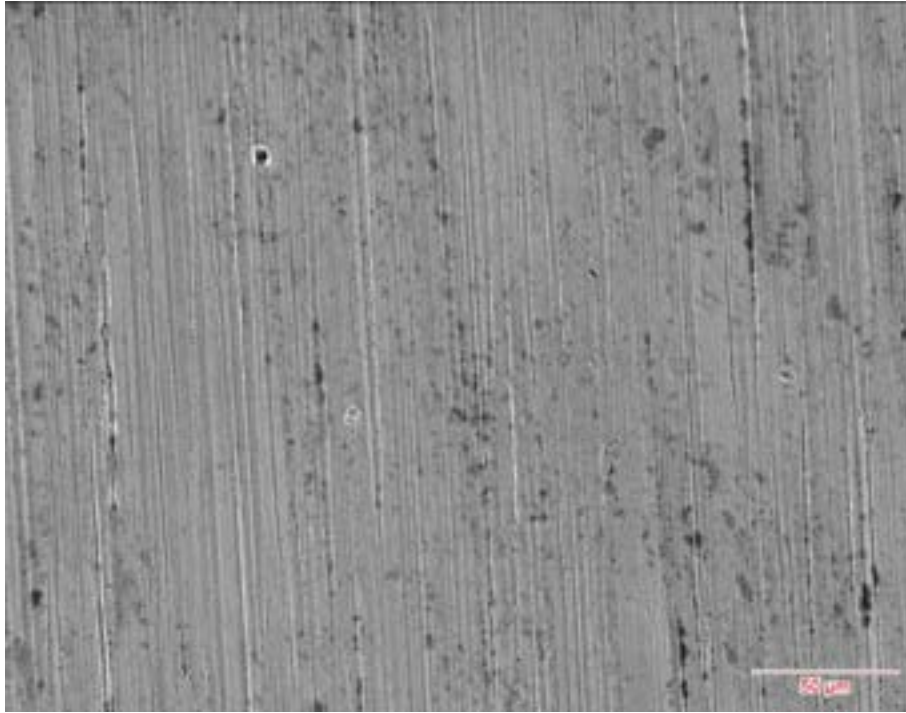
Figure 41: SEM image of specimen #32 surface (secondary electrons) at magnitude 400X. Scale bar above the image.

Apart from the usual stripes produced during the mechanical manufacturing of the sample, no significant morphological alteration, ascribable to corrosion phenomena, is seen. By comparing Figure 42 with the bottom half of Figure 38 (observations made at the same magnitude) it appears anyway a more ‘granulose’ profile of the specimen #32 surface compared to the fresh one.

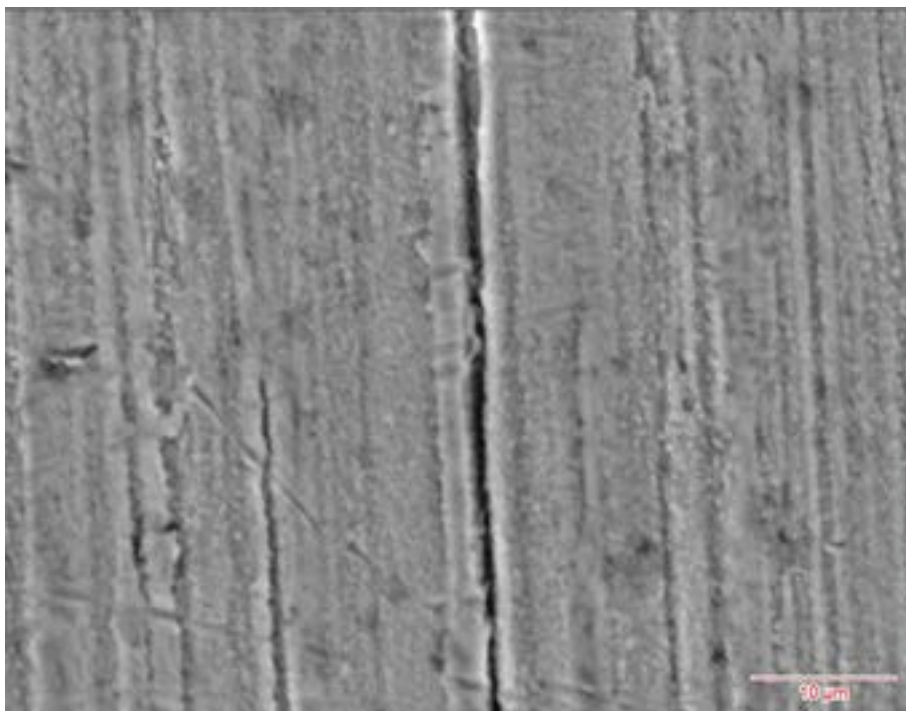
Figure 42: SEM image of spec. #32 surface (secondary electrons) at magnitude 2000X. Scale bar above the image.

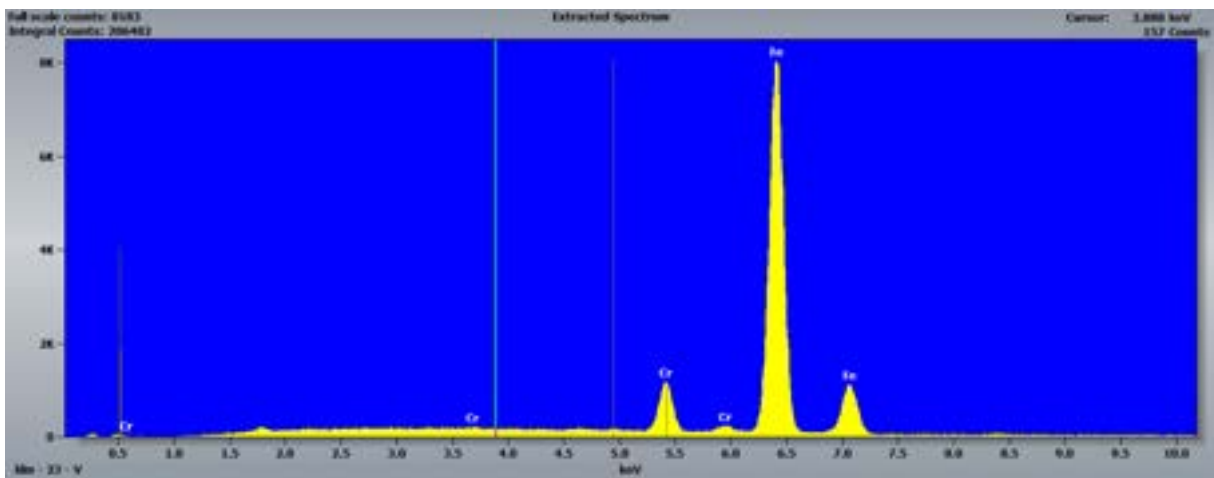
Figure 43 reports the average EDS spectrum of an external surface region; Table 11 summarizes the values of the related compositional analysis. Looking at the Figure, the peak of W is not easily distinguishable from the background noise, therefore this element concentration was not reported in Table 11. By comparing this table values with Table 10 ones, a Chromium depletion at the surface is also noted, corresponding to -1.1% by weight; Iron is instead a bit increased, to compensate other elements diminutions.

Figure 43: EDS spectrum obtained at specimen #32 surface

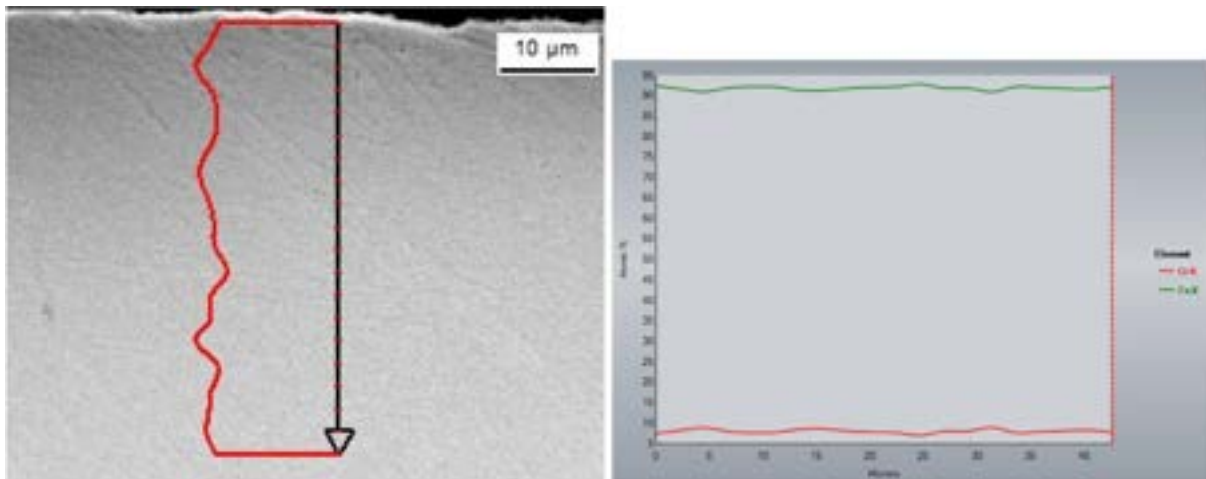
Finally, Figure 44 (left) shows a SEM image at 2000X of a representative cross section of specimen #32, together with the overlapped Chromium concentration vs depth profile, constructed by the EDS analysis of equidistant points (~ 2.2 μm spaced), in the arrow direction. On the right side of Figure 44 is instead reported a graph showing the profiles of Chromium and Iron elements along the arrow direction, where y-axis is the atomic % concentration, while x-axis indicates the distance from the surface (the surface position is on the left boundary of the graph, in correspondence of x = 0). From the observation of Figure 44 left, it is possible to note that the internal specimen structure is in good condition, with no morphological alteration or grain detachment. The concentration profiles on the right indicate no increasing or decreasing trend of values moving inside the specimen. Small oscillations in Cr concentration are due to little local deviations from the theoretical alloy composition and/or to the analysis uncertainty; specular fluctuations are seen in Fe concentration values, since the sum of Cr and Fe makes always 100.

Figure 44: left: SEM image and Cr concentration profile (EDS) of specimen #32 section; right: Cr (red) and Fe (green) concentration profiles along the specimen section.

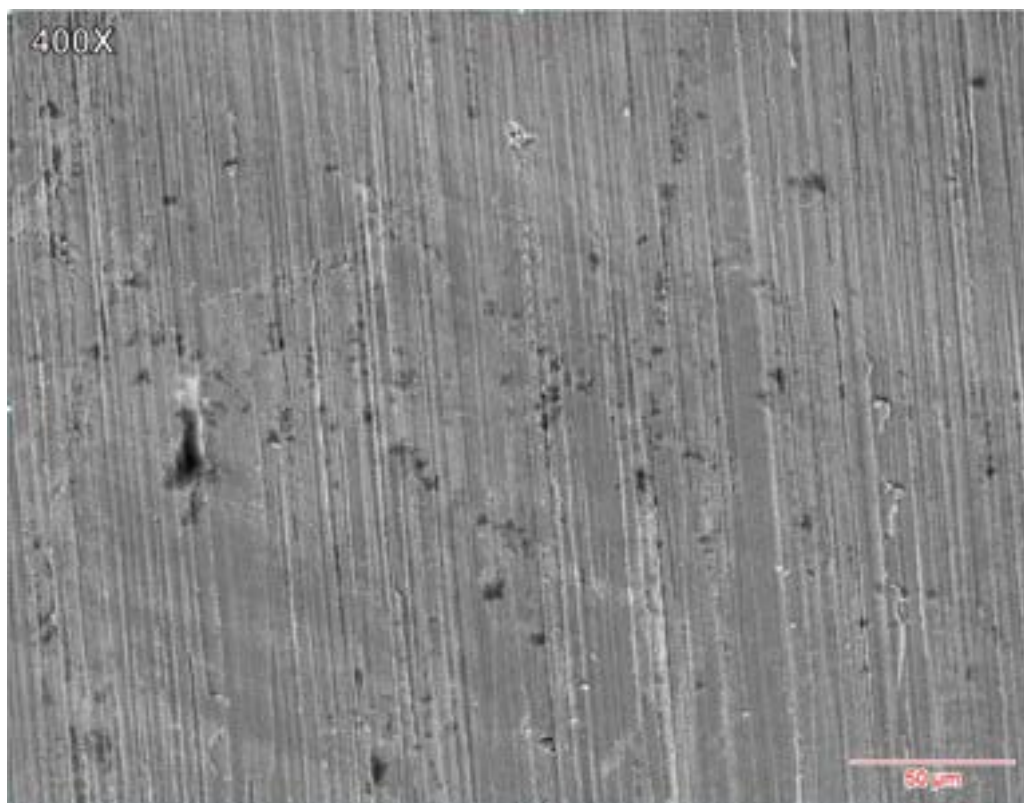
Figures 45 and 46 show, respectively at magnitude 400 and 2000X, 2 portions of the external surface of this specimen. In both these figures are visible the usual signs produced by mechanical manufacturing of the specimens, in the form of vertical stripes, which, at large magnifications, appear as narrow and shallow channels, as well as the black spots associated to sticked organic substances. By comparing Figure 46 with the bottom half of Figure 38 (observations made at the same magnitude), a more 'granulose' profile of the specimen #34 surface compared to the fresh one also appears.

Figure 45: SEM image of specimen #34 surface (secondary electrons) at magnitude 400X. Scale bar above the image.

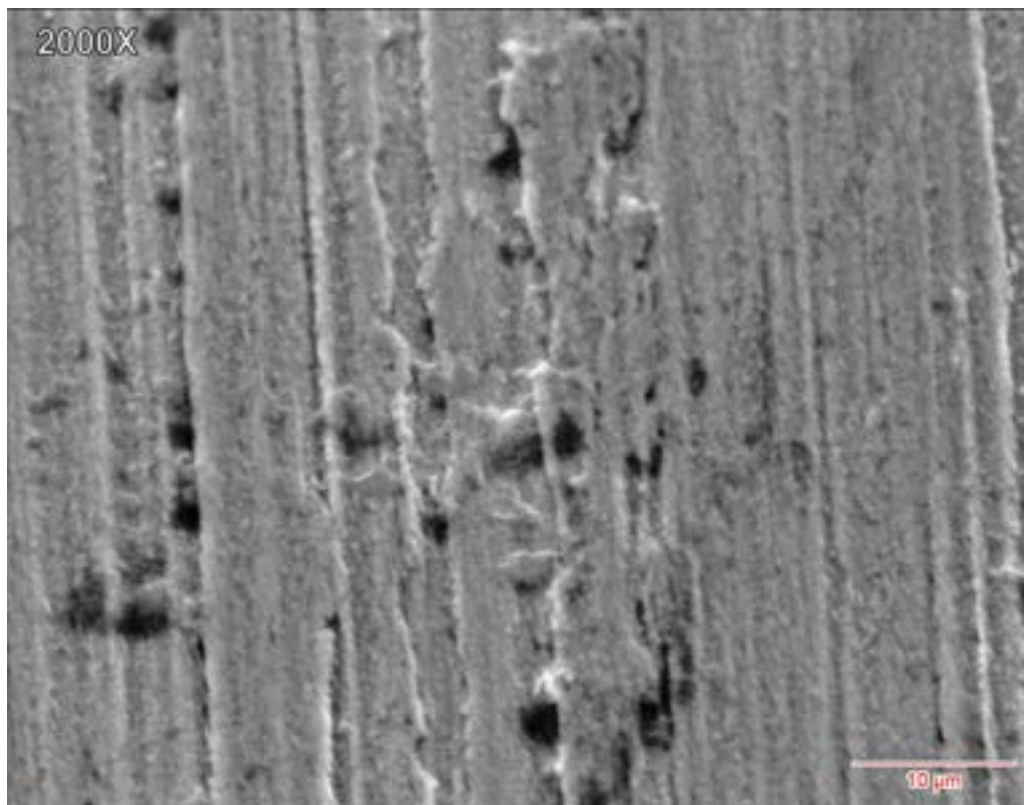
Figure 46: SEM image of spec. #34 surface (secondary electrons) at magnitude 2000X. Scale bar above the image.

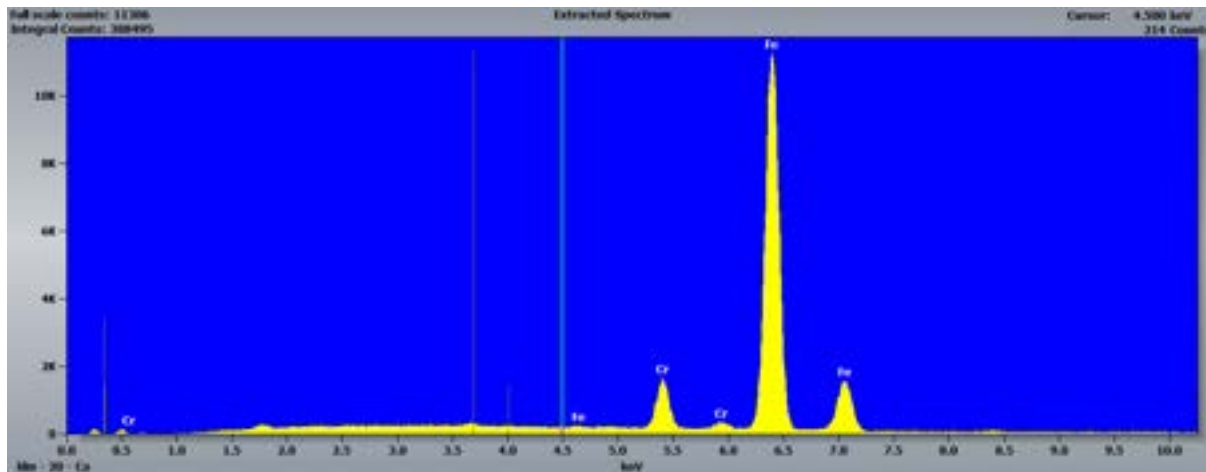
Figure 49 reports the average EDS spectrum of the whole region; Table 12 summarizes the values of the related compositional analysis. By comparing this table values with Table 10 ones, a Chromium depletion at the surface is also noted, corresponding to -1.5% by weight; Tungsten is below the quantification limit; Iron is instead a bit increased, to compensate other elements diminutions.

Figure 49: EDS spectrum obtained at specimen #34 surface

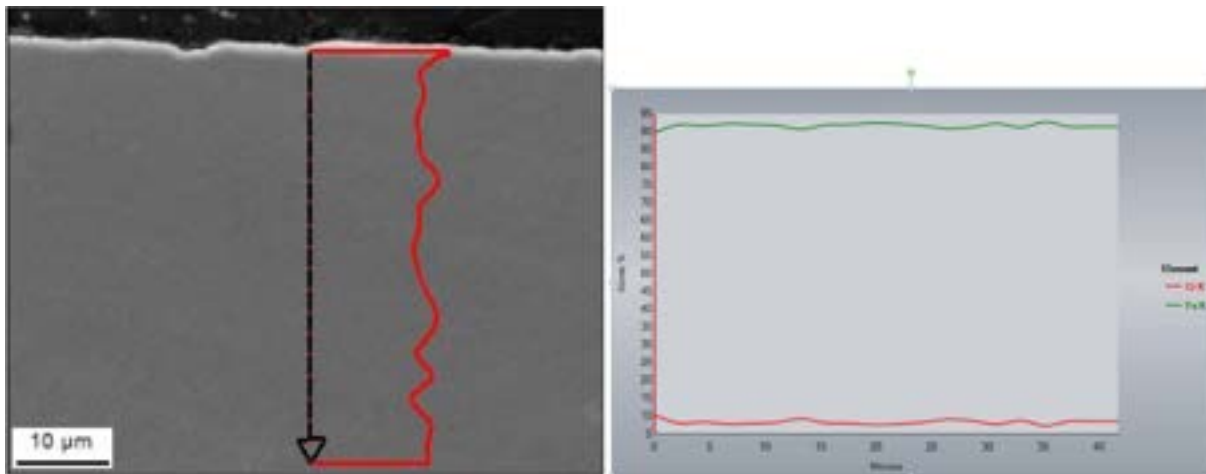
Finally, Figure 50 (left) shows a SEM image at 2000X of a representative cross section of specimen #34, together with the overlapped Chromium concentration vs depth profile, constructed by the EDS analysis of equidistant points (~ 2.2 μm spaced), in the arrow direction. On the right side of Figure 50 is instead reported a graph showing the profiles of Chromium and Iron elements along the arrow direction, where y-axis is the atomic % concentration, while x-axis indicates the distance from the surface (the surface position is on the left boundary of the graph, in correspondence of x = 0). From the observation of Figure 50 left, it is possible to note that the internal specimen structure is in good condition, with no morphological alteration or grain detachment. The concentration profiles on the right indicate no increasing or decreasing trend of values moving inside the specimen. Small oscillations in Cr concentration are due to little random deviations from the theoretical alloy composition and/or to the analysis uncertainty; specular fluctuations are seen in Fe concentration values, since the sum of Cr and Fe makes always 100.

**Figure 50: left: SEM image and Cr concentration profile (EDS) of specimen #34 section; right: Cr (red) and Fe (green) concentration profiles along the specimen section.**

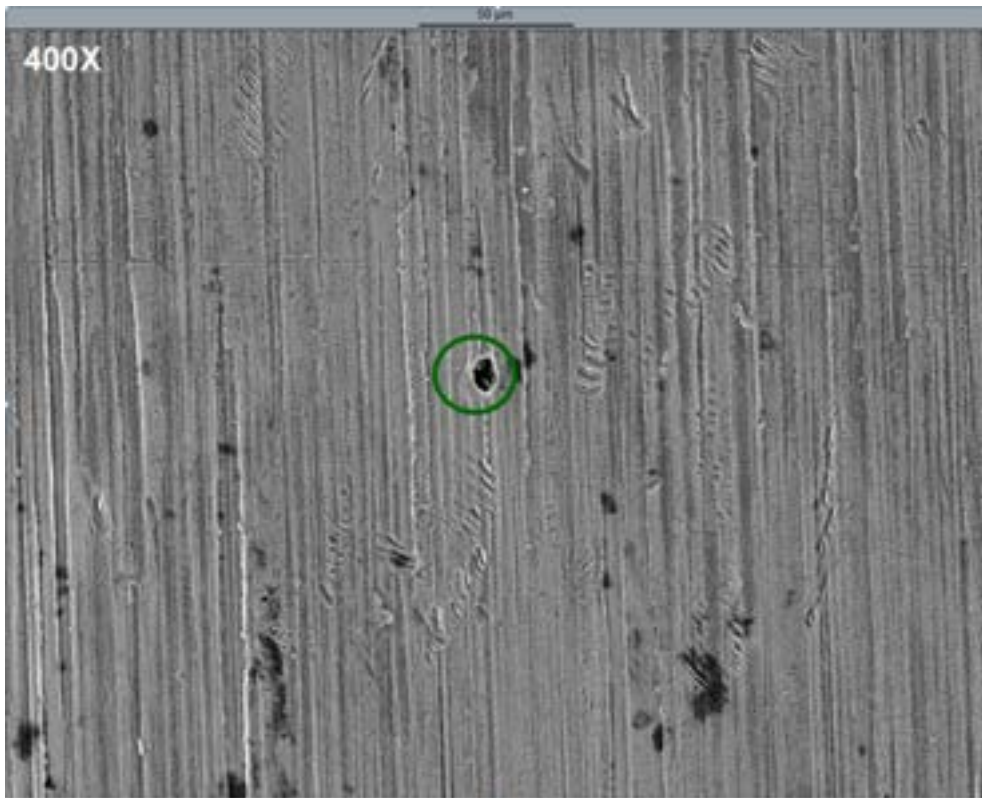
Now let's look at the F82H specimens exposed to flowing Lithium for a total time of 4000 hours, starting with specimen #28. Figure 51 shows, at magnitude 400X, a region of the external surface of this specimen. Apart from the usual vertical stripes produced during the manufacturing of the sample, additional mechanical alterations like scratches and abrasions are visible, which are not indicative however of a corrosion action exerted by Lithium. In the centre of Figure 51 is instead detected a roundish dark object (circled in green), which, especially when observed at higher magnification (Figure 52, 2000X), reveals its nature of cavity originated in response to a corrosion phenomenon.

Figure 51: SEM image of specimen #28 surface (secondary electrons) at magnitude 400X. Scale bar above the image

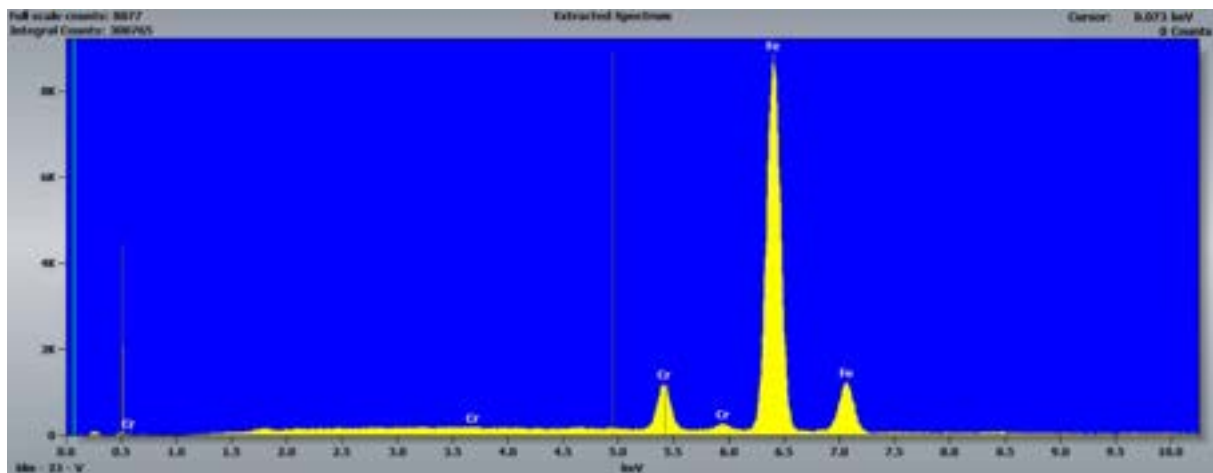
The average EDS spectrum of a large surface region ( $\sim 160 \times 130 \mu\text{m}^2$ ) around the discussed cavity is shown in Figure 53; Table 13 reports the concentration values calculated from those peaks. Again, as for the previously discussed specimens, the Tungsten surface concentration decreased below the quantification limit, a Chromium depletion was observed (-1.6% by weight) and Iron increased a bit, to compensate other elements diminutions.

Figure 53: EDS spectrum obtained at specimen #28 surface

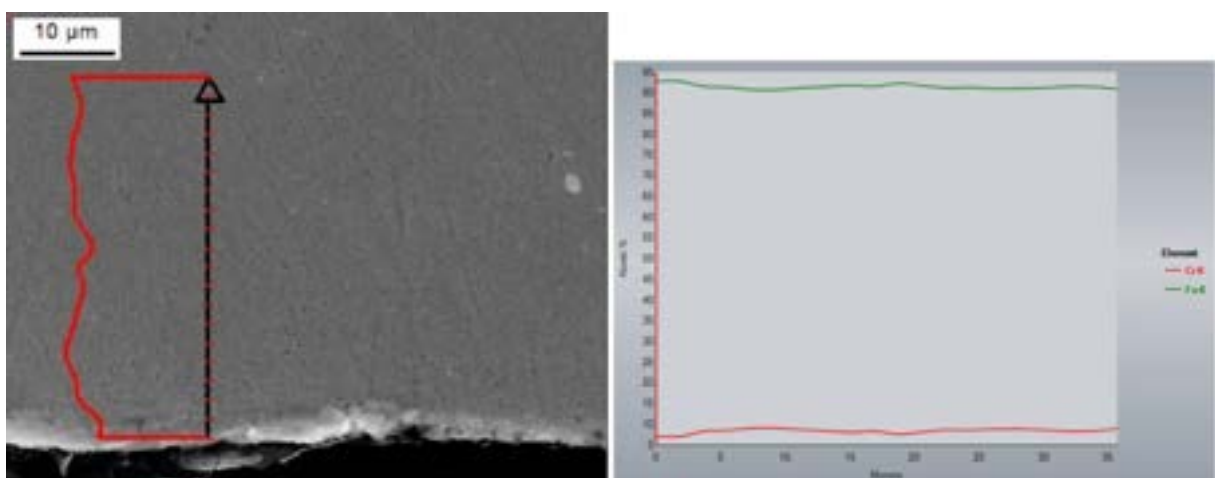
Finally, Figure 54 (left) shows a SEM image at 2000X of a representative cross section of specimen #28, together with the overlapped Chromium concentration vs depth profile, constructed by the EDS analysis of equidistant points ( $\sim 2 \mu\text{m}$  spaced), in the arrow direction. On the right side of Figure 54 is instead reported a graph showing the profiles of Chromium and Iron elements along the arrow direction, where y-axis is the atomic % concentration, while x-axis indicates the distance from the surface (the surface position is on the left boundary of the graph, in correspondence of  $x = 0$ ). From the observation of Figure 54 left, it is possible to note that the internal specimen structure is in good condition, with no morphological alteration or grain detachment. The concentration profiles on the right indicate no increasing or decreasing trend of values moving inside the specimen (the first Cr point, on the left extremity, corresponds the smallest concentration value, but it is not physically sure, since measured too close to the border of the specimen). Small oscillations in Cr concentration are due to little local deviations from the theoretical alloy composition and/or to the analysis uncertainty; specular fluctuations are seen in Fe concentration values, since the sum of Cr and Fe makes always 100.

Figure 54: left: SEM image and Cr concentration profile (EDS) of specimen #28 section; right: Cr (red) and Fe (green) concentration profiles along the specimen section.

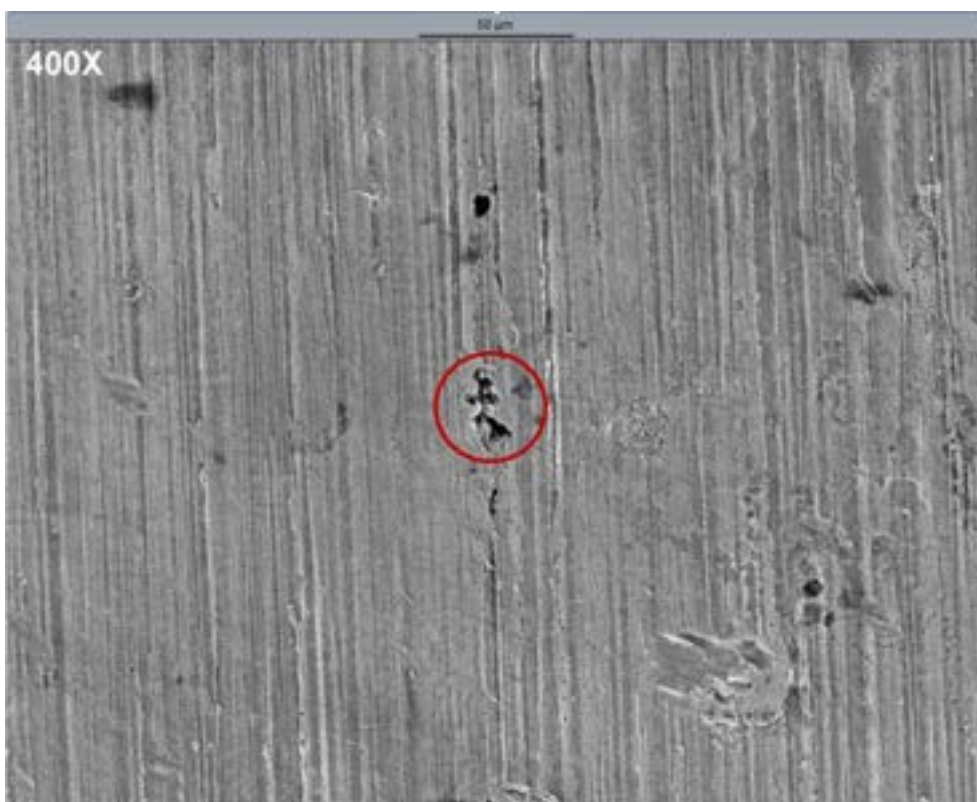
Last, but not least, specimen #29. Figure 55 shows, at magnitude 400X, a region of the external surface of this specimen. The general appearance of the surface is good, and characterized by the usual vertical stripes originated during the manufacturing of the sample. Anyway some localized alterations produced by corrosion phenomena are also visible, in the form of small pits and ulcerations; one of them, circled in red in Figure 55, can be better observed in the enlargement (4000X) reported in Figure 56.

Figure 55: SEM image of specimen #29 surface (secondary electrons) at magnitude 400X. Scale bar above the image.

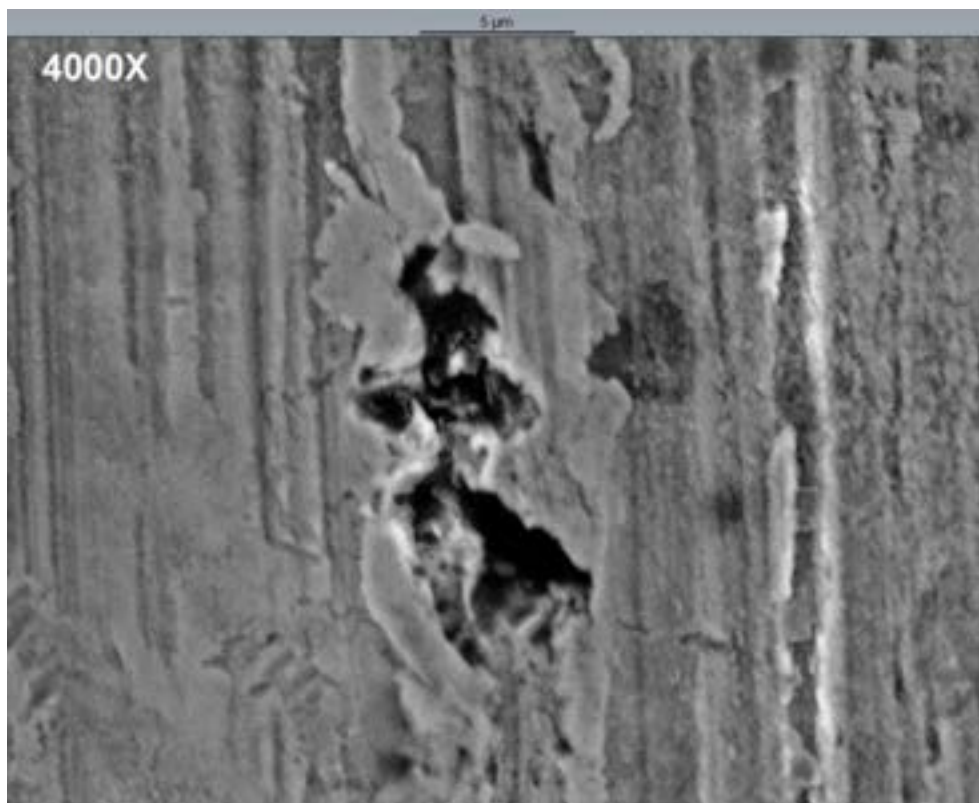
Figure 56: SEM image of specimen #29 surface (secondary electrons) at magnitude 4000X (enlargement of Figure 55). Scale bar above the image.

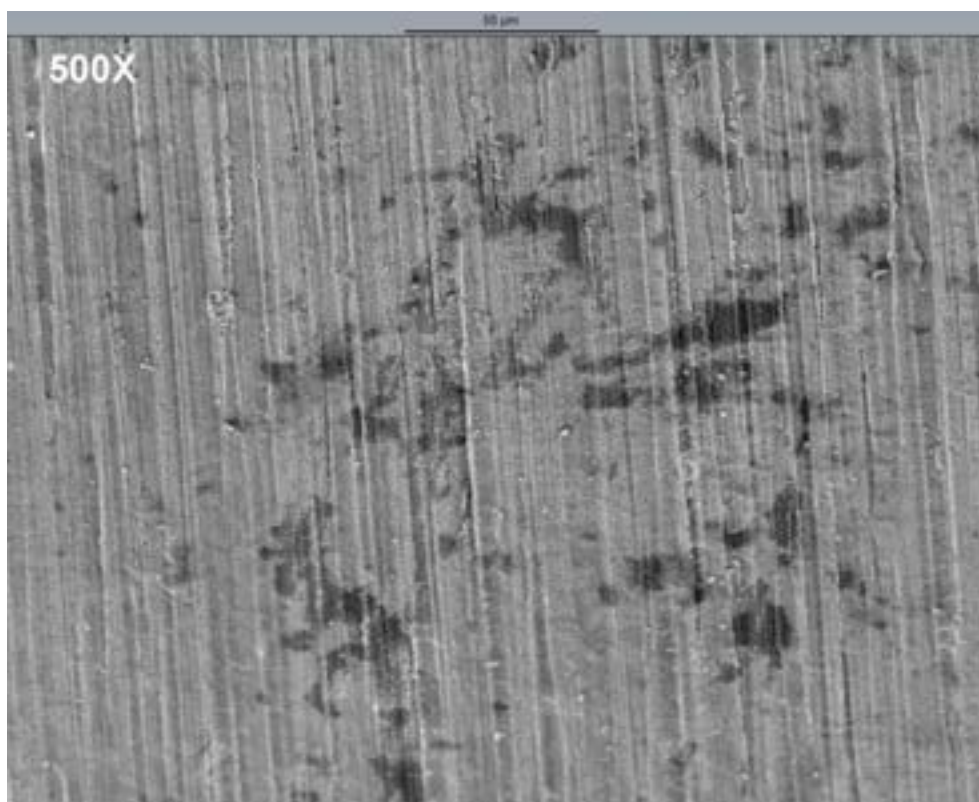
On the surface of specimen #29 are present also a lot of dark spots, probably due to organic substance, as evidenced by Figure 57 (500X); moreover, when enlarging the centro-left/bottom of this figure to Figure 58 (4000X), in correspondance of these spots the surface seems also affected by a more pronounced degradation.

Figure 57: SEM image of an other portion of specimen #29 surface (secondary electrons) at magnitude 500X. Scale bar above the image.
