## Risultati relativi alla campagna sperimentale di medio termine sui fenomeni di erosione/corrosione da Litio liquido fluente nell'impianto Lifus 6

P. Favuzza, M. Cuzzani, V. Cuzzola, G. Fasano, A. Ventura (ENEA)

Settembre 2017

Progetto: B.3.2 – Attività di Fisica della Fusione Complementari a ITER

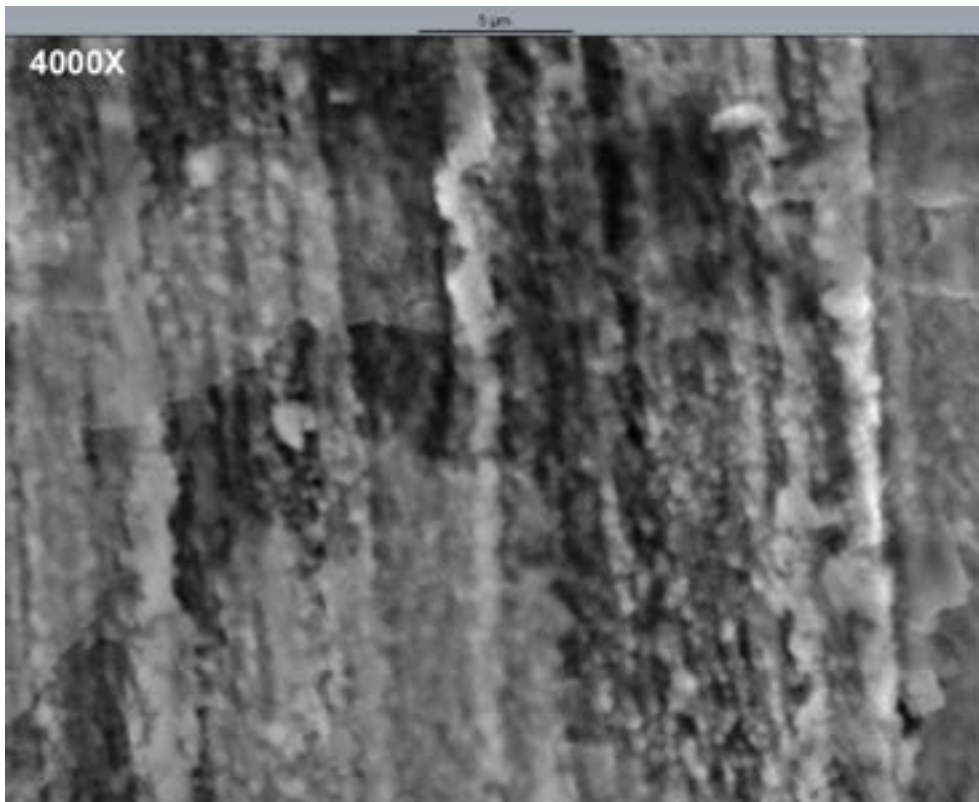
On the surface of specimen #29 are present also a lot of dark spots, probably due to organic substance, as evidenced by Figure 57 (500X); moreover, when enlarging the centro-left/bottom of this figure to Figure 58 (4000X), in correspondance of these spots the surface seems also affected by a more pronounced degradation.

Figure 58: SEM image of specimen #29 surface (secondary electrons) at magnitude 4000X (enlargement of Figure 57). Scale bar above the image.

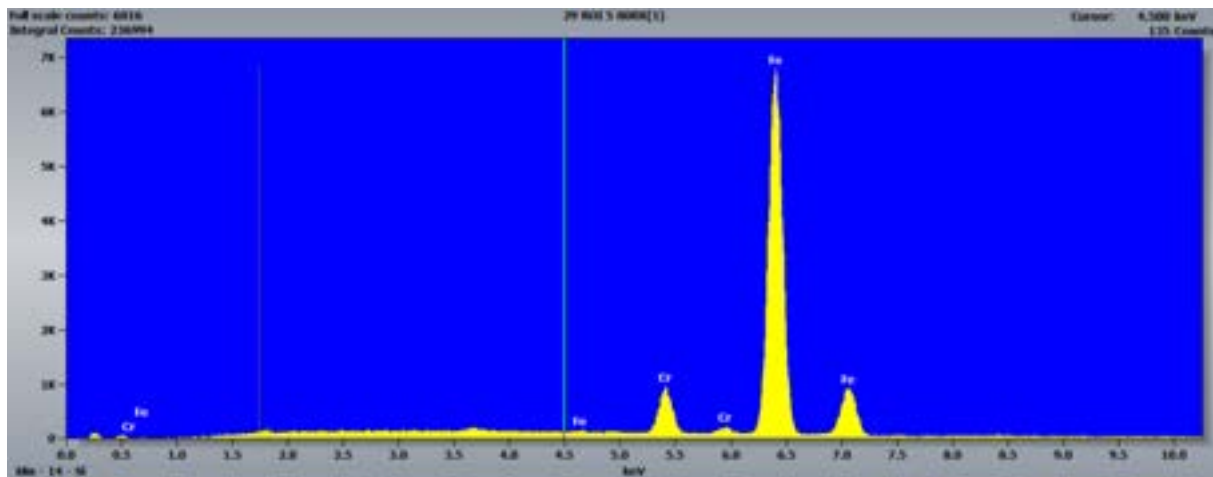
Figure 59 summarizes the EDS analysis outcome reporting the average spectrum of a large, intact, surface region; Table 14 converts it in weight % concentration numbers. The average chemical composition at the surface is very similar to the one measured for specimen #28 after the erosion-corrosion test (Table 10) and indicates a Chromium depletion equal to -1.6% by weight. Other elements are not found in a quantifiable amount. The rest of the analyzed material is then Iron.

Figure 59: EDS spectrum obtained at specimen #29 surface

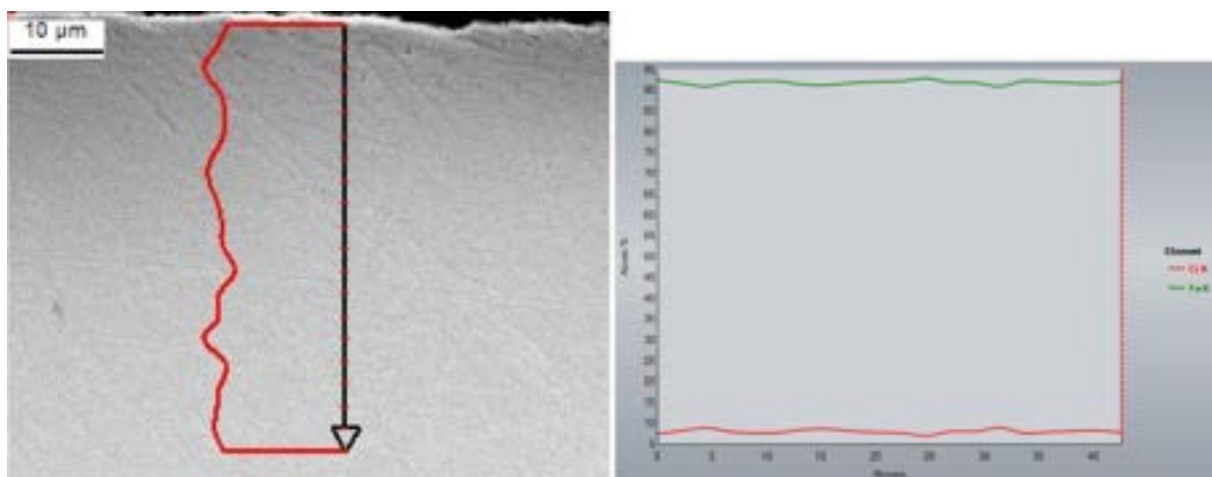
Finally, Figure 60 (left) shows a SEM image at 2000X of a representative cross section of specimen #29, together with the overlapped Chromium concentration vs depth profile, constructed by the EDS analysis of equidistant points (~ 2 μm spaced), in the arrow direction. On the right side of Figure 60 is instead reported a graph showing the profiles of Chromium and Iron elements along the arrow direction, where y-axis is the atomic % concentration, while x-axis indicates the distance from the surface (the surface position is on the left boundary of the graph, in correspondence of  $x = 0$ ). From the observation of Figure 60 left, it is possible to note that the internal specimen structure is in good condition, with no morphological alteration or grain detachment. The concentration profiles on the right indicate no increasing or decreasing trend of values moving inside the specimen. Small oscillations in Cr concentration are due to little local deviations from the theoretical alloy composition and/or to the analysis uncertainty; specular fluctuations are seen in Fe concentration values, since the sum of Cr and Fe makes always 100.

**Figure 60: left: SEM image and Cr concentration profile (EDS) of specimen #29 section; right: Cr (red) and Fe (green) concentration profiles along the specimen section.**
